## **AIRCRAFT ACCIDENT REPORT**

**IN-FLIGHT FIRE AND IMPACT WITH TERRAIN**  
**VALUJET AIRLINES FLIGHT 592**  
**DC-9-32, N904VJ**  
**EVERGLADES, NEAR MIAMI, FLORIDA**  
**MAY 11,1996**

AIRCRAFT ACCIDENT REPORT  
NTSB/AAR-97/06(PB97-910406)

**Adopted: August 19, 1997  
Notation 6704B**

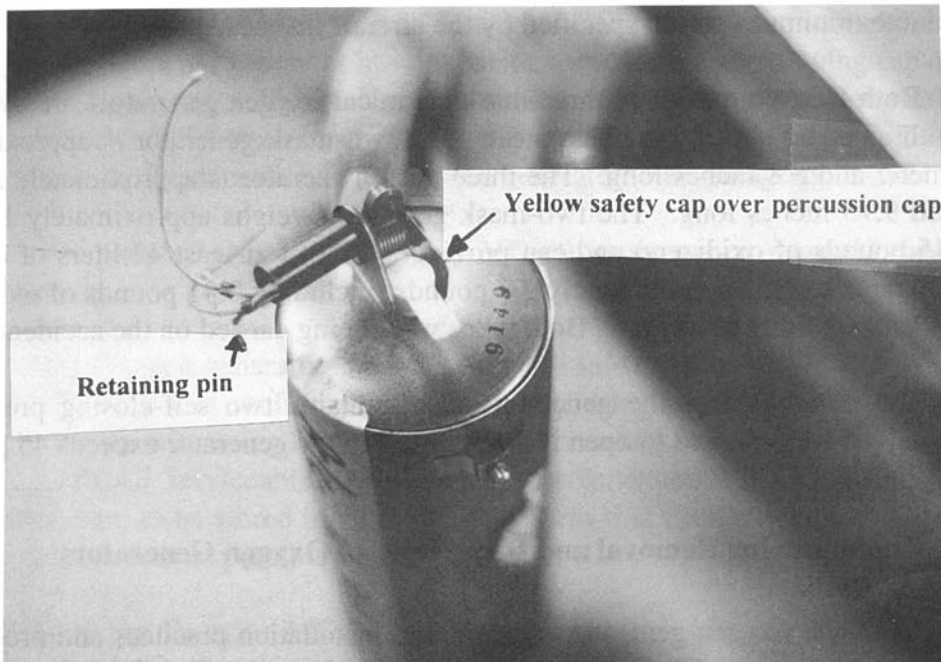
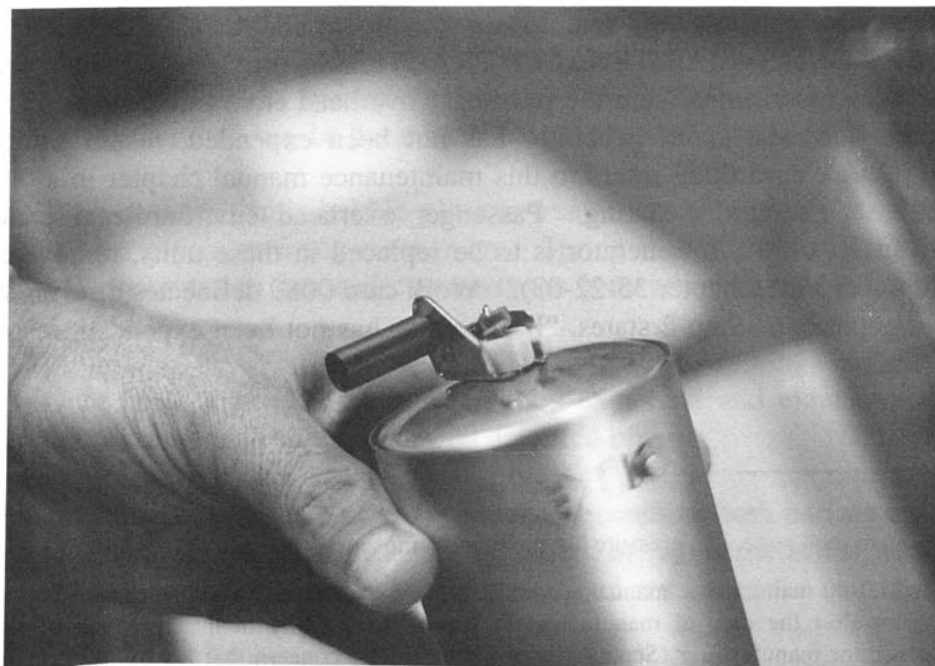
Figure 2b—Photographs of passenger oxygen generator unit

The chemical reaction is exothermic, which means that it liberates heat as a byproduct of the reaction. This causes the exterior surface of the oxygen generator to become very hot; the maximum temperature of the exterior surface of the oxygen generator during operation is limited by McDonnell Douglas specification to 547 °F when the generator is operated at an ambient temperature of 70 to 80 °F. Manufacturing test data indicate that when operated during tests, maximum shell temperatures typically reach 450 to 500 °F.

Both the two-mask and three-mask chemical oxygen generators are cylindrical in appearance with an outer skin of stainless steel. The two-mask generator is approximately 2.5 inches in diameter and 8.8 inches long. The three-mask generator is approximately 2.75 inches in diameter and 9.75 inches long. The two-mask generator weighs approximately 1.25 pounds (including 0.45 pounds of oxidizers) and can provide a total of at least 42 liters of oxygen; the three-mask generator weighs approximately 1.7 pounds (including 0.81 pounds of oxidizers) and can produce at least 62 liters of oxygen. Both types were being carried on the accident airplane.

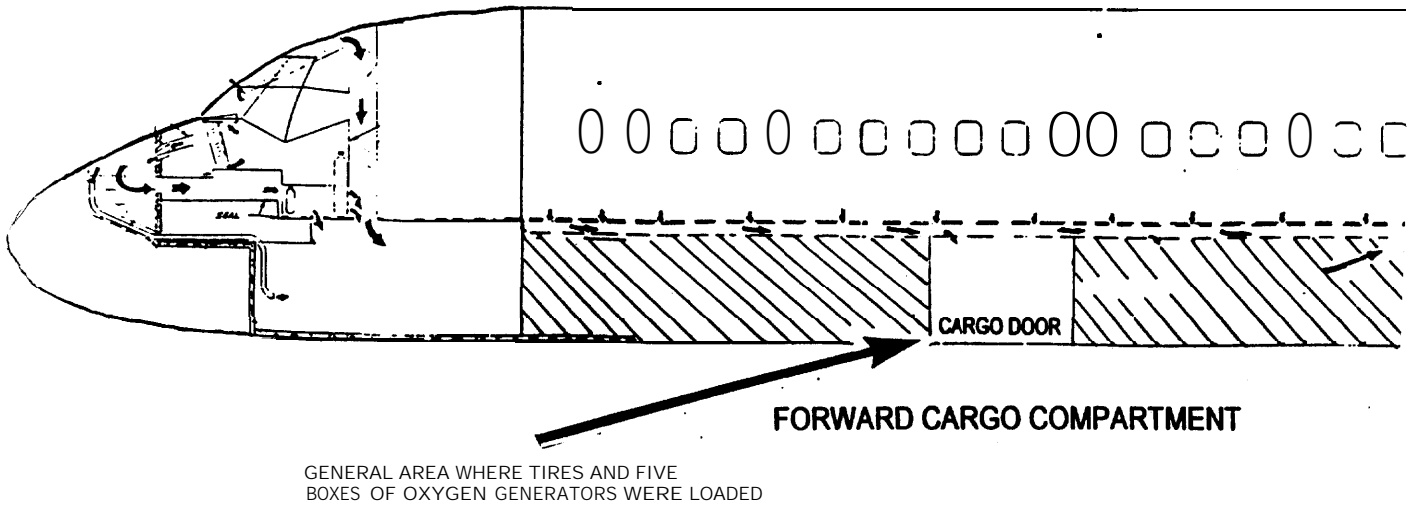
Figure 3—Forward cargo compartment

The accident airplane was equipped with two class D cargo compartments. (See figure 3—forward cargo compartment.) The volume of the forward cargo compartment in the DC-9 airplane is about 560 cubic feet.

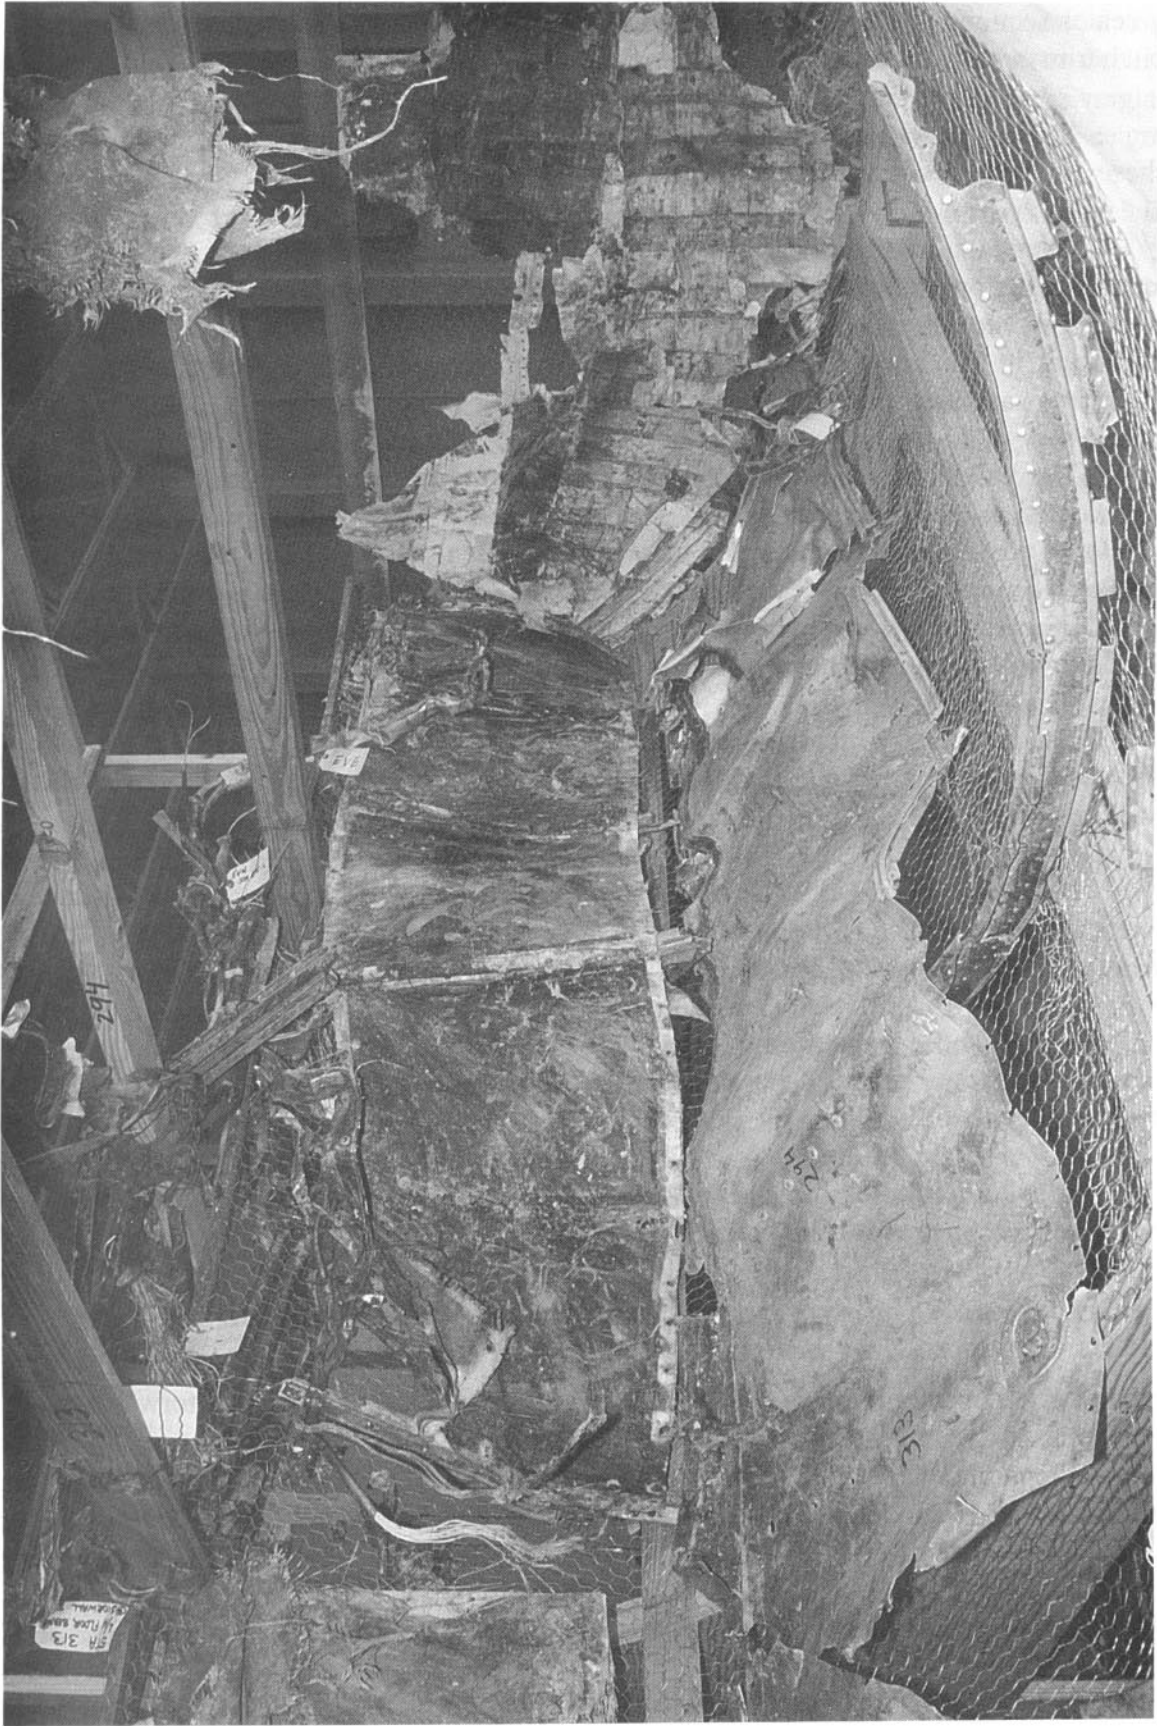
Figure 5—Cargo compartment mockup

these pieces, which included the cargo floor, cargo liners, and fuselage structure, exhibited soot and heat damage.
