For sale by Clearinghouse for Federal Scientific and Technical Information, U.S. Department of Commerce, Springfield, Va. 22151 Annual subscription price \$12.00 Domestic; \$15.00 Foreign: Single copy \$0.00; Microfiele \$0.65, Report Number: NTSB-AAR-70-15

ALLEGHENY AIRLINES, INC., DC-9, N988VJ AND A FORTH CORPORATION, PIPER PA-28, N7374J 4 MILES NORTHWEST OF FAIRLAND, INDIANA SEPTEMBER 9, 1969

NATIONAL TRAISPORTATION SAFETY BOARD DEPARIMENT OF TRANSPORTATION AIRCRAFT ACCIDENT REPORT

Adopted: July 15, 1970

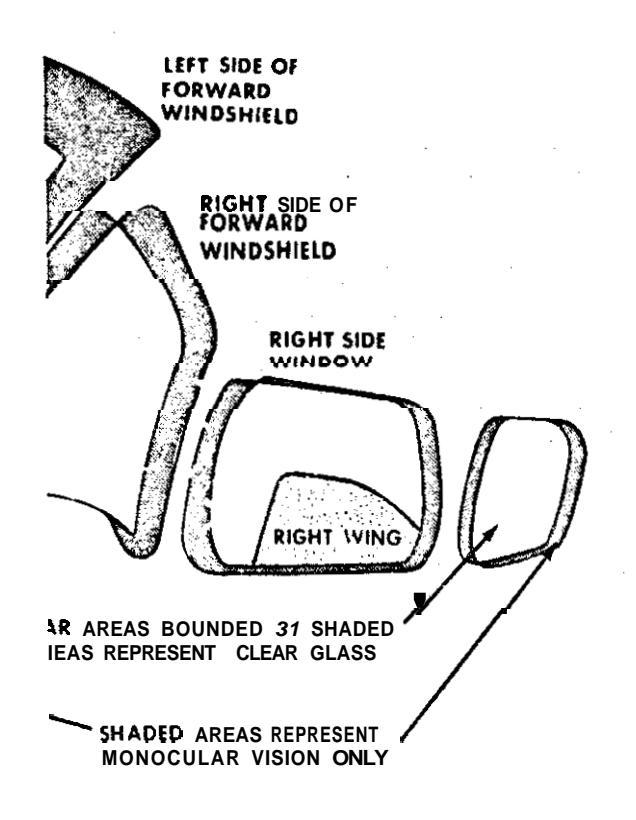
CALCULATED PIPER CHEROKEE (PA-28-140B) PILOTS VIEW NORMAL POSITION

A cockpit visibility study was conducted to determine the physical limitations to visibility from the crewmember seats in each aircraft, and what effect the flightpaths might have had. The flightpath of Allegheny 853 was based on the flight recorder data and, since there was no other source, the data for N7374J at the moment of impact was projected backward for 22.8 seconds prior to collision. The reconstruction (Attachment A) revealed that, at that time, the aircraft were 12,130 feet apart and Allegheny 853 was approximately 850 feet above N7374J. Allegheny 853 was 55" to the left of N7374J, and the relative bearing of N7374J to Allegneny 853 was 19° to the right. As the aircraft closed to a range of 5,430 feet, 10.2 seconds prior to collision, there was approximately 350 feet vertical separation. As Allegheny 853 descended through 3,800 feet altitude the range had decreased to 3,500 feet, 6.6 seconds before impact. At 2.4 seconds the range was 1,210 feet and Allegheny 853 was at 3,675 feet. In order to detennine the physical limitations to vision from each cockpit, binocular photographs were taken in a PA-28 and a ∞ -9. A dual lens camera was used to record a panoramic photograph of the window configuration as seen by time pilot when he turns his head from the extreme left to the extreme right. The photographs were taken using the design eye position for each crewmember. Attachments B and C portray the Position of each aircraft in the field of vision of each crewmember, based on this fixed-eye reference. Naturally, any movement or deviation from such a position would have affected the position of the target in the window.
