SA-421

NATIONAL TRANSPORTATION SAFETY BOARD WASHINGTON, D. C. 20591 AIRCRAFT ACCIDENT REPORT

MARTIN 404, N464M 8 STATUTE MILES WEST OF SILVER PLUME, COLORADO OCTOBER 2, 1970

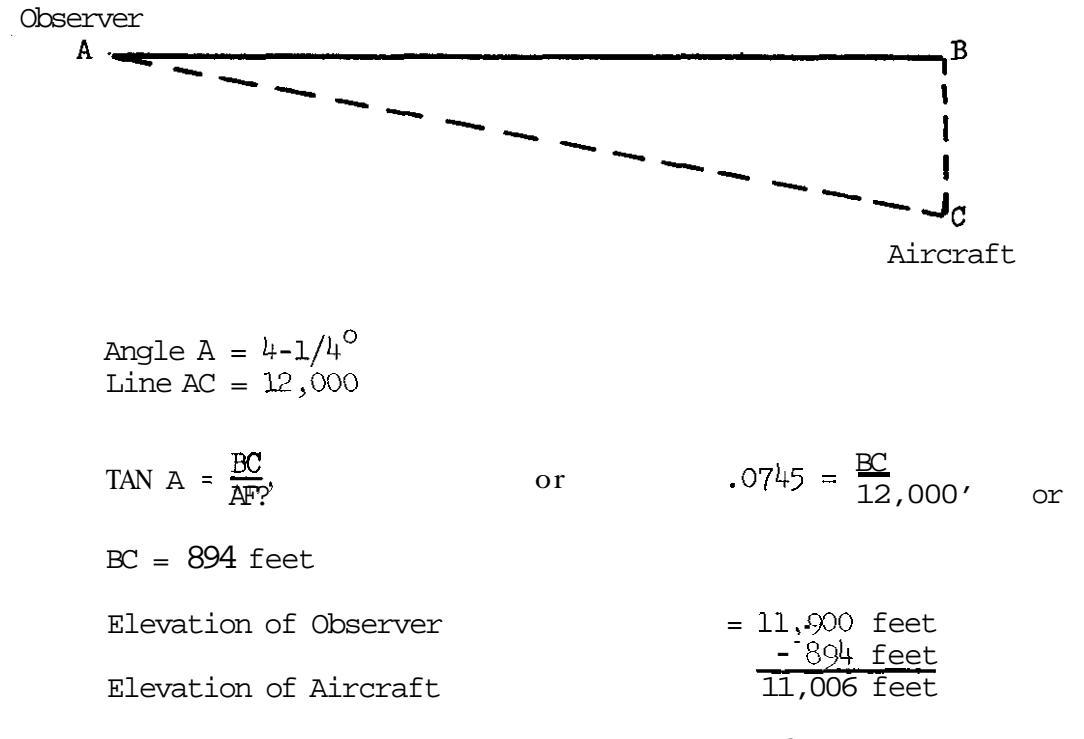
Diagrammatically:

(1) Two witnesses who observed the aircraft from above at Loveland Pass provided a sight line with a depression angle of 4-1/4° as measured by an Abney level. The aircraft was first observed when it was east of Dry Gulch. The distance was approximately 12,000 feet.
