NATIONAL TRANSPORTATION **SAFETY** BOARD

AIRCRAFT ACCIDENT REPORT

ZANTOP INTERNATIONAL AIRLINES, INC., LOCKHEED L-I 88A ELECTRA CHALKHILL, PENNSYLVANIA MAY 30, 1984

NTSB/AAR-85/04

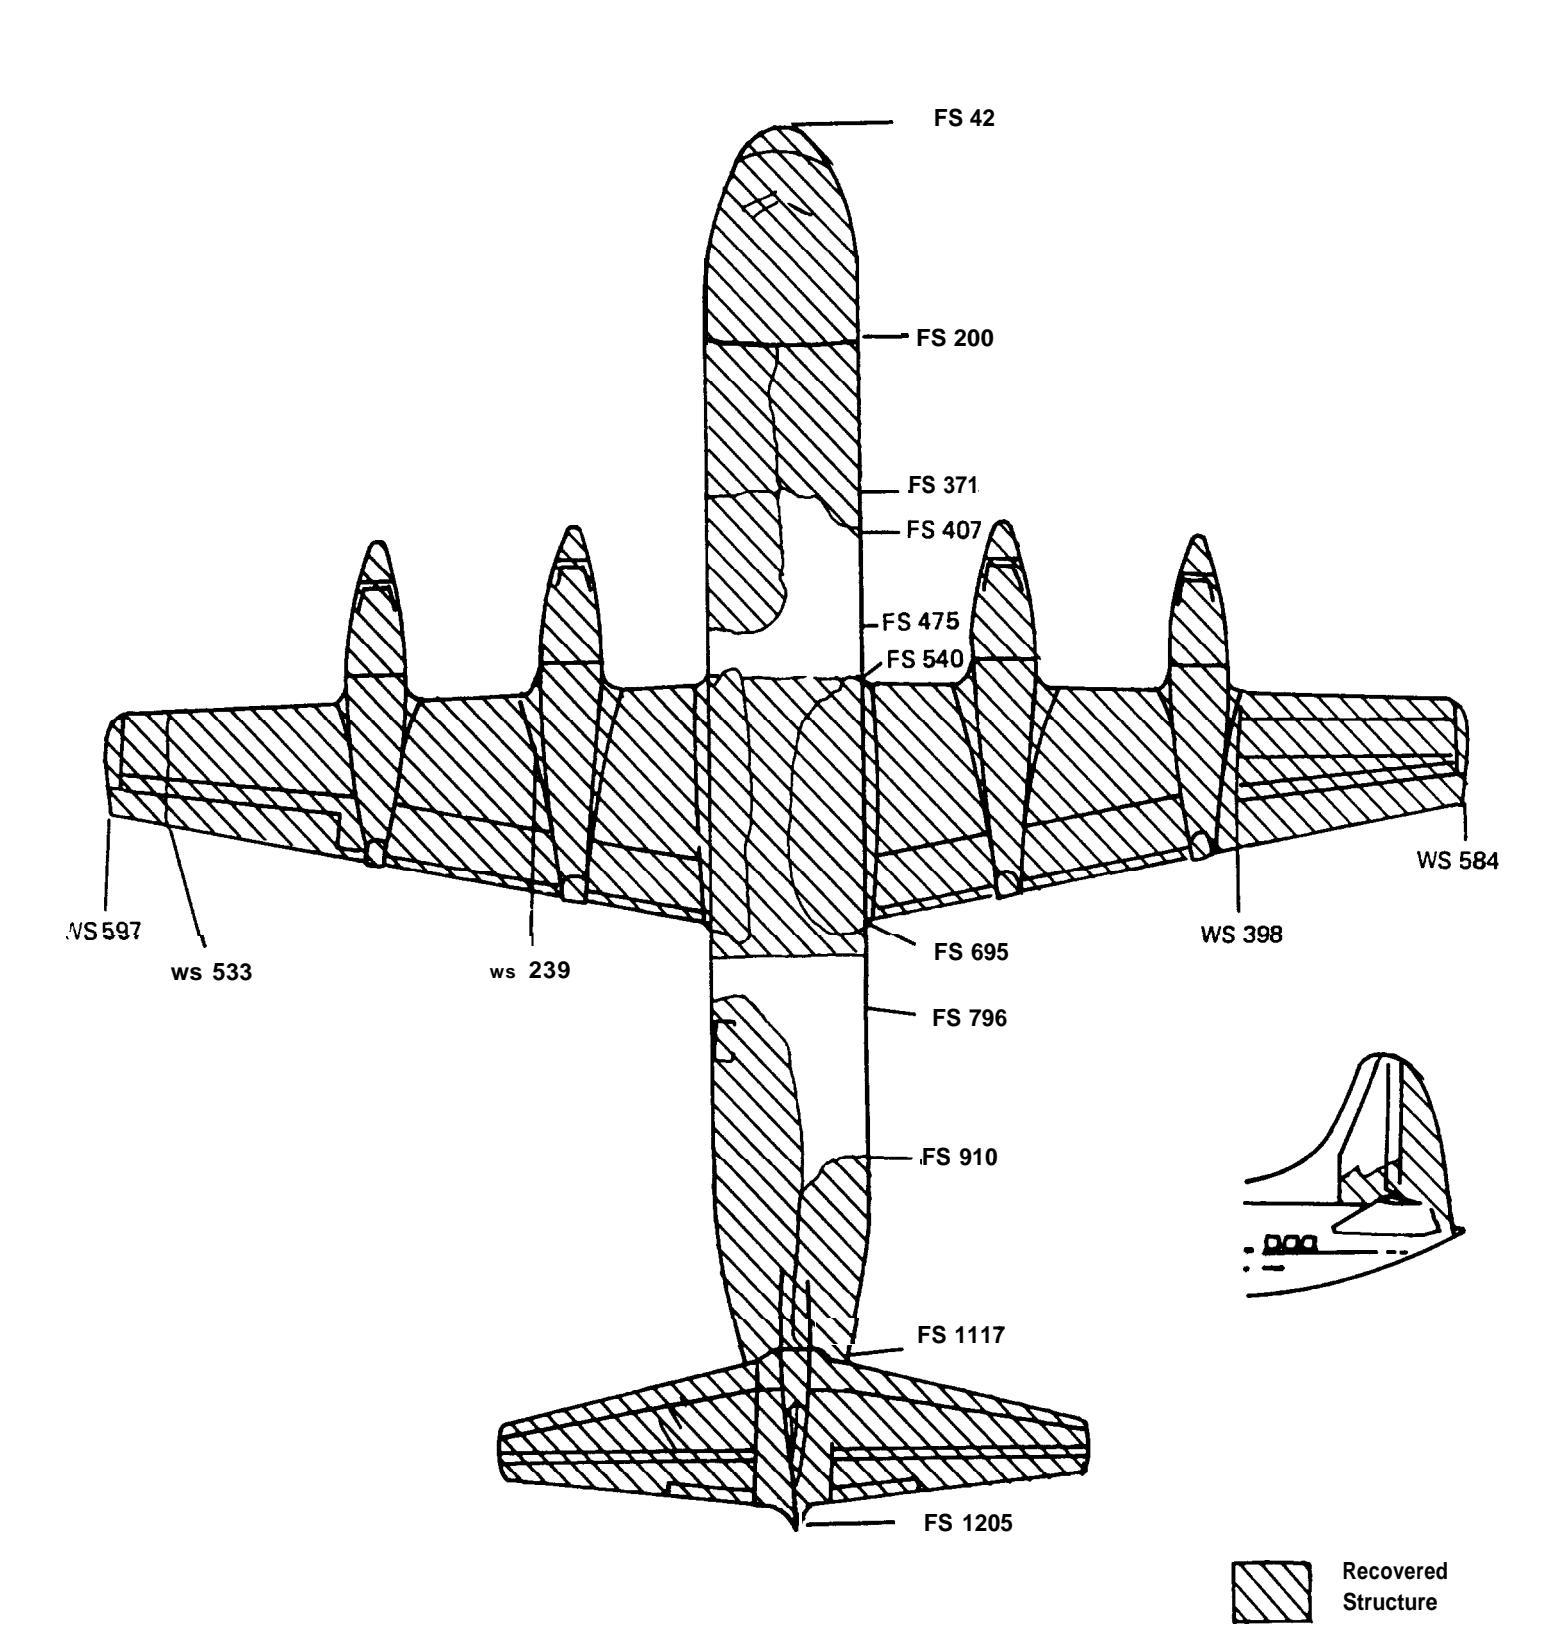
Figure 1.--Airplane diagram

Fuselage.--The fuselage broke apart in flight, and the damage from fuselage station (FS) 200 aft to FS 1117 was extensive. (See figure 1.) The main sections of the fuselage which were recovered were the nose and cockpit section from FS 42 to FS 200; the left forward fuselage section encompassing the four static ports and a portion of the forward entrance door frame; the left aft fuselage section (FS 796 to FS 1117) which included a portion of the cabin floor and the main cargo door assembly; and the right fuselage section from FS 540 to FS 695, including the bottom fuselage from FS 540 to FS 715, which was fragmented into small pieces and unidentifiable sections.

The main cargo door was closed and locked. The fuselage skin and associated support structure from the main cargo door aft to FS 1117 was folded in the forward and upward direction.

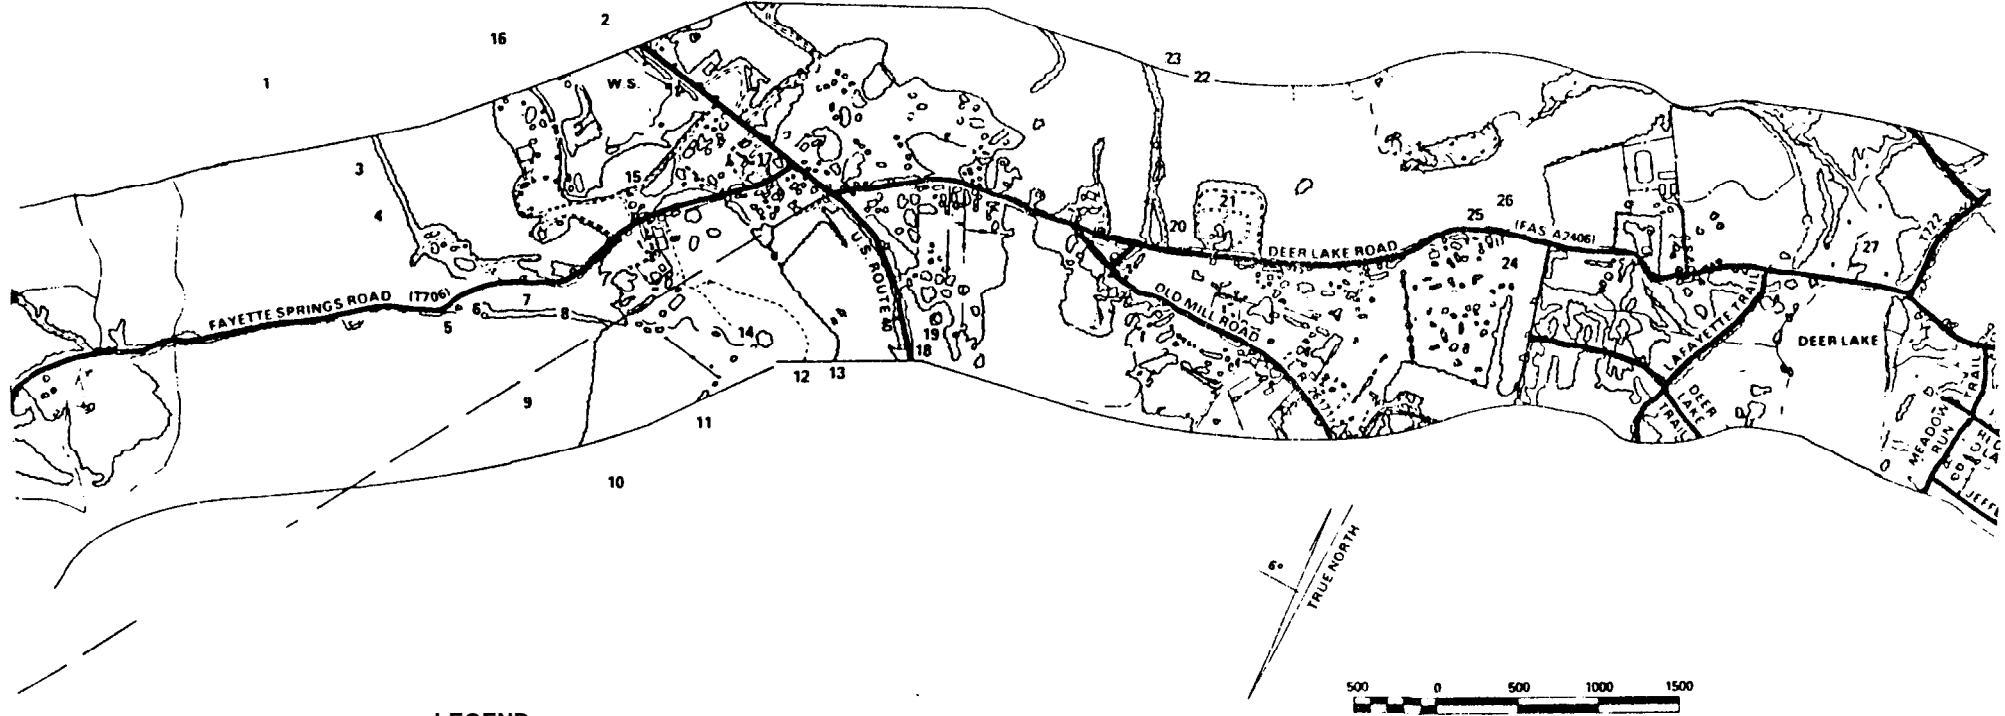
WRECKAGE DIAGRAM

The airplane came apart in flight. The wreckage scattered over an area about 2 miles long by 1 mile wide and oriented northeast by southwest on a line through Chalkhill, Pennsylvania. (See appendix **F.)** Falling wreckage damaged some houses; however, most of the wreckage **fell** in uninhabited, wooded areas.
