NATIONAL TRANSPORTATION SAFETY BOARD WASHINGTON, D. C. 20591 . AIRCRAFT INCIDENT REPORT

American Airlines, Inc., Boeing 747-121, N743PA San Francisco, California September 18, 1970

SYNOPSIS

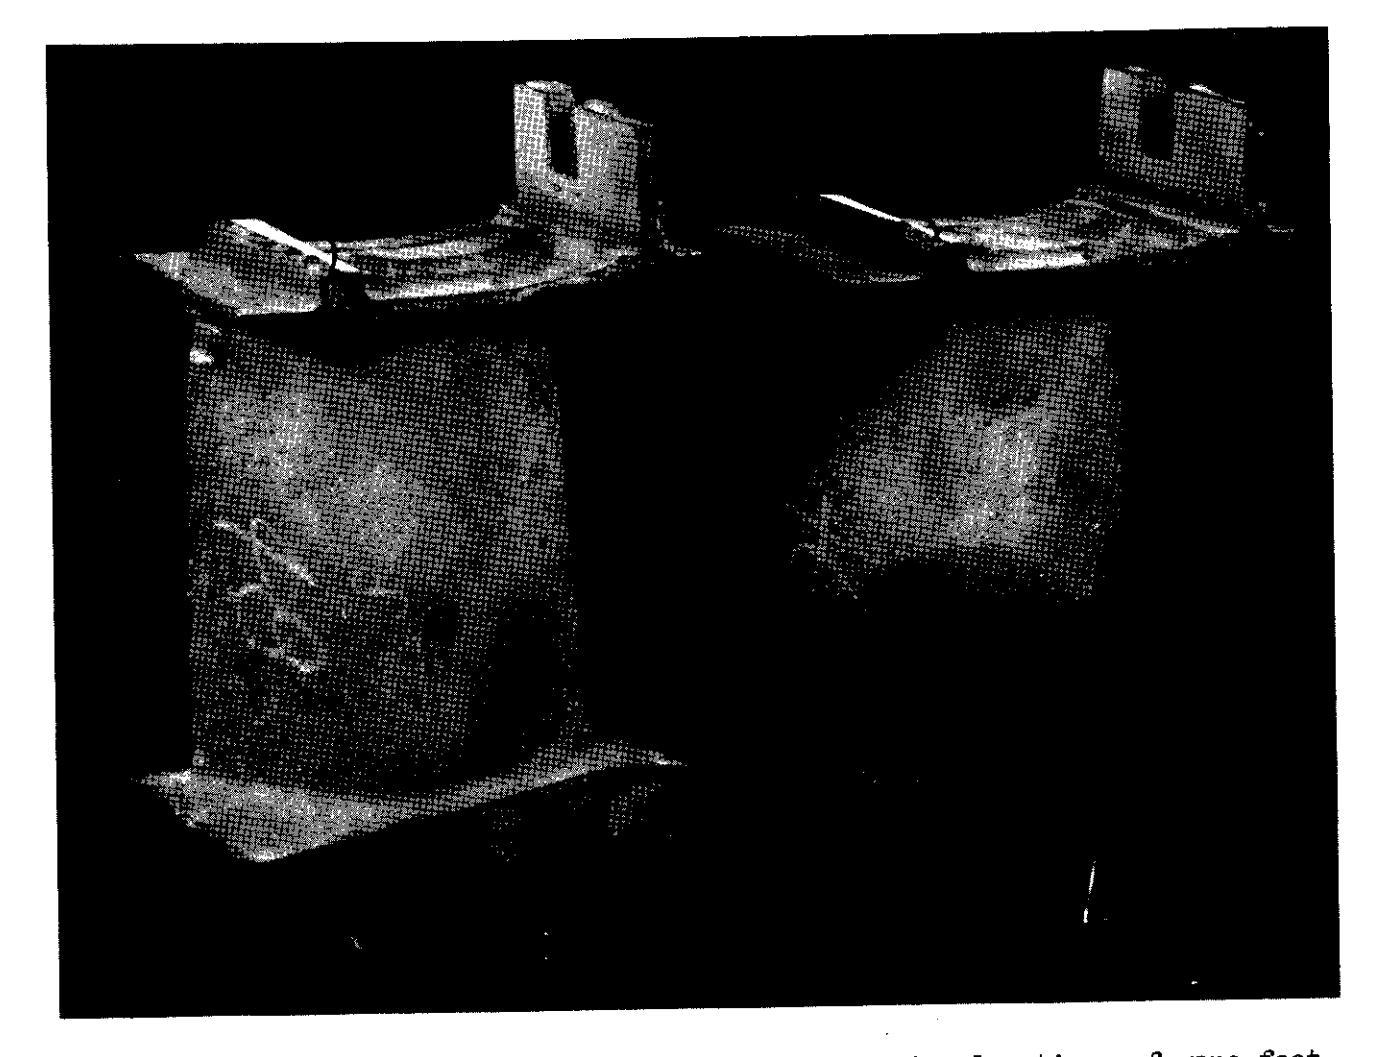
Once the failure of one or more of the first-stage blades had taken place, severe and unusual vibratory loads were imposed upon the secondstage turbine vanes, inducing progressive fatigue failures of approximately 30 percent of the rear inner shroud feet of the vanes. The minimum thickness of the vane feet utilized in the No. 1 engine of N743PA was .083 inches. These were not designed to withstand the nearly 41 increase in vibratory loads which occurred when the initial failure of the firststage blades occurred.

The fatigue failures of these inner shroud hear vane feet allowed the second-stage turbine stator shroud assembly to shift rearward and rub against the front web surface of the second-stage turbine hub. This continued rubbing caused grooves to be worn into the disk portion of the front turbine hub. Finally, the front turbine hub fractured circumferentially in a rapid tensile manner at the grooved and weakened points, relating the entire im portion of the disk. In reviewing the operating history of the engine (S/N 662274), it becomes quite apparent that the laboratory findings relative to the pre-existing failures of at least four first-stage turbine blades is quite accurate.

Photograph No. 4 Second-stage turbine vane feet showing locations of vane foot fractures. (Note: Bracketed areas of vane feet at fracture surfaces).

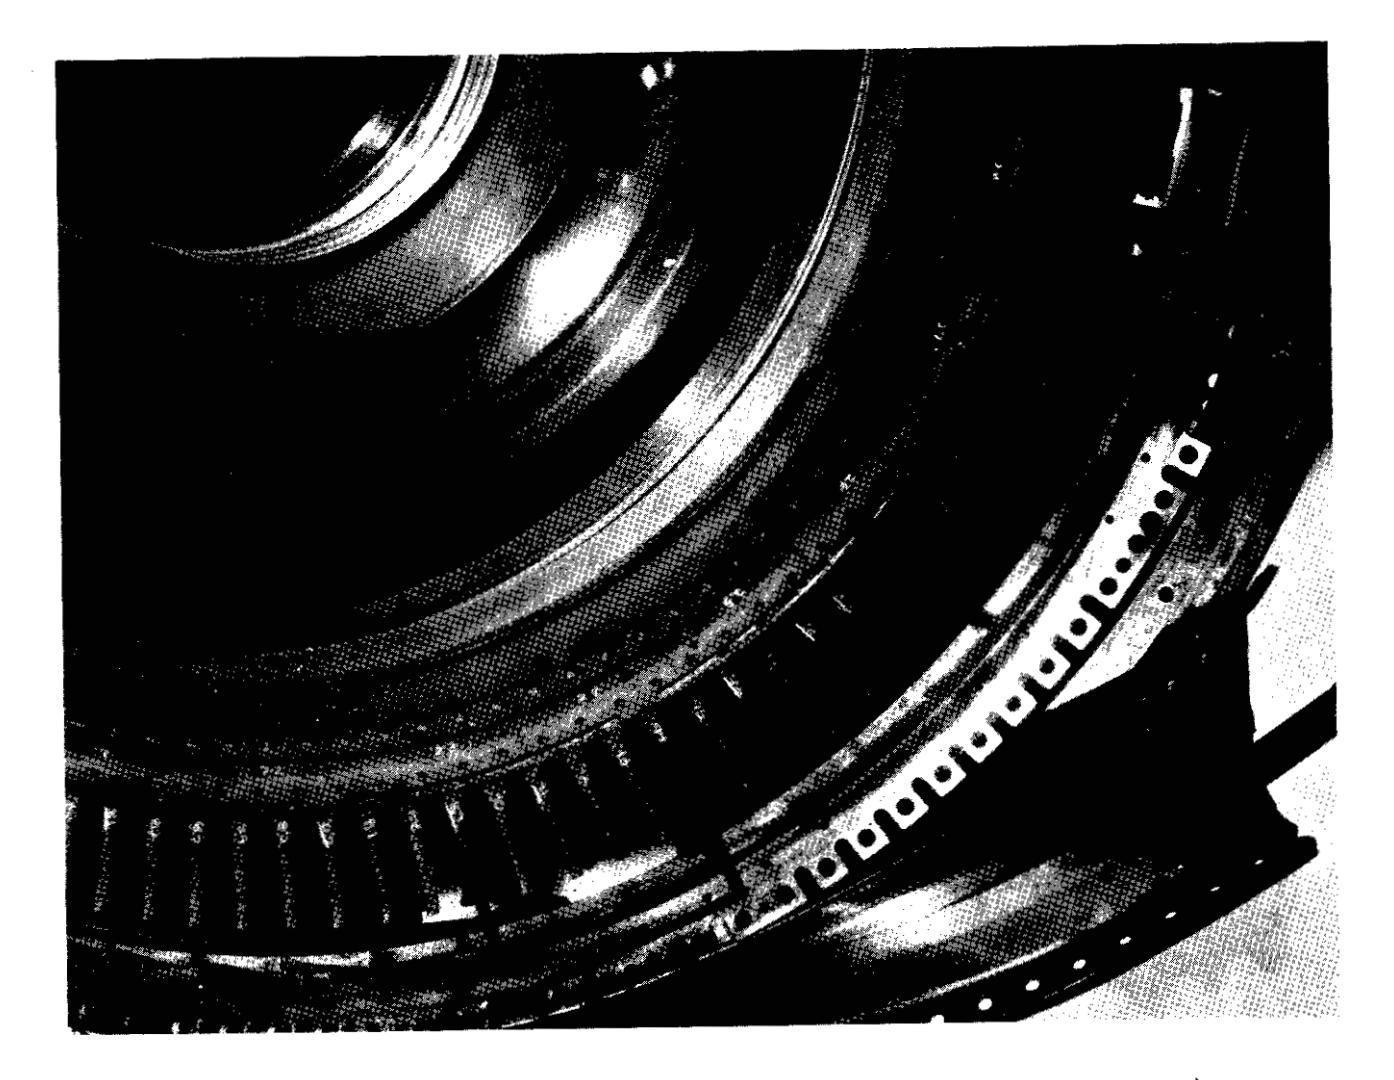
Detailed laboratory examination of seven P/N 674331 first-stage _ turbine blades disclosed transverse fractures through the airfoil sections approximately 1 inch above the blade root platforms. Thirty additional PN 674331 first-stage blades exhibited cracks in the leading edges at locations similar to those found in the fractured blades (Photograph No. 5). The complete fractures, as well as the fractures seen through the cracks, exhibited oxide discolor ted dendritic surfaces. There was no evidence of fatigue. Spectographic analysis of the turbine blade material disclosed that the material fully conformed to required specifications. None of the failed blades, nor 16 additional blades sectioned at random, showed any evidence of blocked cooling passages.

Metallographic examination of the fractured blades disclosed intergranular, oxidized fracture surfaces with associated alloy depletion. Evidence of sulfidation attack was also present along the fracture surfaces. This examination also provided evidence of metal temperatures of approximately 2,050° F. to 2,200' F. at the first-stage blade leading edges, and $2,000^{\circ}$ F. to 2,050° F. at the blade trailing edges. Normal leading edge temperature of first-stage blades at takeoff thrust, operating on a standard 80″ F. day, average 1,970° F. Under the same conditions, the maximum permissible temperatures at this point are between 2,025°F. and $2,050^{\circ}$ F. Thirty-two P/N 654352 second-stage turbine vanes had transverse fatigue fractures through the vane feet. The fractures, as well as cracks in other additional vanes, originated from the base of the front face of the vane feet near the convex side. Laboratory analyses disclosed that the mechanical and chemical properties of the vanes, as well as their dimensions, conformed to existing specifications.

Photograph No. 5 Quadrant of first-stage turbine wheel No. 1 engine N743PA showing two of the fractured turbine blades. (See arrows at top of photo).

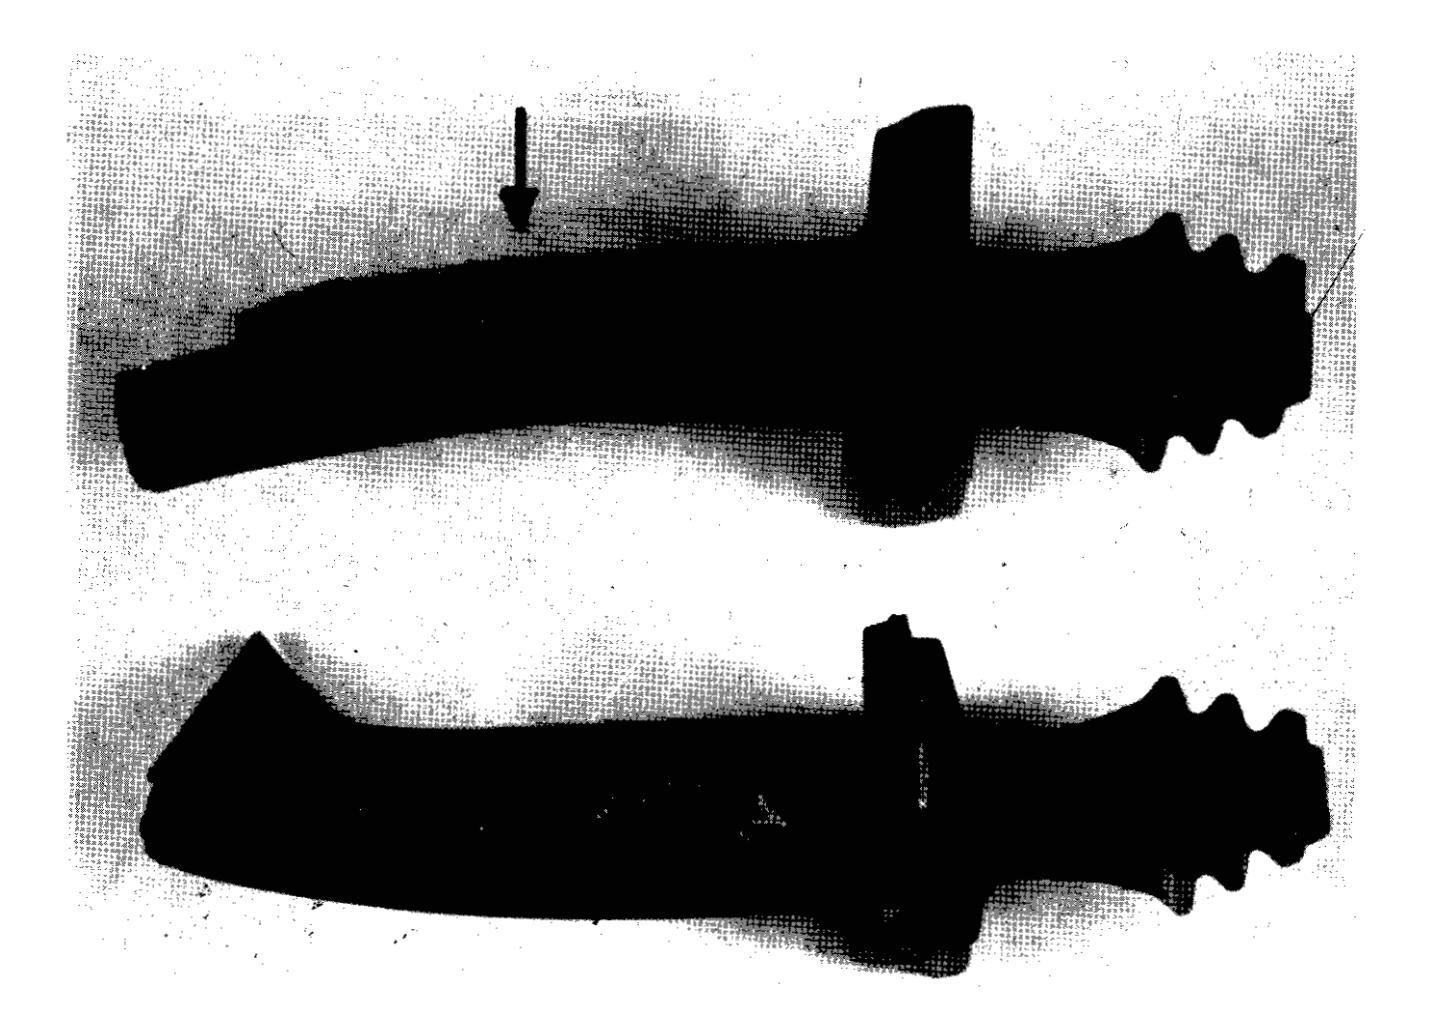
In the case of the JT9D-3 or -3A, which can operate at 43,500 or 45,000 pounds of thrust, respectively, the average metal temperature of the first-stage turbine blades is approximately $1,970^{\circ}$ F. during takeoff thrust conditions. The solution heat treat temperature of these blades is $2,125" + 25^{\circ}$ F. If for some reason the operating temperature of the blade closely approaches or exceeds this temperature, the blade's designed high-temperature strength and resistance to failure by stress rupture may be seriously impaired.

The laboratory analysis of the four failed first-stage blades disclosed relative depths of oxide scale and alloy depletion layers that suggest these blades had been fractured for some time prior to the turbine disk rupture. Fresh fracture surfaces of similar blades were statically exposed in air at various controlled temperatures to determine the time element required to attain certain alloy depletion depths. The results of these laboratory tests were conclusive in establishing that several hours of exposure to temperatures in excess of 2,050° F. were required to attain the degree of alloy depletion seen in four of the failed first-stage blades; however, engine overheating conditions of only a few seconds duration may be sufficient to alter significantly the alloy microstructure.

Photograph No. 6 Two first-stage turbine blades showing airfoil bending and stress rupture crack of one blade. Blade on top of photograph shows partial crack in the same general area where complete fractures occurred.
