TECHN.	LCAL REPORT DOCUMENTATION PAGE
Report No.	2.Government Accession No.	3.Recipient's Catalog No.
 Fille and Subtitle PRINAIR deHavilland H N575PR, Alexander Han St. Croix, US. Virgin Isl 	Aircraft Accident Report— eron, DH-114, nilton Airport, Christiansted, and, July 24, 1979	5.Report Date March 28, 1980 6.Performing Organization Code

NATIONAL TRANSPORTATION SAFETY BOARD WASHINGTON, D.C. 20594

Adopted: March 28, 1980

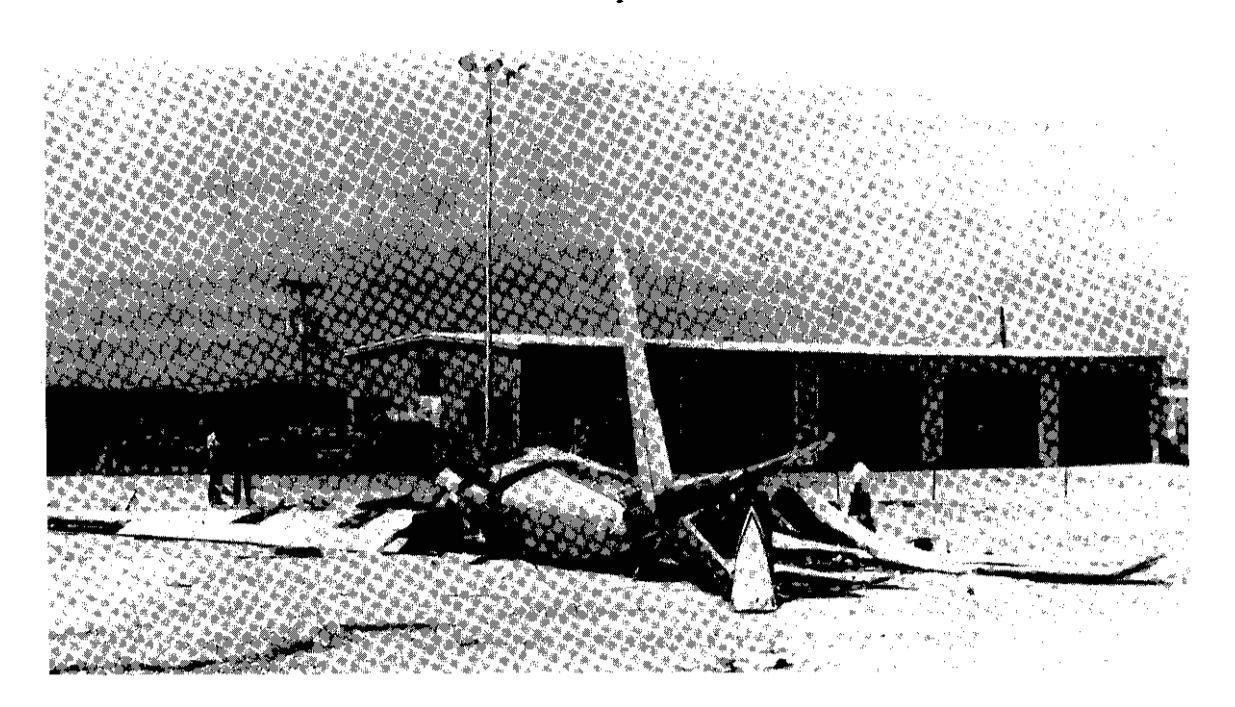
The aircraft came to rest on its right side adjacent to the firehouse. A small postaccident engine fire was extinguished immediately. (See figure 1.)

Figure 1.-Left side of aircraft
