AIRCRAFT ACCIDENT REPORT

KENNEDM FLITE CENTER GATES LEARJER MODEL 23, N866JS BYRD INTERNATIONAL AIRPORT RICHMOND, VIRGINIA MAY 6, 1980

NTSB-AAR-80-12

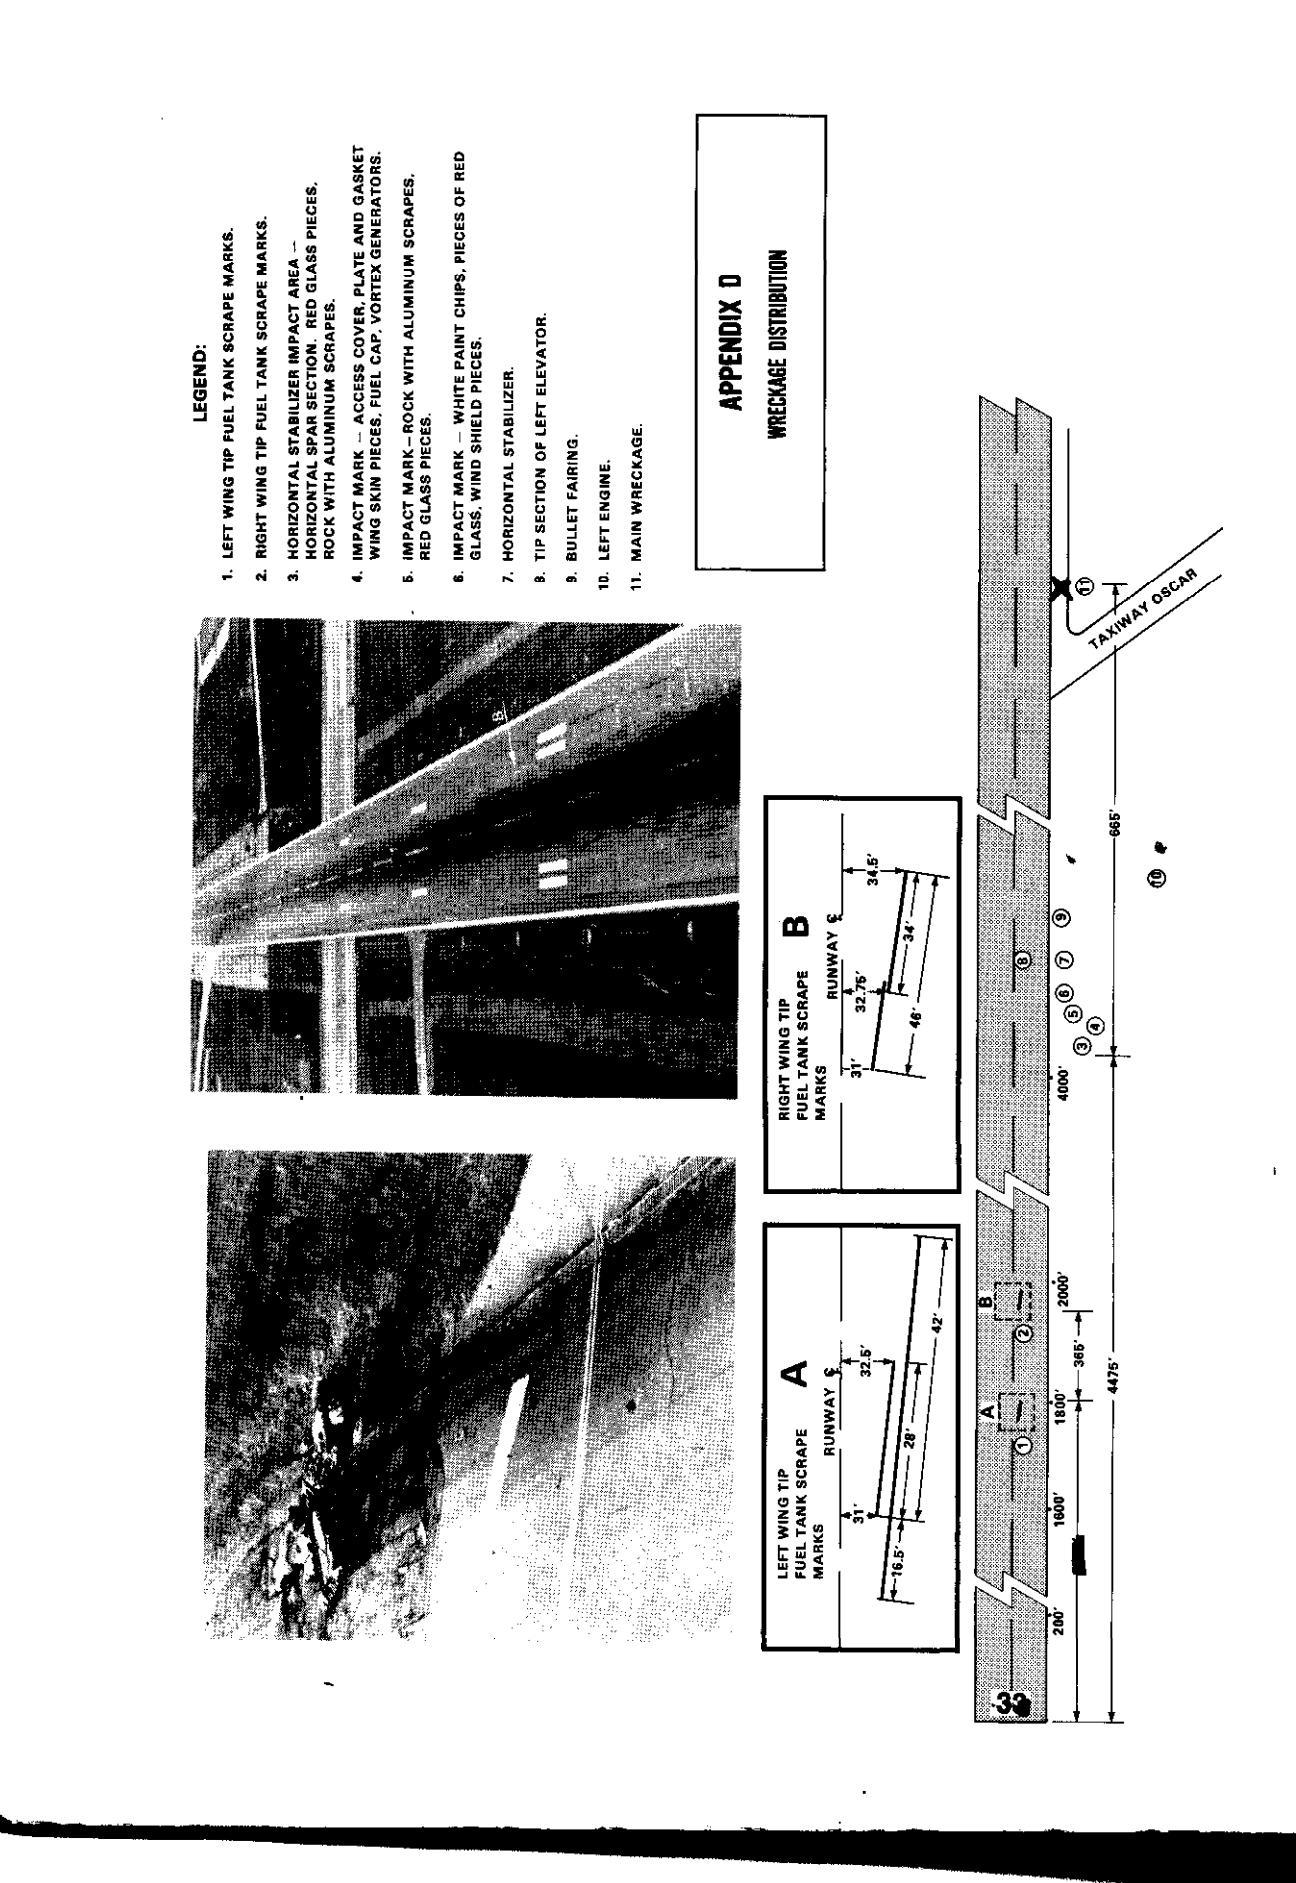
The main wreckage came to rest 5,140 feet beyond the runway threshold 150 feet right of the centerline on the edge of the runway. The wreckage consisted of the cockpit/cabin area, fuselage, empennage, right wing, right engine, and a part of the left wing. The wreckage was damaged by ground fire. (See appendix D.)

The nose dome was intact and partially attached. The bottom and left side of the dome were crushed inward. The access panels fitted to the upper fuselage nose structure between the cockpit windshield and nose dome had separated. The access panels and various pieces of equipment were recovered along the wreckage path. The cockpit windshield had been shattered as a result of ground impact forces. Small pieces of the windshield were found throughout the wreckage pattern. A section of upper fuselage structure adjacent to the cockpit windshield which measured about 4 feet by 4 feet had been torn and bent in the upward direction.

The aft fuselage showed fire damage on its left side with heavy sooting on its right side. The vertical stabilizer leading edge had been crushed and severely burned at its upper area. The dorsal fin remained intact; however, this area had been subjected to intense ground fire. The forward end of the dorsal fin was missing. The rudder assembly remained attached to the aft fuselage structure through the torque tube assembly. The rudder separated from the vertical stabilizer at its mid and upper points of attachment. Both the mid and upper rudder attachment bolts were retained within the vertical stabilizer to rudder attachment brackets.

Left Wing.--The left wingtip fuel tank had separated from its wingbox attachment structure. Portions of the wingtip fuel tank assembly were recovered along the wreckage path. The aft section measured about 4 feet in length and included the fin. Scrape marks were found on the bottom surface of the tip tank. The outboard end of the fin assembly showed evidence of scrape marks and the trailing edge of the fin was feathered. The surface of the leading edge was normal and not covered by any foreign substance.

A section of outboard wing structure, measuring about 5 feet in length, separated and had been subjected to intense ground fire. A short section of the left wing flap assembly and the outboard end of the left aileron were with the left wing section and had severely burned. The left wing spoiler assembly had separated from the wing structure. <u>Right Wing.</u>—The right wing remained intact with continuity existing between the right wing and left wing structure. The right wing had been subjected to ground fire, with no evidence **of** burn-through. The leading edge of the right wing showed no evidence of ground impact damage; however, the inboard end which was positioned within the fuselage had been subjected to high heat. The surface of the leading edge was normal and not covered by any foreign substance.

Portions of the right wingtip fuel tank remained attached to its wingbox attachment structure. A major portion of the tip tank had been consumed by ground fire. The forward end of the right wingtip fuel tank was recovered in the pattern and showed no evidence of fire damage. The aft end of the tip tank remained with the right wing structure. The fin section showed evidence of scrape marks on its outboard end, bottom side.
