I REWRI DOCOMENTATION PAGE
Report No. NTSB-AAR-82-10	2.Government Accession No. PB82-910410	3.Recipient's Catalog No.
. Title and Subtitle Airc	raft Accident Report	5.Report Date
Midair Collision, USAF F-1	11D, Building	<u>August 24. 1982</u>
Contractors, Inc., Cessna T	J-206G, Clovis,	6.Performing Organization
<u>New Mexico, Februarv 6. 19</u>	980.	Code
Author(s)		8.Performing Organization
		Report No.
. Performing Organization	Name and Address	10.Work Unit No. 3567
National Transportation Sat Bureau of Accident Investig	ety Board ation	11.Contract or Grant No.
Washington, D. C. 20594		13.Type of Report and

AIRCRAFT ACCIDENT REPORT

MIDAIR COLLISION UNITED STATES AIR FORCE, F111-D, BUILDING CONTRACTORSINC., CESSNA **TU-206G,** CLOVIS, NEW MEXICO FEBRUARY 6,1980

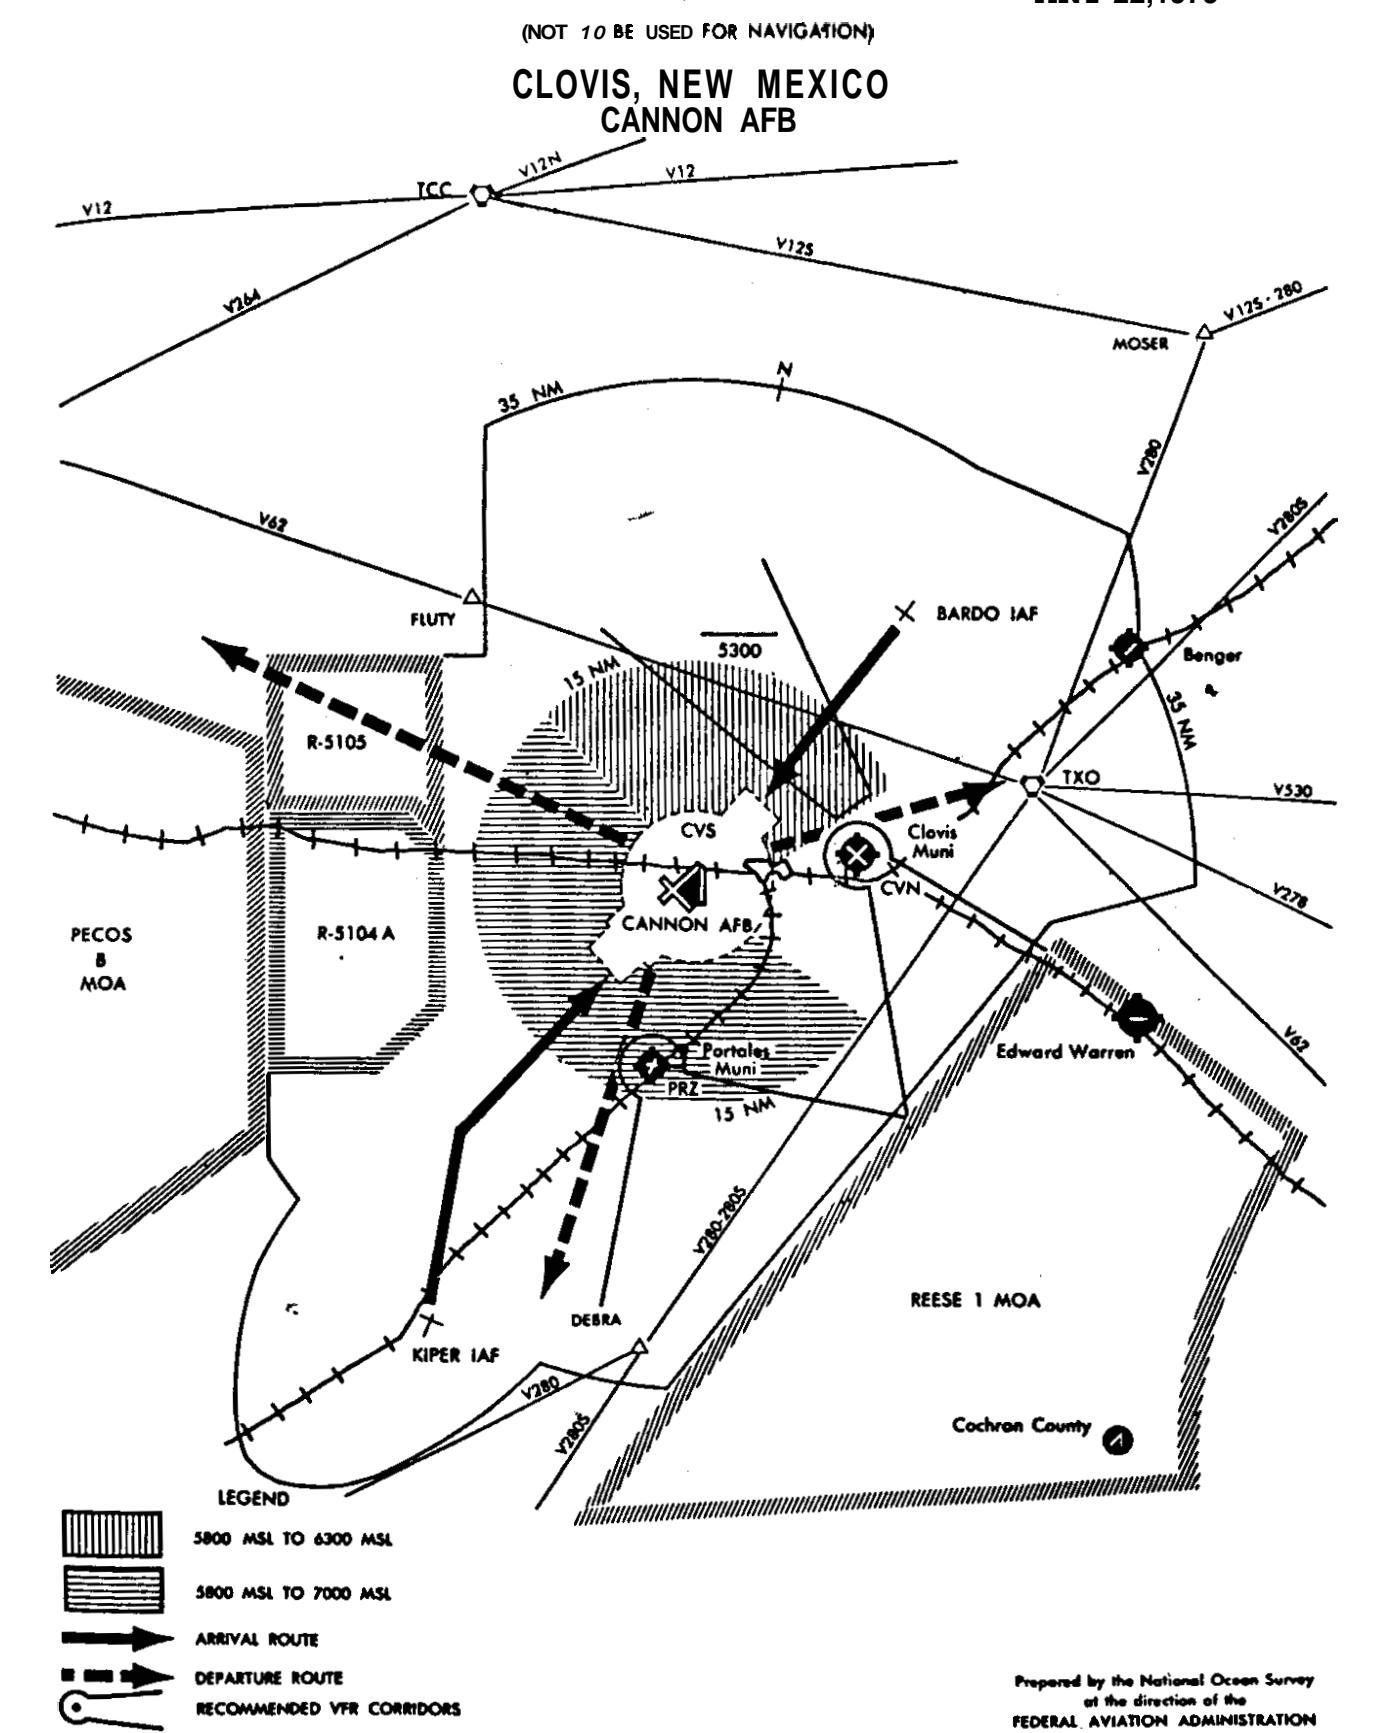
APPENDIX G

On this particular chart, dated February 22, 1979, the northern portion of the Cannon AFB controlled airspace was designated as a cautionary area between the altitudes of 5,800 feet and 6,300 feet. The remaining southern portion was noted as a cautionary area between the altitudes of 5,800 feet and 7,000 feet. Recommended VFR corridors for entry/exit to the civilian airports, Clovis and Portales, were depicted to the east and south of the cautionary area. A geometric outline appears in the northeast quadrant of the cautionary area. This trapezoidal-like outline originates north of the cautionary area where there is a numerical symbol on the chart intended to denote that the maximum altitude in that airspace is 5,300 feet m.s.l. The symbol is illustrated as a straight line over numerals (5300). Neither the outline nor the symbol is explained in the accompanying legend. It is not known if the Cessna pilot was familiar with the FAA publication "Graphic Notices and Supplemental Data."

TERMINAL AREA GRAPHIC NOTICE, CHART DATED FEBRUARY 22,1979
