PB90-910404 NTSB/AAR-90/04

# AIRCRAFT INCIDENT REPORT

USAIR FLIGHT 105 BOEING 737-200, N283AU KANSAS CITY INTERNATIONAL AIRPORT, MISSOURI SEPTEMBER 8, 1989

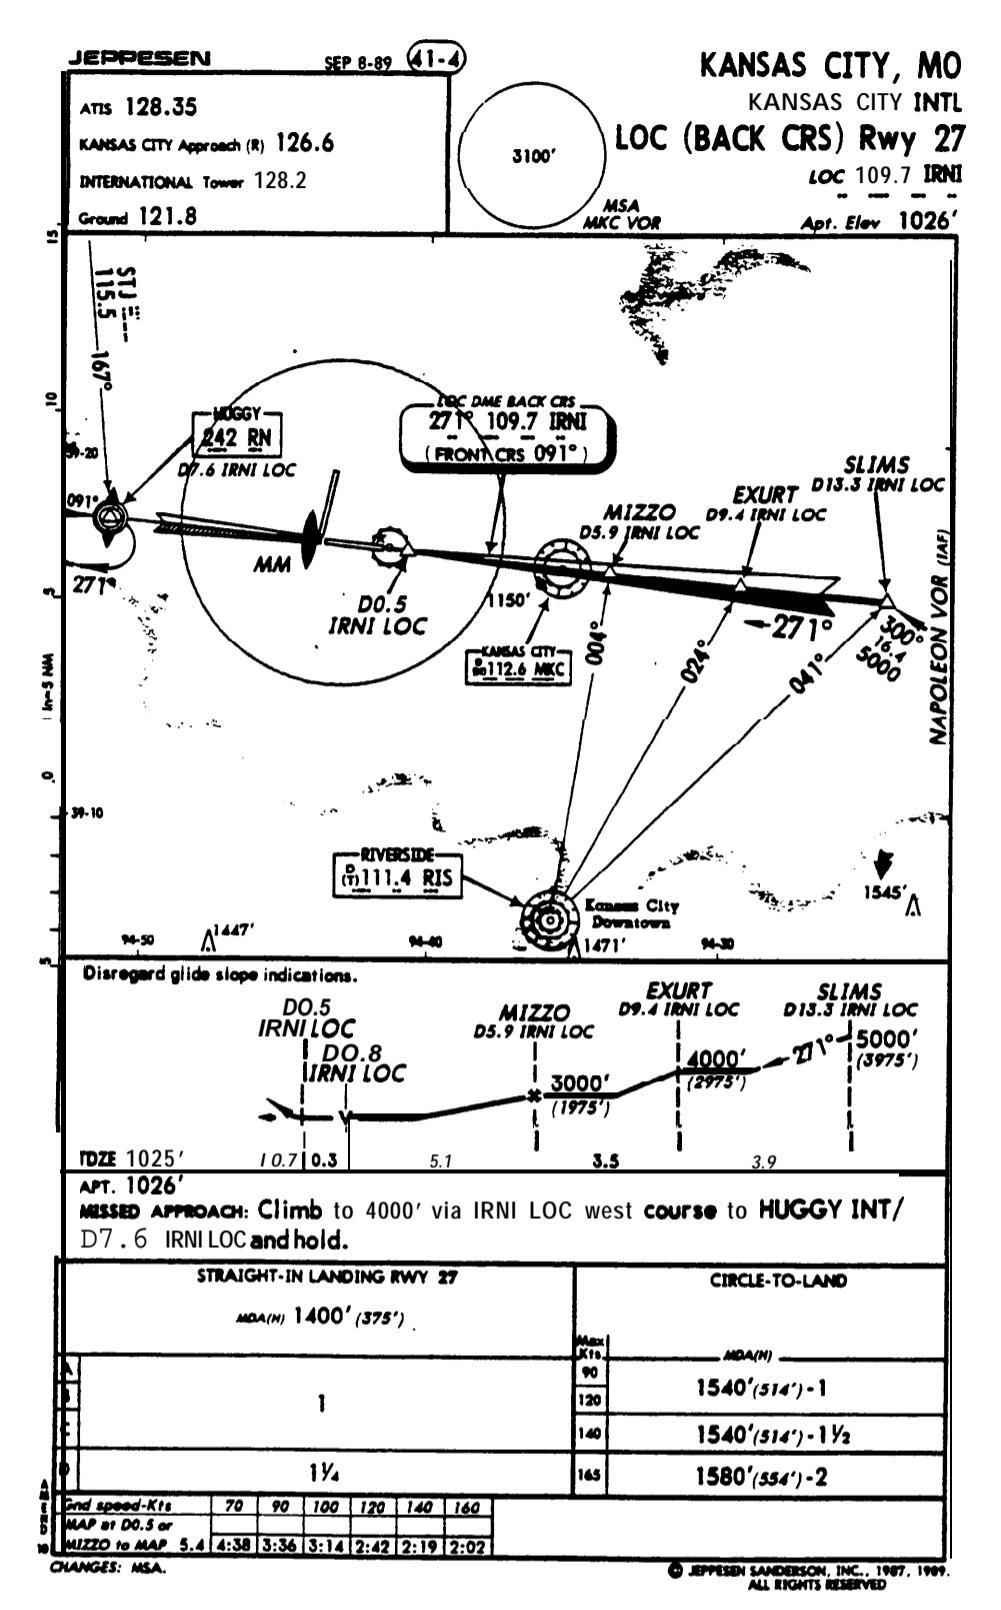
Figure 1.--Localizer back course approach to MCI's runway 27. Copyright, Jeppesen Sanderson, Inc. reprinted with permission.

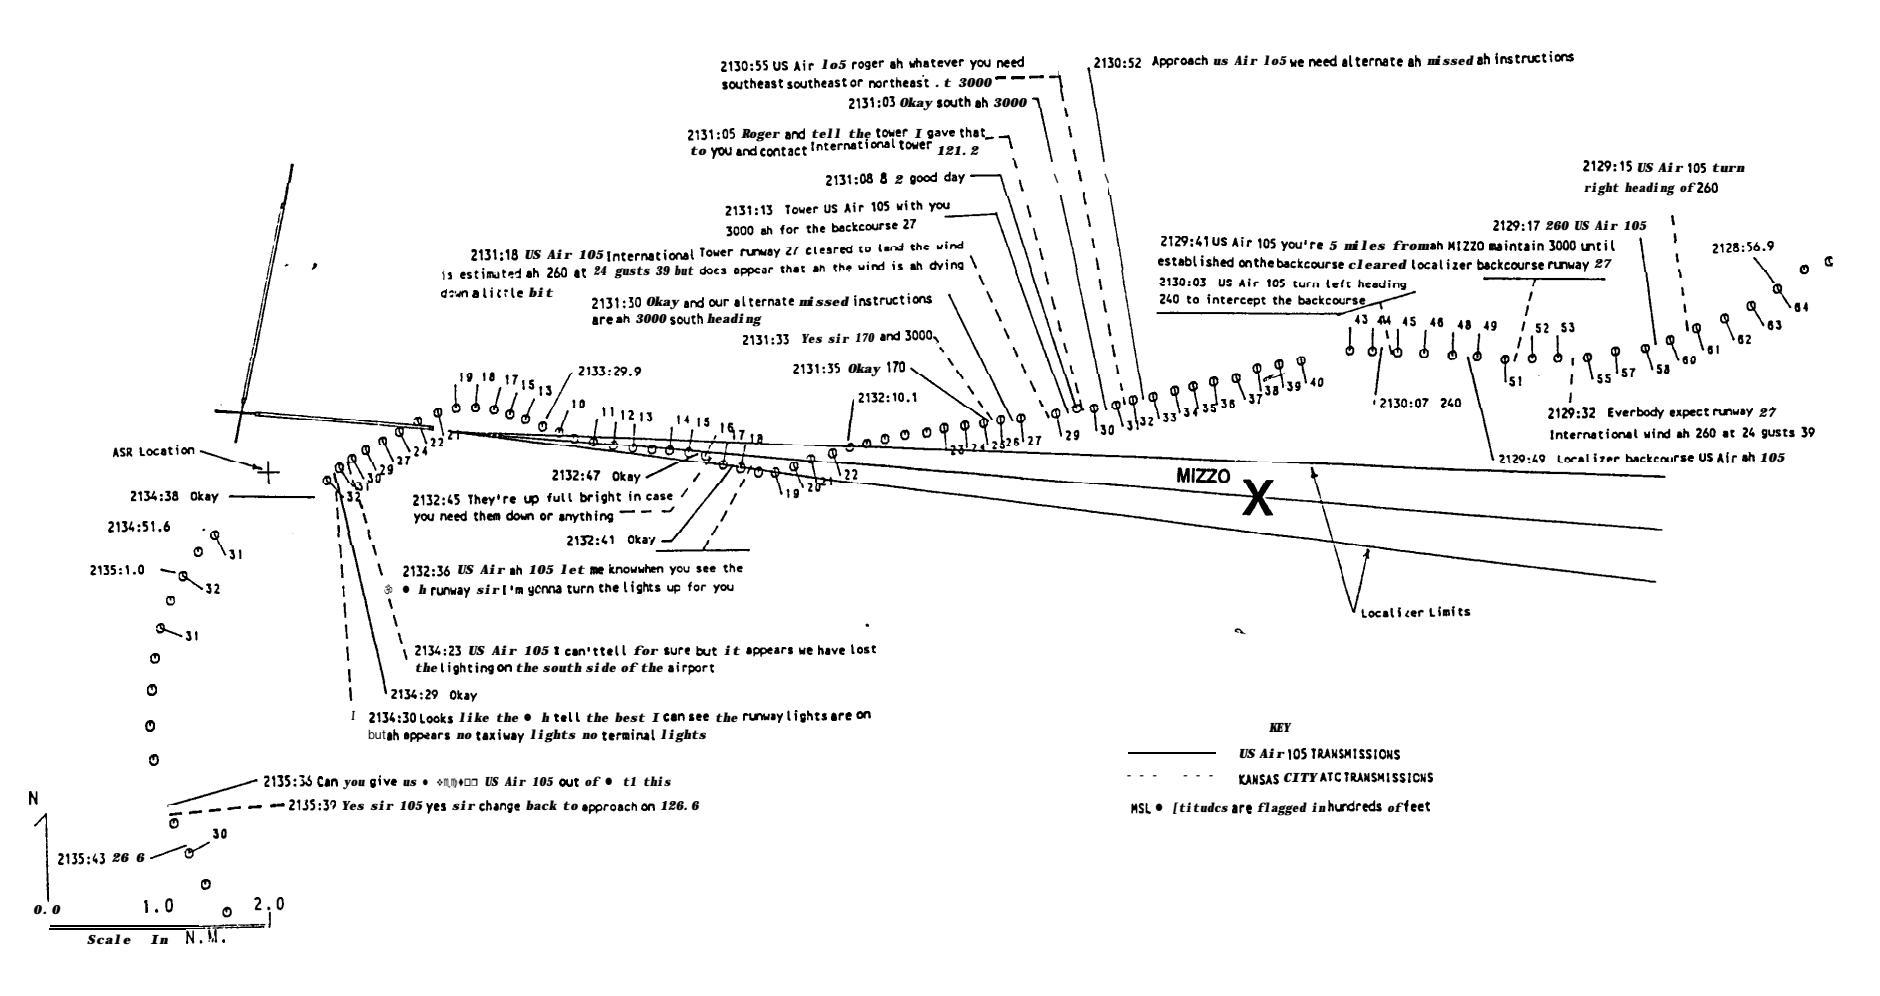
Figure 3. -- Overhead view of flight path.

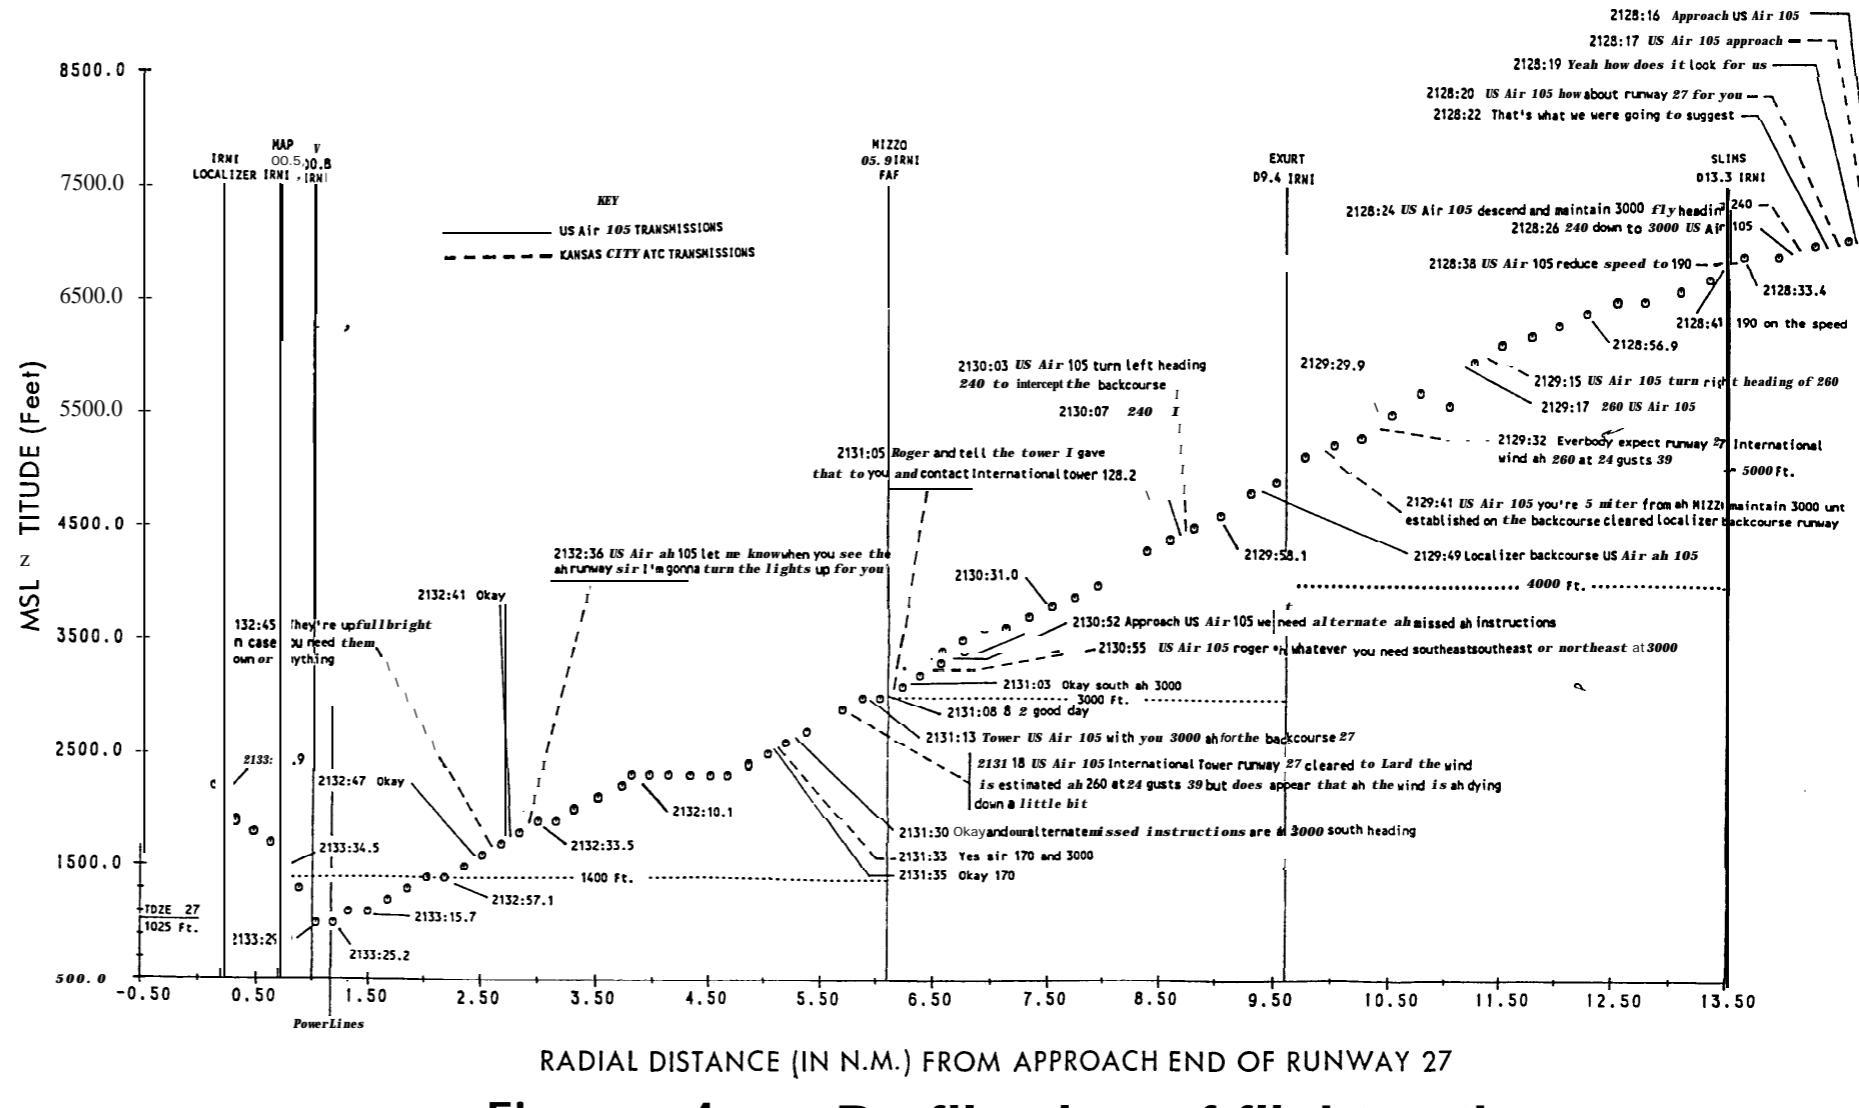
Figure 4. -- Profile view of flight path.
