NATIONAL TRANSPORTATION SAFETY BOARD

AIRCRAFT ACCIDENT REPORT

FUEL FARM FIRE AT STAPLETON INTERNATIONAL AIRPORT DENVER, COLORADO NOVEMBER 25, 1990

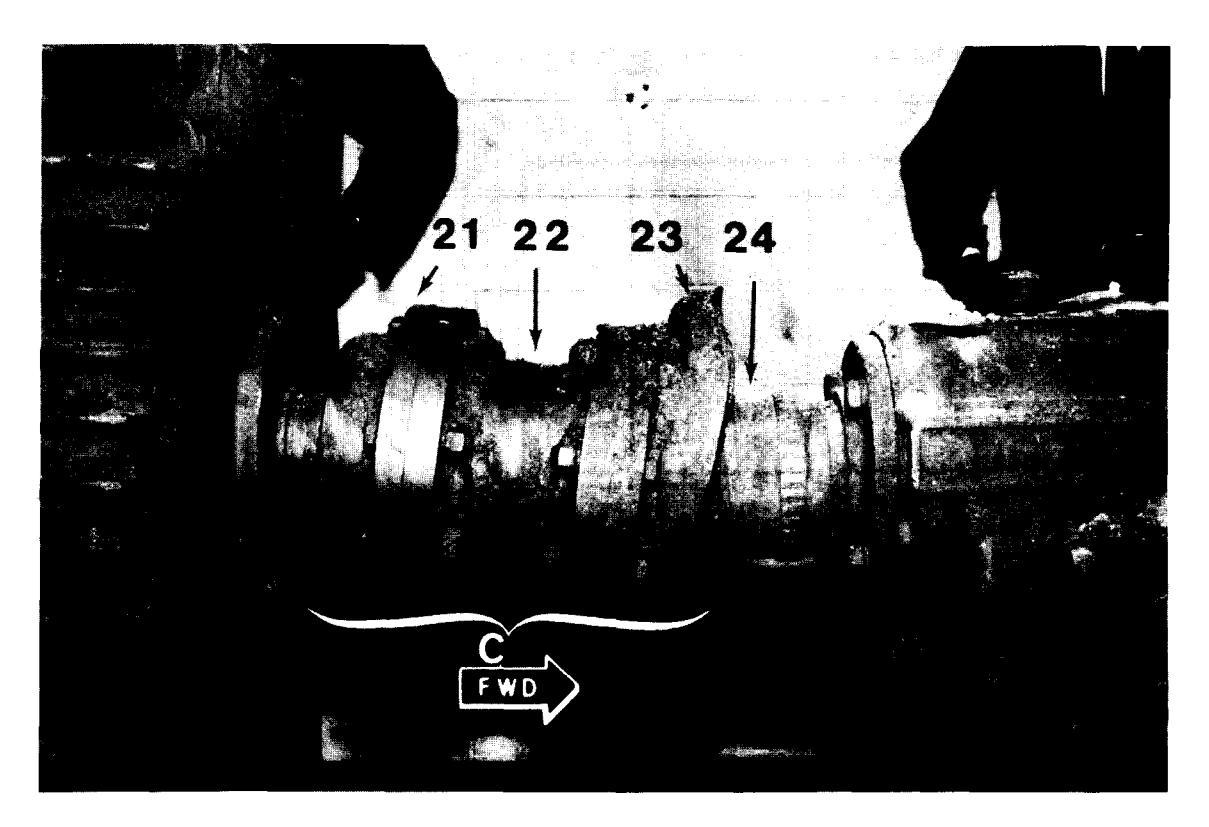
Figure 7. -- Damaged coupling assembly of motor/pump unit 3. The coupling gear is denoted by brace C; 21 is the motor shroud; 22 is the coupling spacer; 23 is the pump shroud; and 24 is the separated pump hub.

Examination of the guard over the coupling assembly exhibited rotational damage consistent with the rotating coupling assembly pressing against the guard. The coupling assembly was extensively damaged. The pump gear teeth (J in figure 12) were badly worn; the pump hub had been forced forward onto the pump shaft until it was pressed against the bearing case; the corners of the pump hub exhibited circumferential wear damage and gouge marks (Y in figure 12); and the pump shaft, key, and key way exhibited heavy metal smear damage. The pump shroud gear that mates to the pump hub gear (figure 13) was stretched open, and the pump hub gear was badly worn. The teeth in the pump shroud gear were worn or completely gone (area Z in figure 13). Wear marks were also noted in the stretched area; they appear to be consistent with the pump shroud gear wearing against the pump gear and shaft.

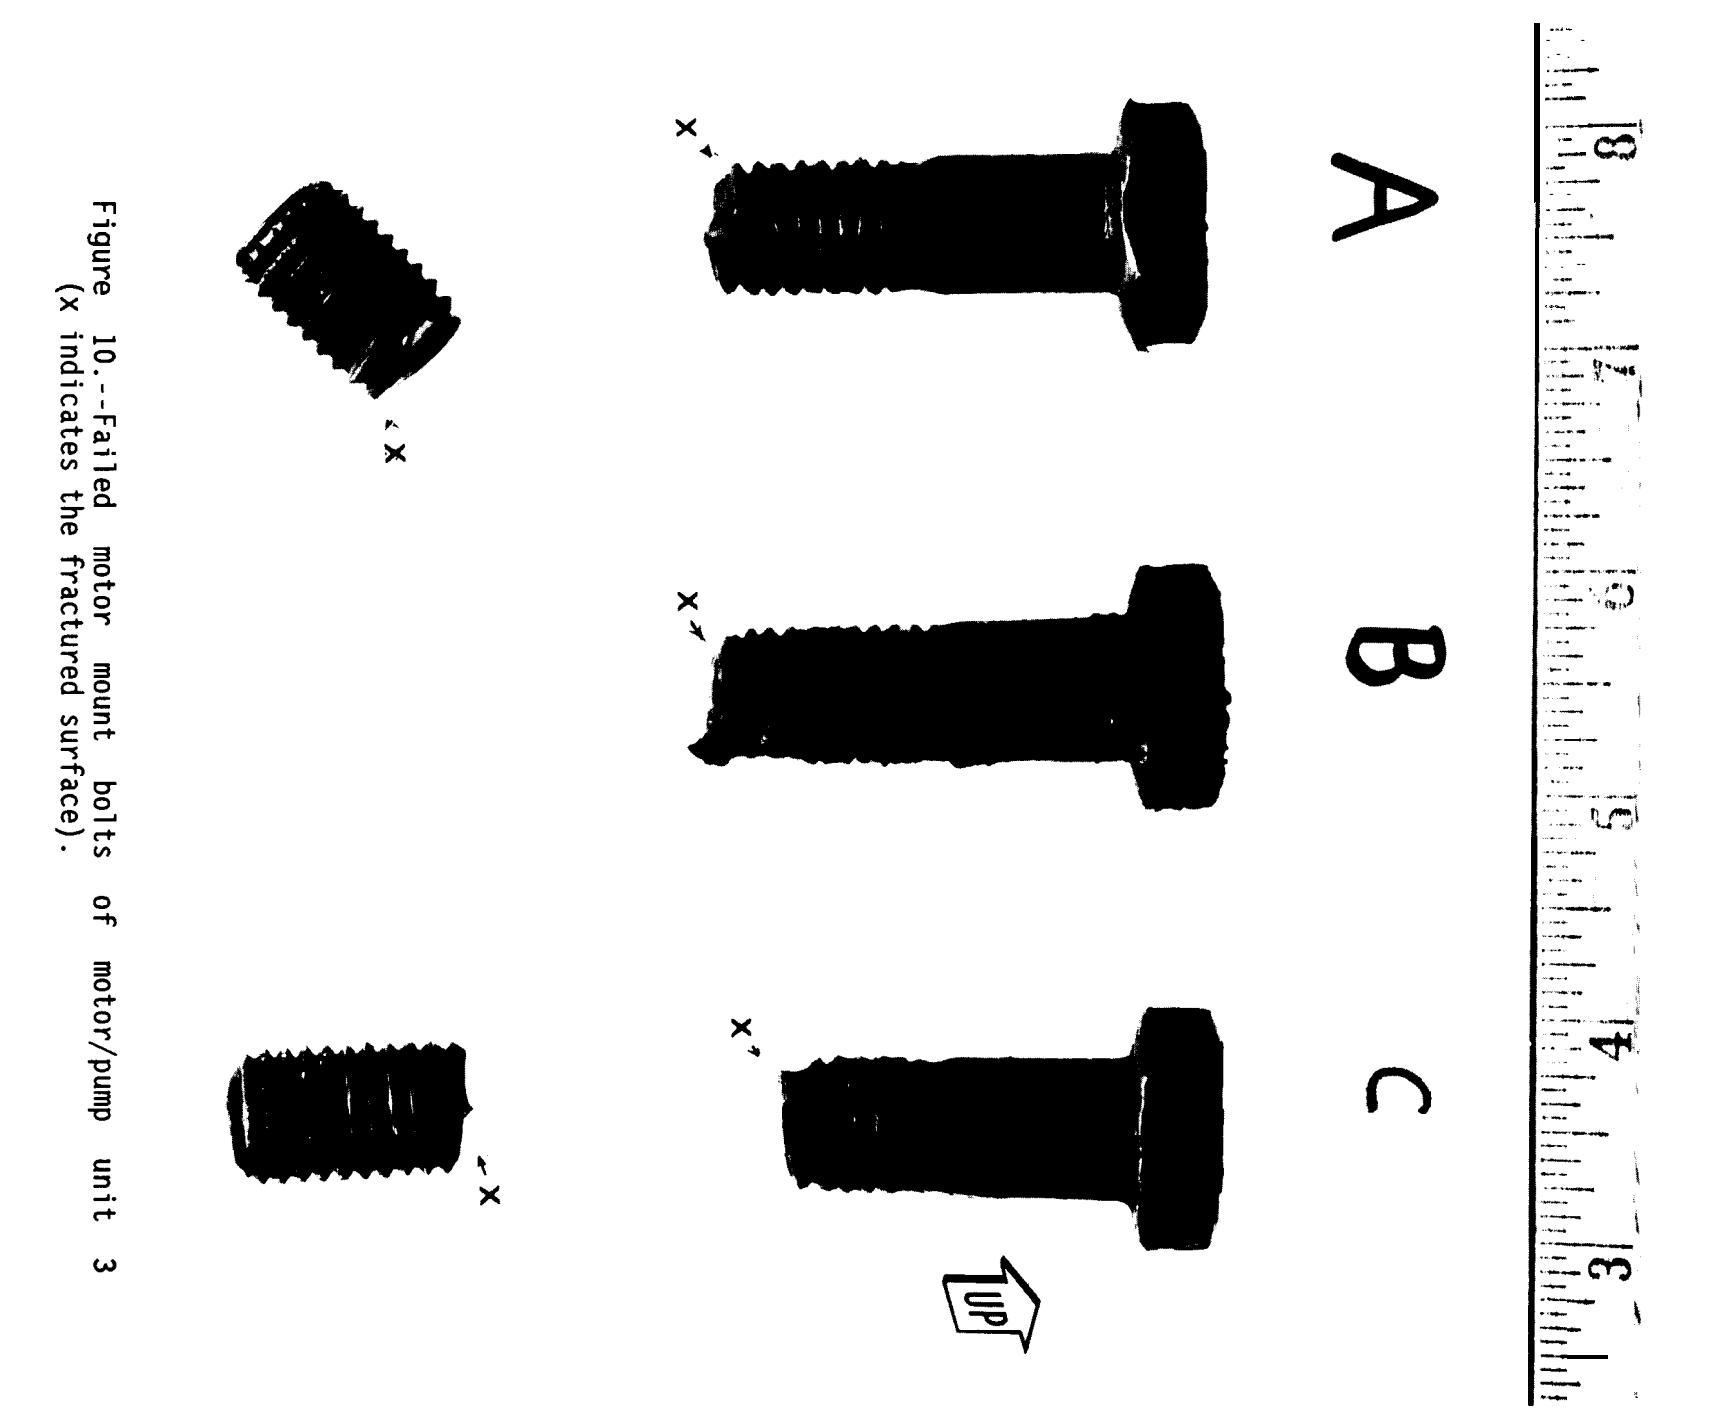
All four 5/8-inch-diameter bolts that secured motor 3 to its pedestal were fractured. These fractures occurred in the threaded area (see figure 10). Remnants of all four bolts remnined in the threaded holes of the

pedestal. The heads of only three bolts were located. The heads of two of these bolts were found on the bed plate; a third head was found on the motor pedestal. The three bolt heads were covered with soot and were heavily oxidized, and the undersides of all three bolt heads were rounded and exhibited deformation in an upward direction.

M croscopic examination of the fracture surfaces on the three sections of bolts with the heads attached indicated features characteristic of fatigue cracks originating at multiple sites along the thread roots on diametrically opposite sides of the bolts. The remnining fracture surfaces between the fatigued areas revealed features typical of overstress separations. Examination of the fracture surface on the bolt remnant that remnined in the left forward hole in the motor pedestal revealed damage consistent with the motor base sliding across the bolt surface.

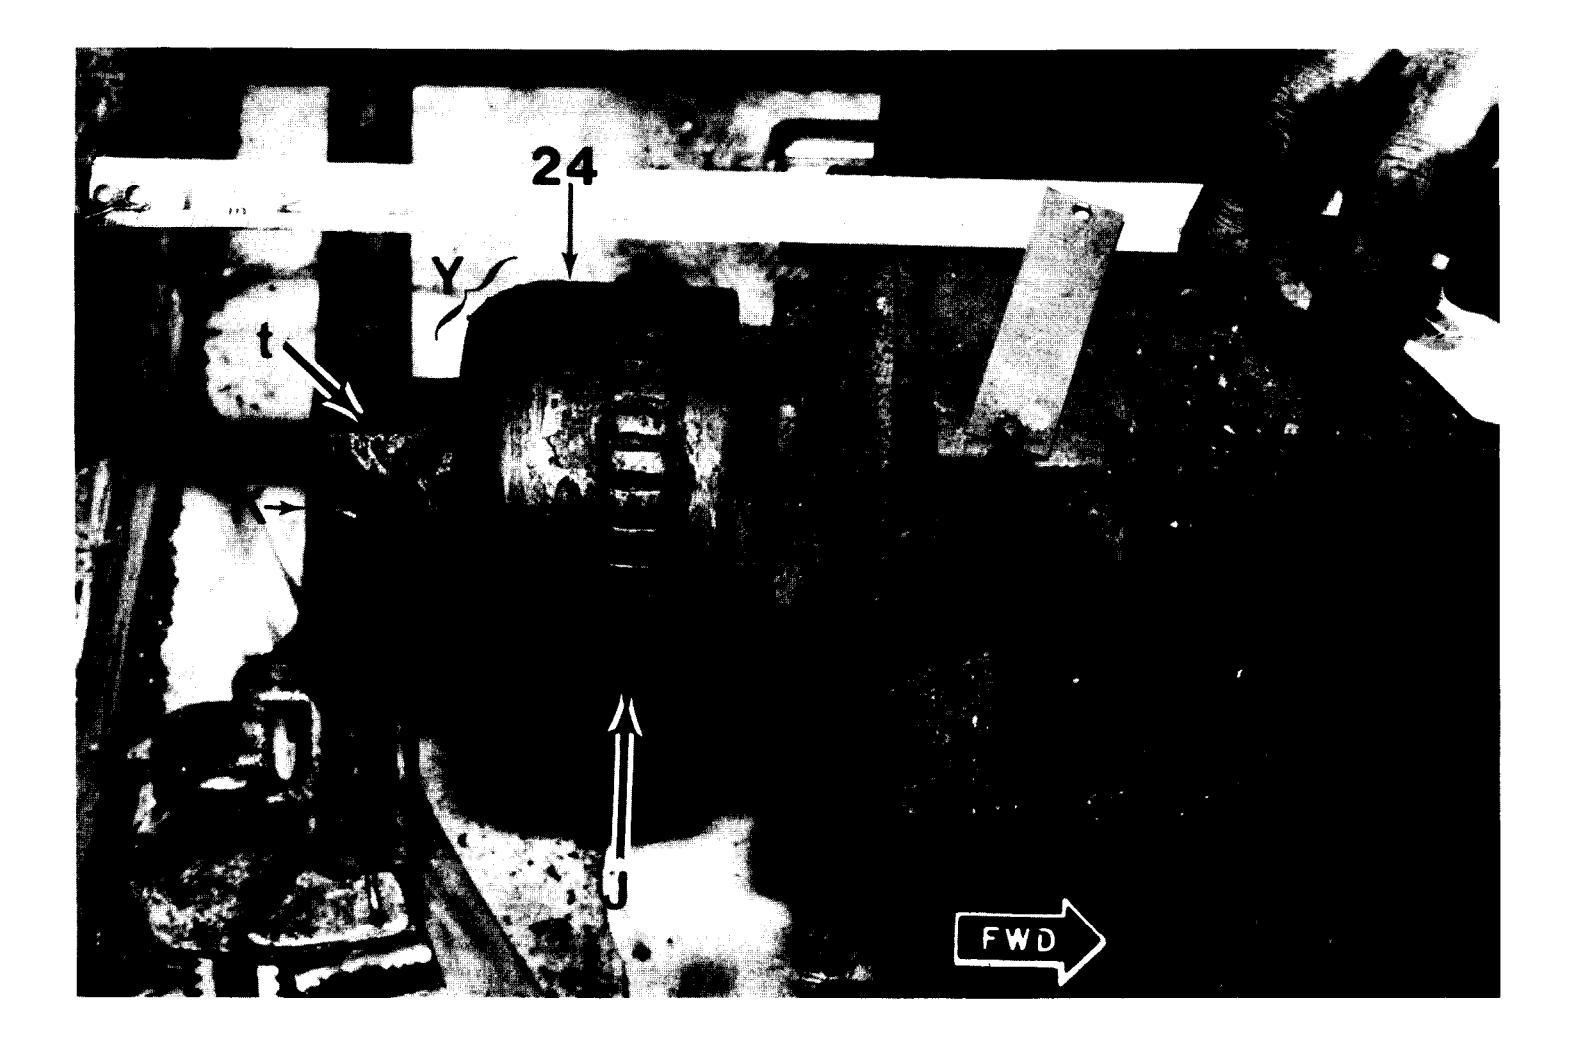
Figure 12. -- Pump hub of motor/pump unit 3 (arrow 24 in figure 7) and associated damage. J indicates worn pump gear teeth; K indicates damaged shaft key; t indicates pump shaft damage; and brace Y indicates worn pump hub.

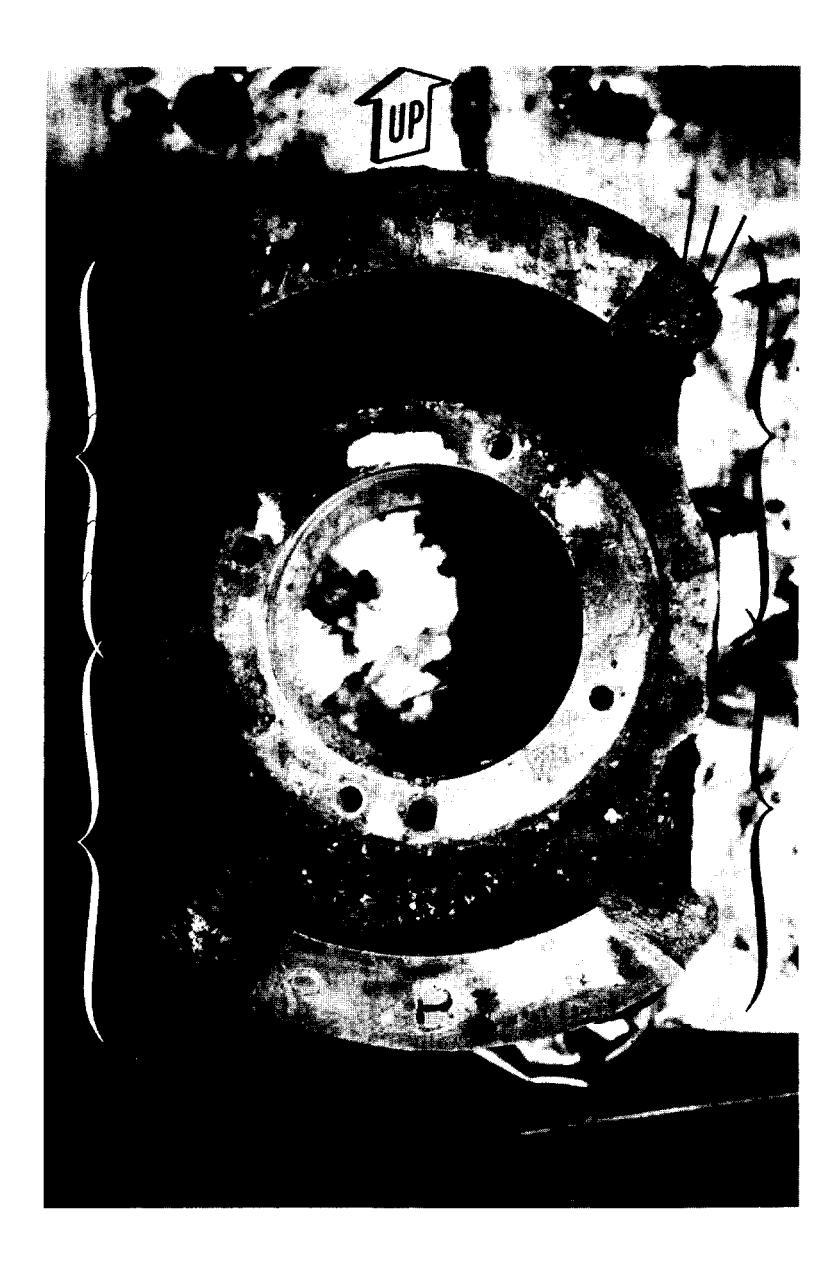
When the bearing case was disassembled from the impeller case, pieces of metal on the bearing case fell off the right and left side. The exposed fracture surfaces on the right side of the case exhibited round globule shaped material that appeared to be solidified from the molten state (see arrows in figure 16). The machined face of one of these fragments was ground, polished, and etched. Metallurgical examination revealed a microstructure consisting of graphite flakes in a matrix of pearlite, which is typical of gray cast iron. No metallurgical anomalies were noted. The examination of the fractured surfaces revealed features consistent with those produced from overstress separation.

Figure 16.--Fractured bearing case of motor/pump unit 3. Arrows point to beads of molten metal.

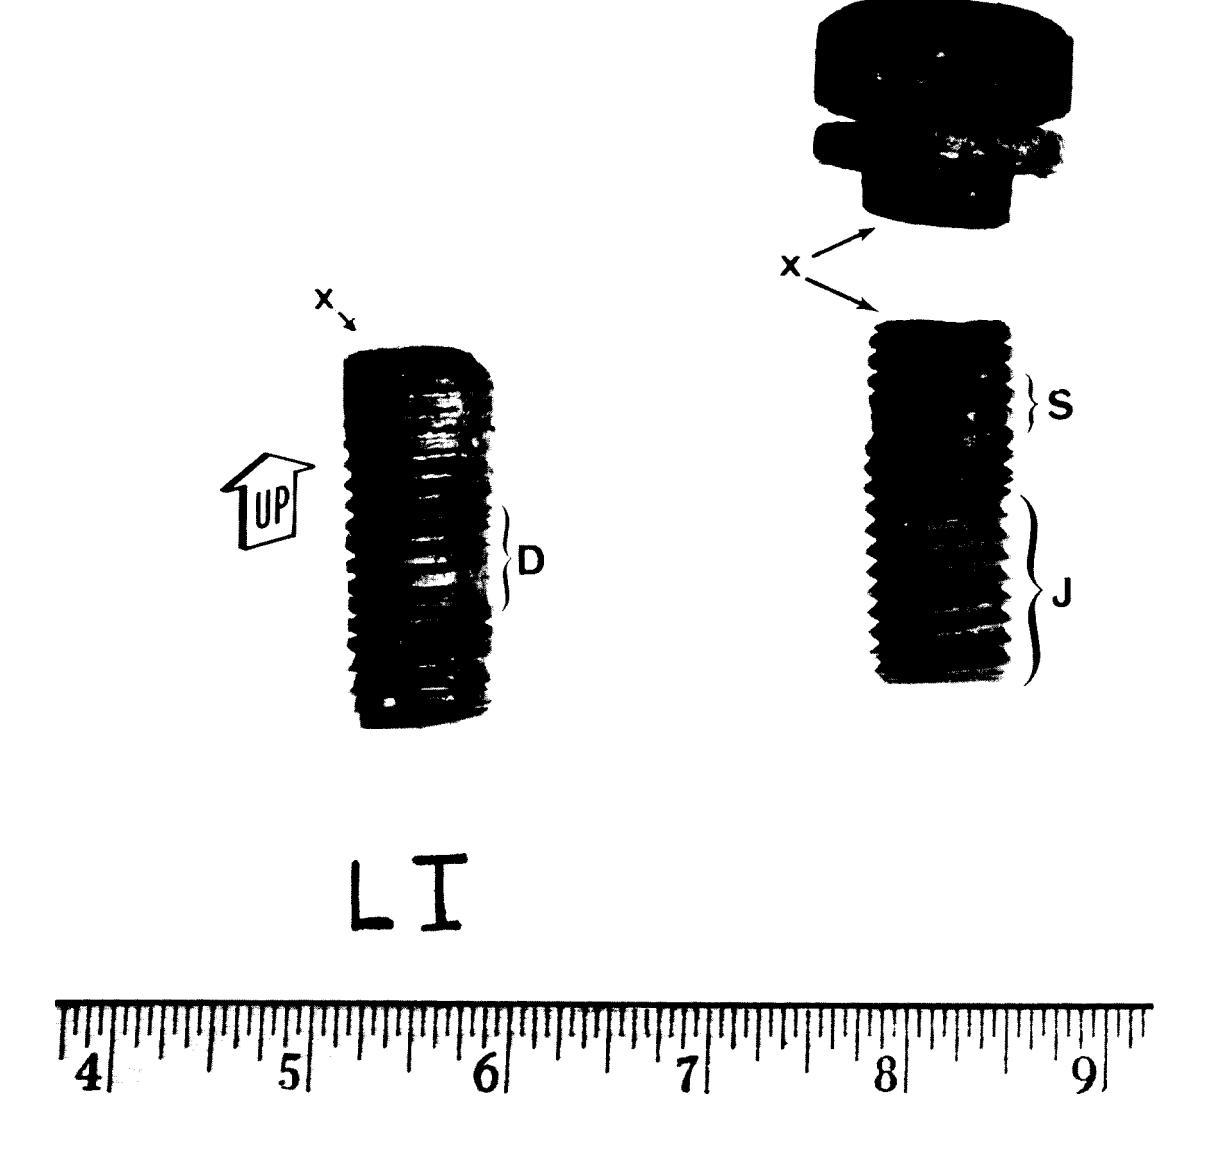
The left rear bolt (as looking forward in figure 6) was separated at the first thread below the hexagonal head (see figure 17). A lock washer was The remnant of this bolt, a total length still installed on the bolt head. of about 18 threads, was found threaded into the pedestal to a depth of about Threads near the top of this remnant (S in figures 17 and 18) 9 threads. were flattened on diametrically opposite sides. The bolt remnant was also bent in the direction of the flattened threads, indicating side loading on Secondary cracks were found in the remnant at a location about the bolt. The bolt head, washer, and the top 7 threads from the top of the remant. nine threads of the remnant were covered with soot. After electrolytic cleaning, the bolt head, washer, and the top seven threads of the remnant exhibited a copper colored coating. Energy dispersive analysis showed an The bolt was ungraded and had a tensile strength of intense copper spectrum about 56 ksi, as determined by post-fire hardness measurements.

The hexagonal head of the left forward bolt was not located. The remnant of this bolt (a total length of 18 threads) was found threaded into the pedestal to a depth of 3 threads. These three threads were deformed in a downward direction with circumferential gaping cracks at the base of the crown threads. Threads 6, 7, 8, and 9 (as counted from the bottom of the remnant) were flattened on diametrically opposite sides (brace D in figure 17). Hardness measurements of the remnant indicated a tensile strength of about 50 ksi.

Examination of fracture surfaces (x on figure 17) on both the left rear and forward bolts showed poorly defined features and oxidation from the fire. The fracture surfaces were normal to the longitudinal axes of these two bolts.

Figure 17. -- Fractured left pump bolts of motor/pump unit 3. D and S indicate flattened threads, and x indicates fractured surfaces.

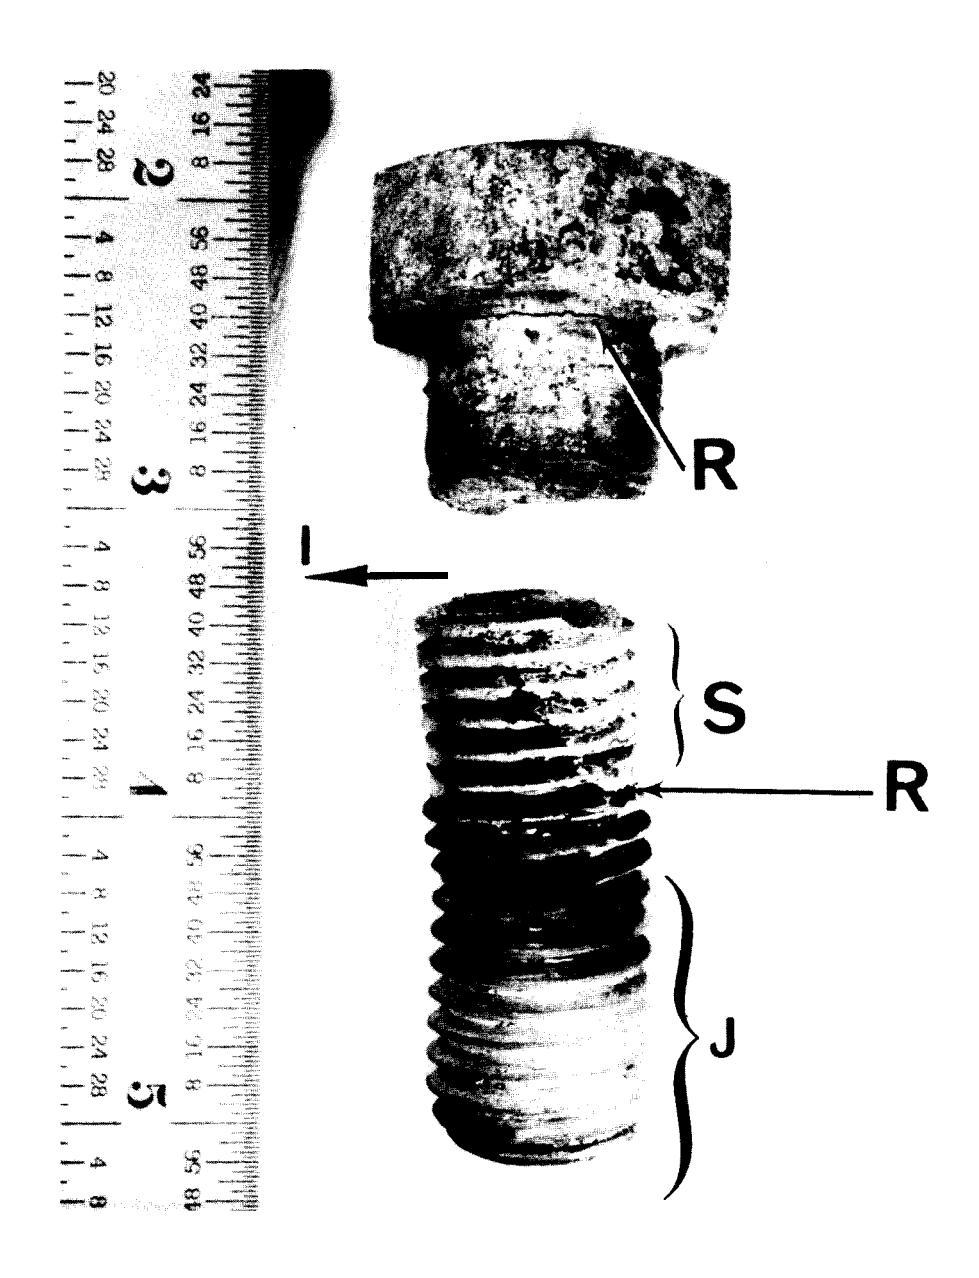
Figure 18.--Fractured pump bolt after electrolytic cleaning. R indicates areas of secondary cracks. S indicates flattened threads.

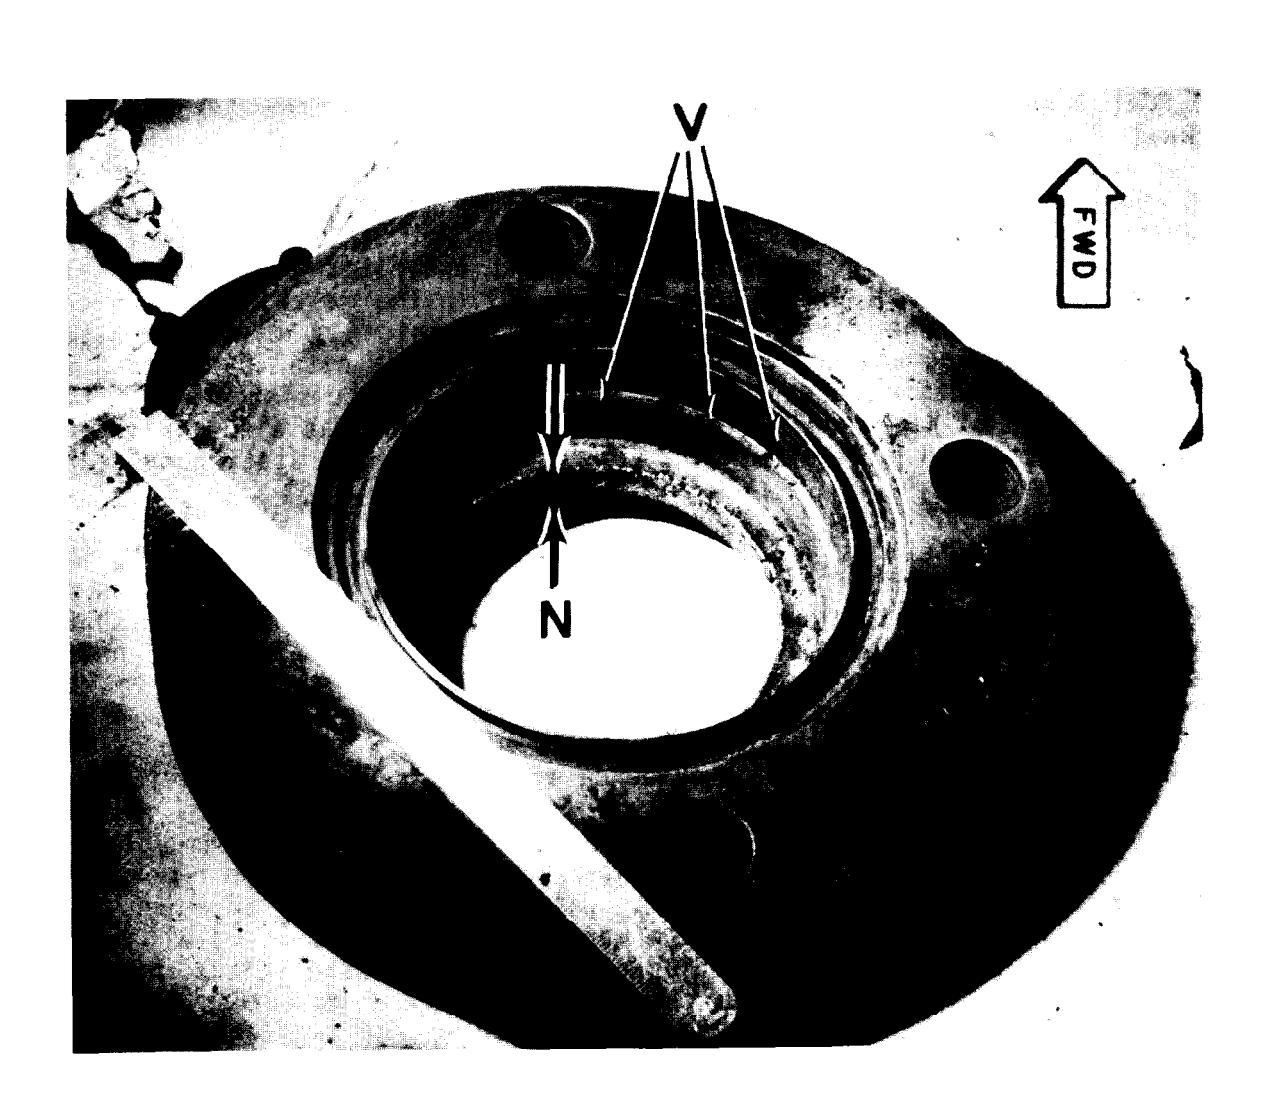
When pump 3 was disassembled. the surfaces of the pump seal. which prevents fuel from escaping into the atmosphere around the pump, were missing but the "O" rings were present and intact. The nump seal consisted of two mating surfaces: (a) a stationary surface (tungsten carbide, silicon carbide, or some equivalent hard material) held in a steel "gland"; and (b) a carbon rotating disk. The carbon rotating disk is held against the stationary surface with a spring under compression to prevent fuel leaks. A small fuel line (seal flush line) carries fuel from the pump discharge to this seal for lubrication and cooling. Repair records by John Crane, Inc. (see discussion "Fuel Farm Maintenance Records") on pump 3 indicate that the mating surface had been silicon carbide. The gland. which holds the stationary mating surface, was damaged. The gland contained indentation marks on the forward bore surface. The gland exhibited wear damage all around the bore (arrow N in figures 19 and 20). The rotating mechanical sleeve, which holds the carbon rotating disk, exhibited a circumferential worn qroove, measuring about 1/32-inch deep, in the area noted by brace Q in figure 20. The location and width of the groove was consistent with the size and position of the worn aft gland bore surface and was also consistent with the rotating seal sleeve having made contact with the stationary gland aft bore surface.

Figure 1g.--Gland of pump seal in unit 3 with wear damage (N) around bore and indentation marks (V).

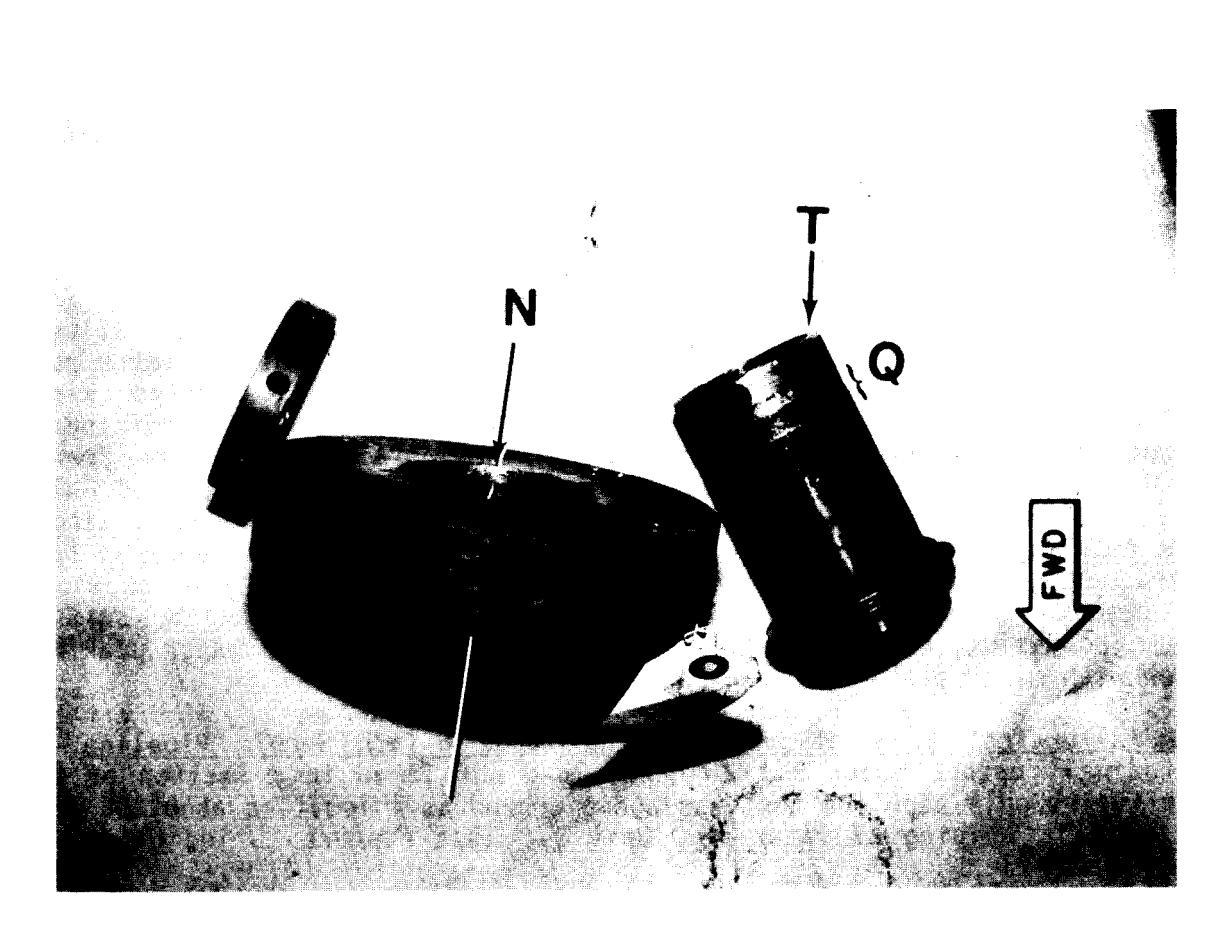
Figure 20. -- Mechanical pump seal sleeve of pump unit 3. N indicates damaged gland around the bore, and Q is the area of a worn groove.
