DOT/FAA/AM-05/18
Office of Aerospace Medicine
Washington, DC 20591

Reliability of the Gas Supply in the Air Force Emergency Passenger Oxygen System

October 2005

Final Report

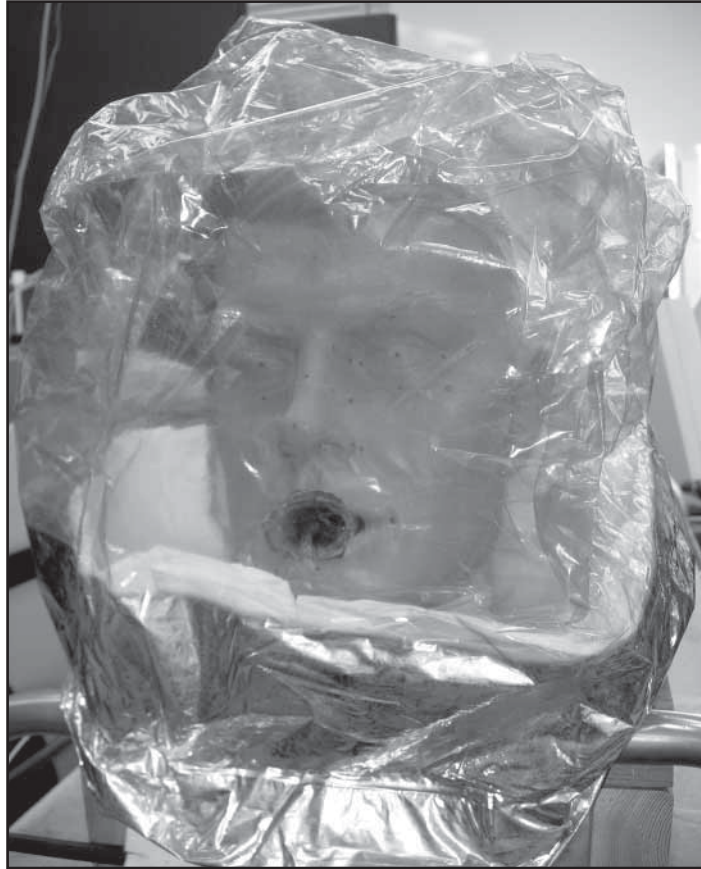
Figure 1. The Emergency Passenger Oxygen System evaluated in this study. The unit contains a single oxygen cylinder (not visible) that is normally opened to the interior of the unit when taken from the packaging for donning.

14. Sponsoring Agency Code		
15. Supplemental Notes					
16. Abstract The protective breathing equipment (PBE) procured by the U.S. Air Force as Emergency Passenger Oxygen System (EPOS; Fig. 1) was alleged to have significant numbers of inadequate oxygen cylinders. In theory, this could prevent the PBE from providing the required time of protection for the user. The Civil Aerospace Medical Institute was requested to participate in the testing for the possibility of inadequate oxygen cylinders through the U.S. Air Force Office of Special Investigations. To test for any potential leakage and therefore an inadequate quantity of oxygen, EPOS units were collected from Air Force bases and submitted by the manufacturer for a series of tests. The primary indicator in the testing was the mass (weight) of oxygen in the cylinder. A total of 92 oxygen cylinders that were manufactured for assembly into EPOS or similar models of PBE were evaluated. Estimated dates of manufacture were between January 1989 and November of 2003. Four tests were conducted. The first measurement was the oxygen concentration in the vacuum-packaged PBE. The oxygen cylinders were then removed from the PBE and any difference between the current cylinder weight and the cylinder weight at manufacture was recorded. The cylinders were then exposed to 40,000 feet altitude in a hypobaric chamber for 4 hours. Weights before and after the chamber exposure were recorded. Finally, the cylinders were emptied of oxygen and the empty cylinder weight recorded. Two oxygen cylinders had large oxygen deficits (>11 grams). Based on the results of the altitude testing, the loss did not appear to be related to diffusion out of the cylinder. Therefore, other explanations need to be examined as to why these two cylinder shortages existed.

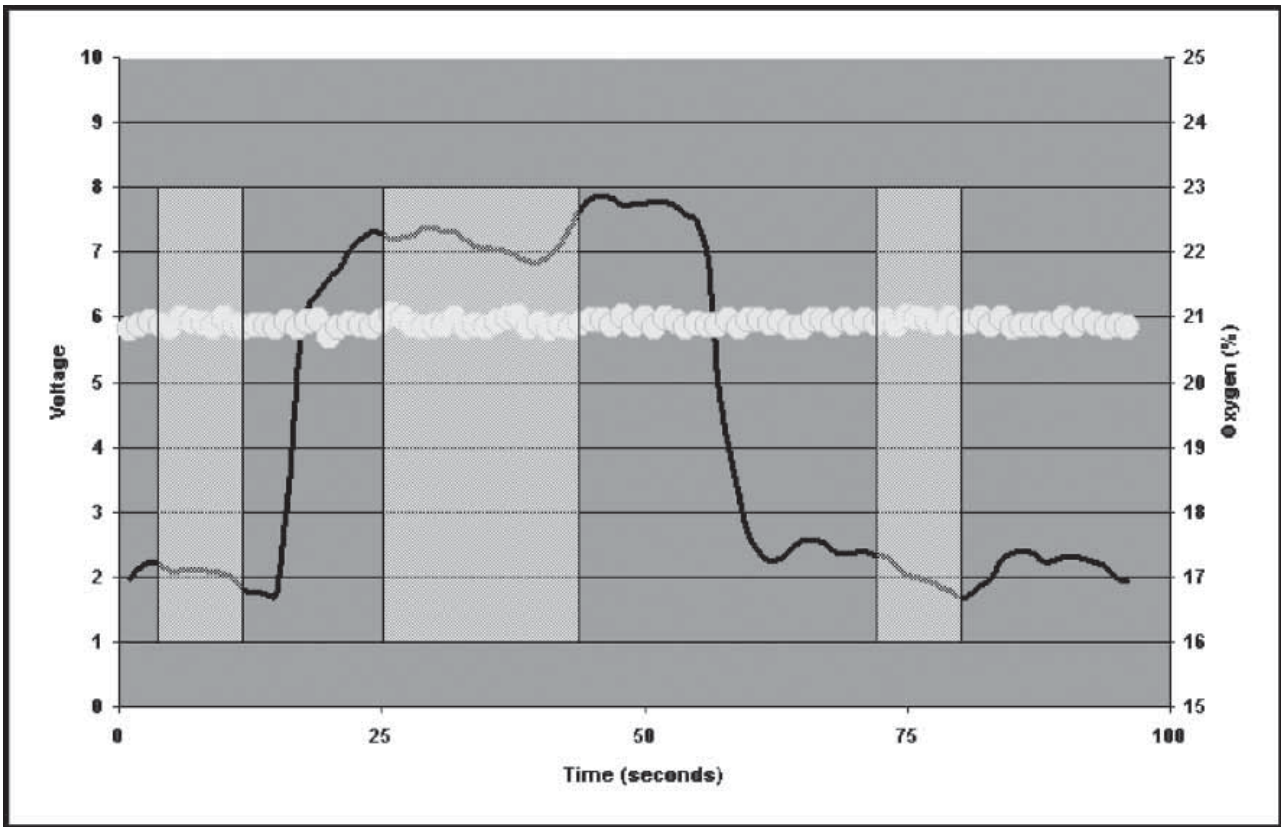
Figure 2. Sampling of gases within the EPOS packaging. This is a representative trial from Test 1. The dark line is a voltage signal use to delineate the sampling period (left y-axis). The light gray boxes are the sample collection periods used for comparison. The circles are the oxygen concentration (right y-axis).

Test 1. The EPOS units were received in their standard vacuum-packaged condition. This process is designed to minimize exposure to humidity that might compromise the carbon dioxide scrubbers. The first test took a gas sample from the units in which the vacuum packaging appeared to be intact. A hypodermic needle was attached to the sampling line of a mass spectrometer (Perkin-Elmer, Model MGA-1100). The needle was inserted into the vacuum packaging, and a 20-30 second sample was taken at one sample per second. Cylinders in which the vacuum packaging had obviously been compromised were excluded.

The concept underlying the first test was that leakage from the cylinders would increase the oxygen concentration in the vacuum packaging protecting the EPOS. If the volume of leakage was large enough, it could potentially rupture the packaging. Of the 69 EPOS units collected by the Air Force Office of Special Investigations, the vacuum seal of four had been compromised. Two of the four had obvious signs of intentional alteration. A square hole had been cut in one package, and the other had been partially opened in a manner consistent with the instructions. The other two compromised packages were a bit more suspicious. Both were ruptured along the seam of the packaging. This is an area that is probably most susceptible to the issues of an increase in pressure. A graph of data representative of the results obtained from testing the other 65 EPOS is presented in Figure 2. The atmospheric oxygen concentration was $20.9 \pm 0.1\%$ prior to sampling from the package; the oxygen concentration in the package was $20.9 \pm 0.1\%$, and atmospheric oxygen was $20.9 \pm 0.1\%$ after sampling from the package. These numbers supported a conclusion that no significant amount of oxygen leaked out of the cylinders and increased the package internal oxygen concentration. This assumes that the packaging is impermeable to atmospheric gases.

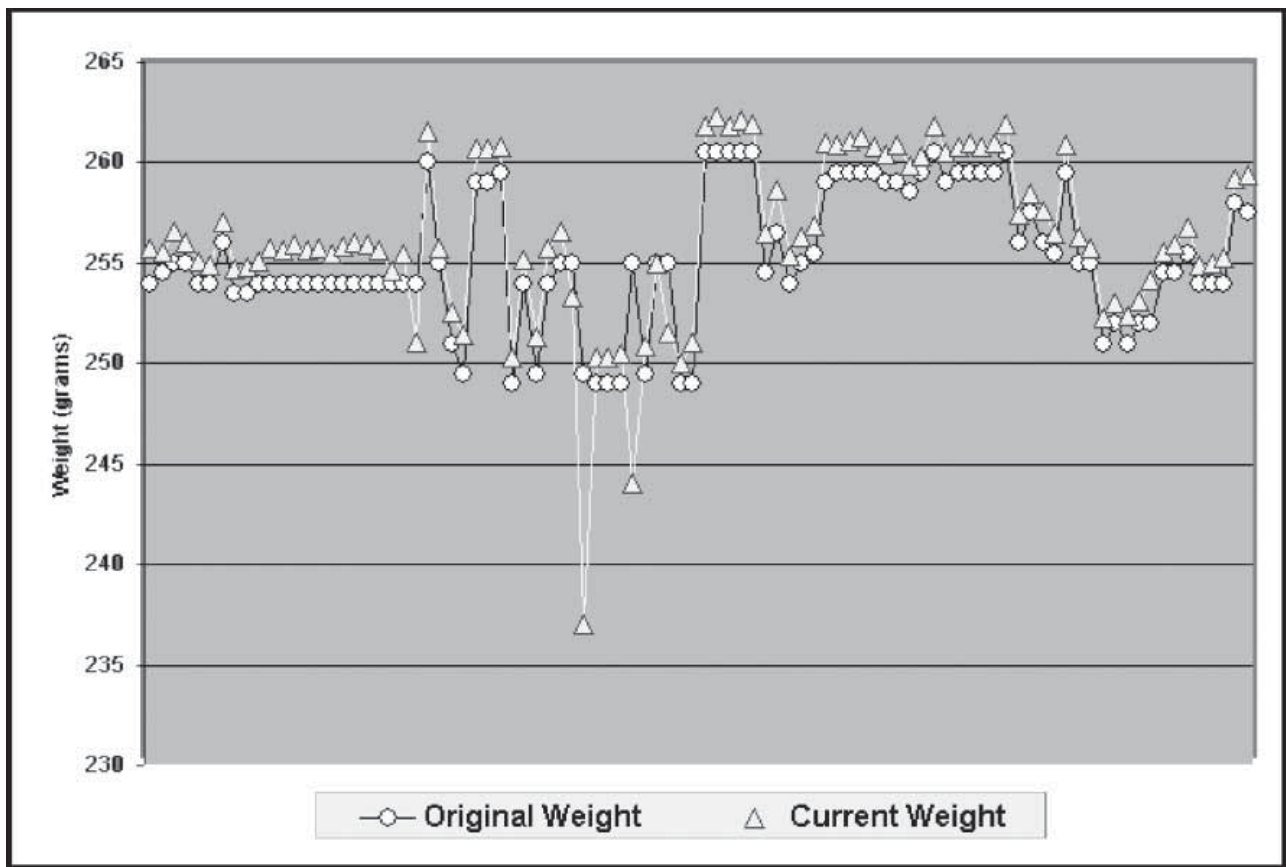
Figure 3. Differences in weight observed between weight at manufacture and the current weight. The production batch number (x-axis) is roughly equivalent to the date of cylinder manufacture. Values listed on the cylinders for weight at manufacture appear to be representative batch weights, not the actual measured weight of each individual cylinder.

The differences in the current cylinder weights and the cylinder weights at manufacture (expressed in oxygen weight) are presented in Figure 3. Weights for all 92 cylinders are presented in order of increasing production batch designation. At manufacture, the cylinders

are designed to contain 24.7 ± 0.6 grams of oxygen. Seven cylinders, 7.6%, fell outside of the range of two standard deviations, assuming the difference represents a loss of oxygen. The average and standard deviation of oxygen shortage for this subset is 6.8 ± 5.1 grams. Two cylinders that were light by 14.4 and 12.8 grams were the major contributors to the large variance. These were the same two cylinders that had the vacuum packaging ruptured along the seams. Four of the seven cylinders that were not within manufacturer weight specifications were from the same production batch-designation.

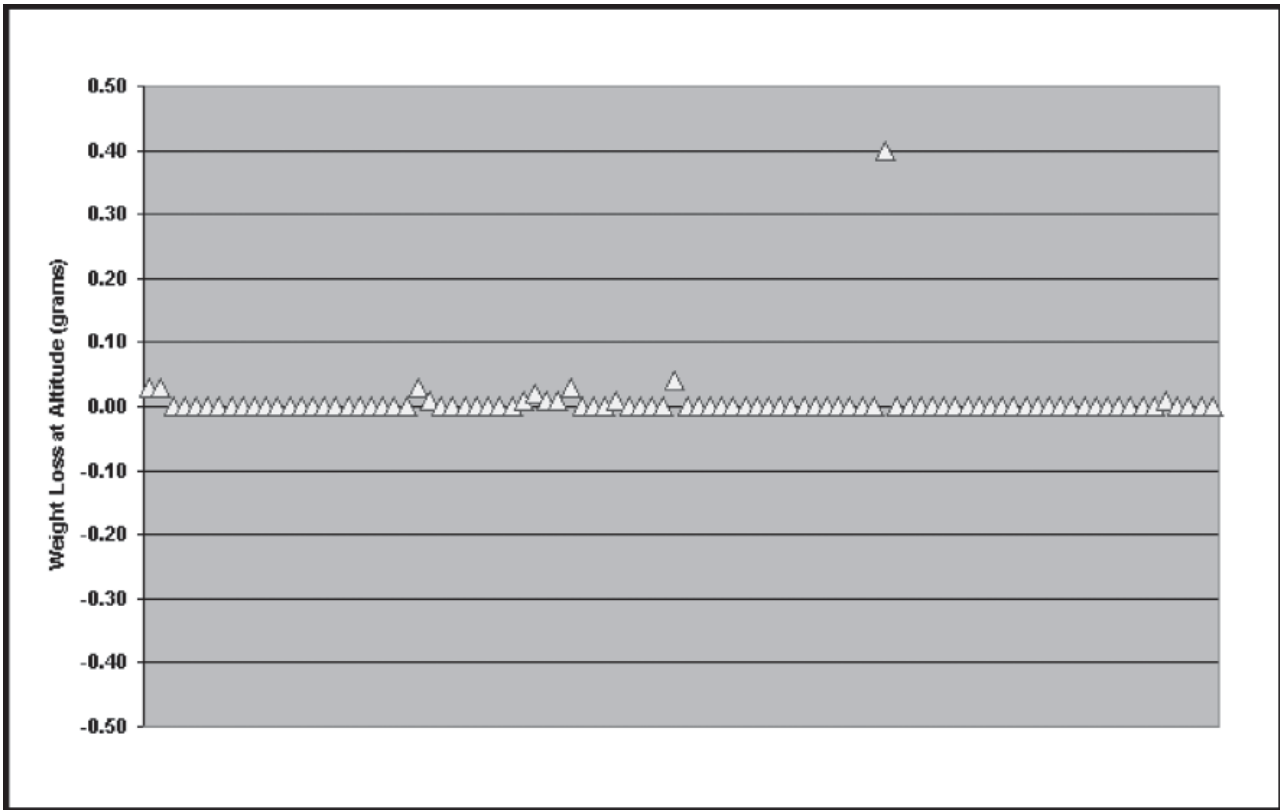
The altitude test was performed to determine if an increased pressure differential led to a loss of oxygen from the cylinder. The weight changes are presented in Figure 4. Although one bottle lost 0.4 grams of oxygen after altitude exposure, the oxygen level of this particular bottle remained within manufacture specifications. Weight consistency after altitude exposure suggested that any oxygen loss from an increased pressure differential was functionally non-existent. This conclusion was further supported by the fact that the Air Force Office of Special Investigations had collected a number of the EPOS that had been installed aboard aircraft. The weights of these units were no different than the ones yet to be used on flights.
