DOT/FAA/AM-06/10  
Office of Aerospace Medicine  
Washington, DC 20591

# **Vaporized Hydrogen Peroxide (VHP®) Decontamination of a Section of a Boeing 747 Cabin**

Final Report

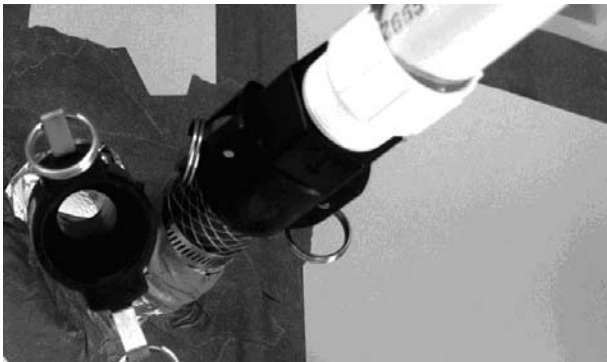
**Figure 3.** Photograph 1 showing the bulkhead penetration of the VHP Inlet pipe and VHP Return (open connector) into the test section of the AERF. Photograph 2 showing the STERIS model 1000 VHP.

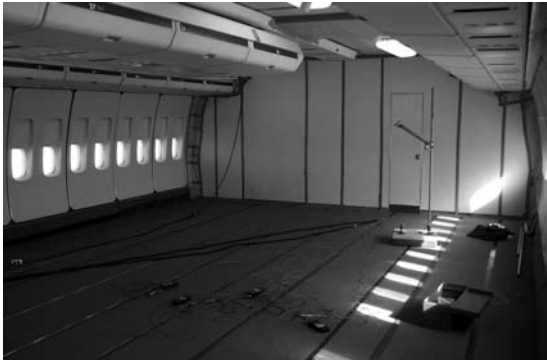
**Figure 4.** Photographs showing the 747 AERF section with the seats removed and bulkheads isolating the test section of the aircraft. Photograph 1 is a view of the Forward bulkhead, and Photograph 2 is a view of the Aft bulkhead.

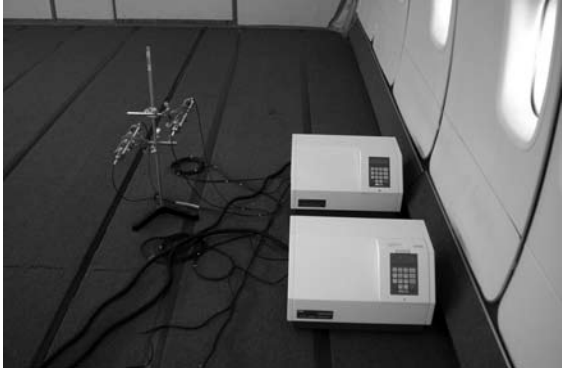
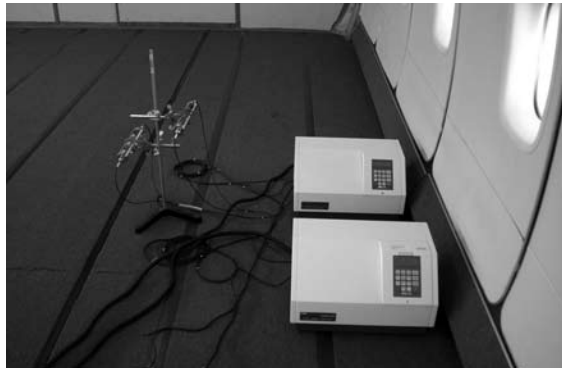
**Figure 5.** Photograph 1 shows the Guided Wave Hydrogen Peroxide monitors installed in the test section of the 747 AERF. Photograph 2 illustrates how the Guided Wave and hot wire anemometer data cables were routed through the floor seat tracks.

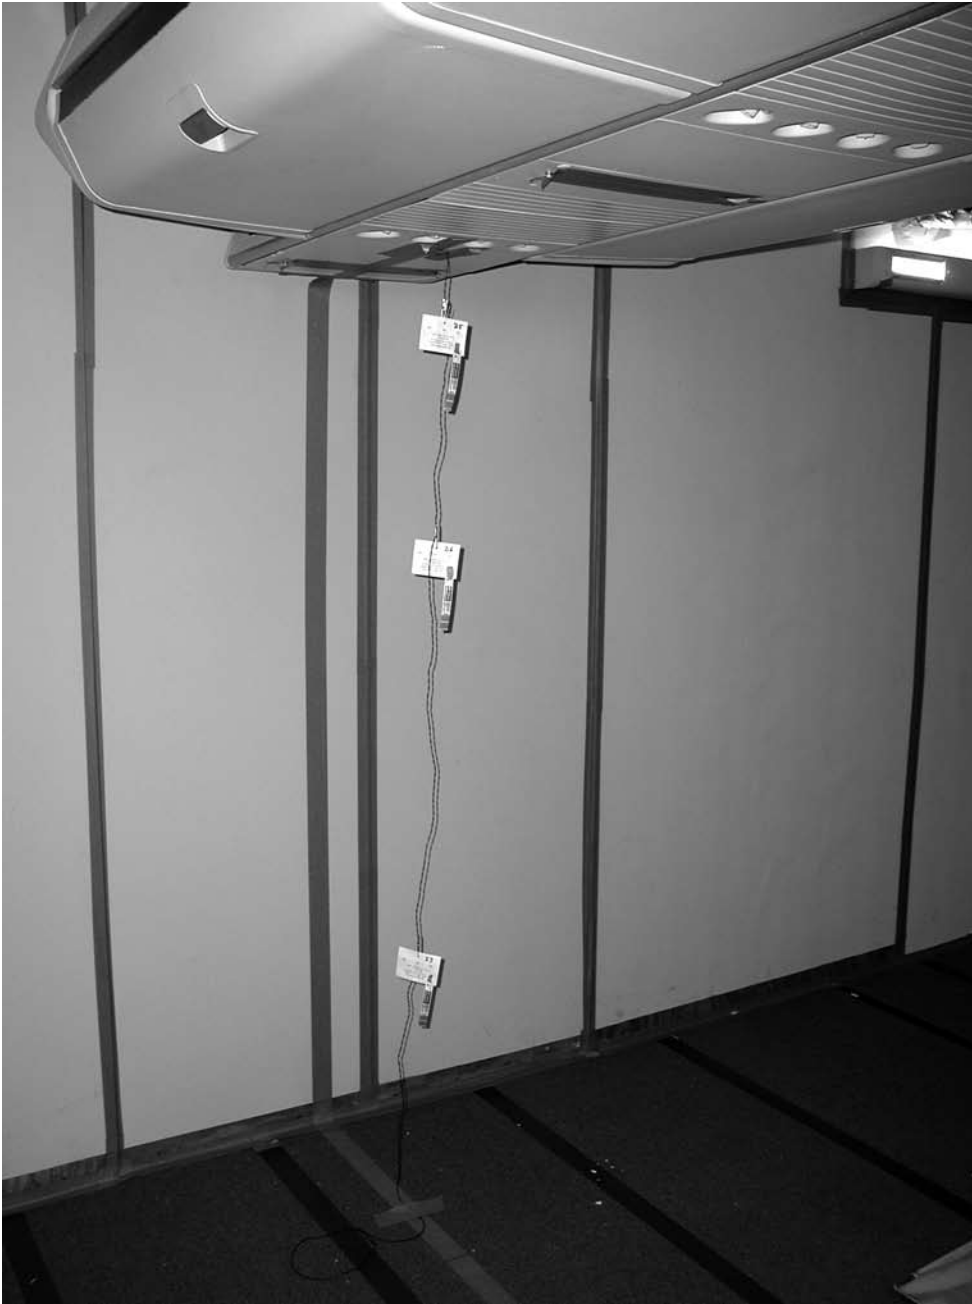
**Figure 6.** Photograph of BIs and CIs (positions no. 25 – 27, as shown in Figure 7 and identified in Table I) attached to wire in preparation for testing.
