DOT/FAA/AM-15/17  
Office of Aerospace Medicine  
Washington, DC 20591

# **Effect of Passenger Position on Crash Injury Risk in Transport-Category Aircraft**

Amanda M. Taylor  
Richard L. DeWeese  
David M. Moorcroft  
Civil Aerospace Medical Institute  
Federal Aviation Administration  
Oklahoma City, OK 73125

Final Report

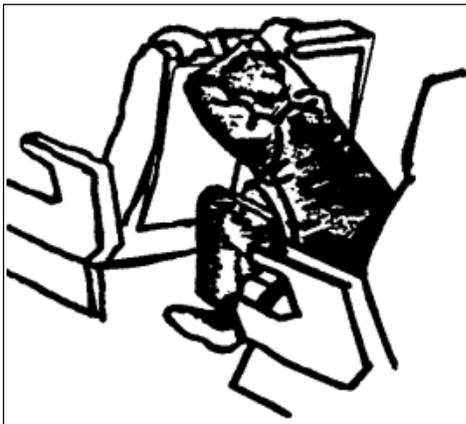
Figure 1. Passenger Brace Positions in AC 121-24B

Many of these recommendations formed the basis of the brace positions cited in Advisory Circular (AC) 121-24B Appendix 4 (Fig.1). Subsequent crash investigations have resulted in new recommendations concerning brace positions [4]. These new recommendations, as well as Federal Aviation Administration (FAA) guidance and previous research findings, were used as the basis of the brace recommendations contained in SAE Aerospace Recommended Practice 4771 [5].

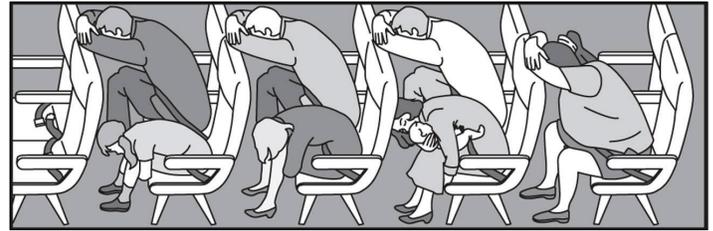
Figure 2. Passenger Brace Position Shown in the US Airways Safety Information Card

On January 15, 2009, US Airways flight 1549, an Airbus A320, ditched in the Hudson River approximately 8.5 miles from LaGuardia Airport. Four passengers sustained serious injuries attributed directly to the impact; two passengers sustained similar shoulder injuries. Both described assuming similar “brace for impact” positions in which they placed their arms on the seat back in front of them and leaned over placing their head on the back of their hands. This is a similar position to the one depicted in the US Airways safety card (Fig. 2).

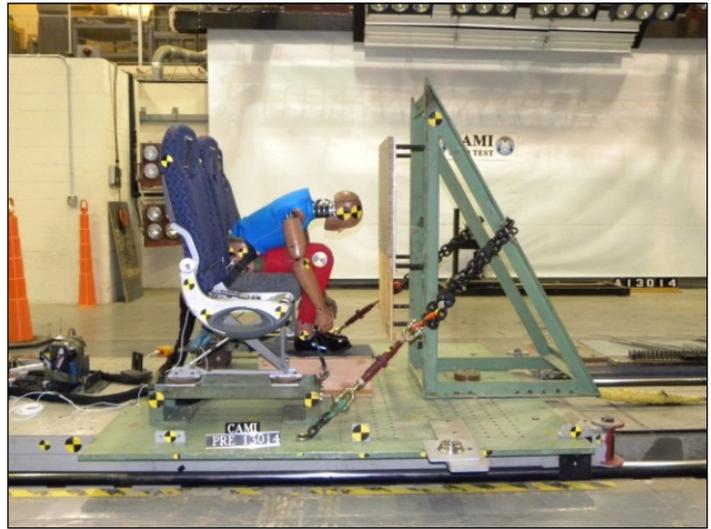
Figure 5. Rigid Wall with Honeycomb Panel

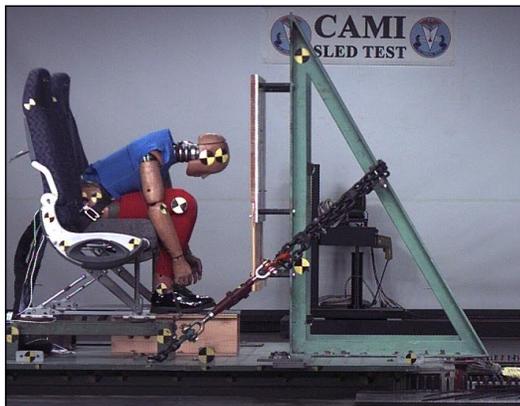
Figure 7. Pike Position Behind a Rigid Wall

- Upright: The nominal seated position. This position is used for qualification tests.
- Braced: Leaned forward with the head touching the seat back. A cord over the back was necessary to maintain this initial position.
- Pike: Leaned all the way over until the neck was horizontal and the chest was touching the tops of the thighs. (Fig. 7) This position was used to assess the worst case axial loading in to the neck. To achieve this position, it was necessary to remove the abdominal insert from the ATD and hold the torso down with a frangible string over the back (designed to break immediately after the test began).

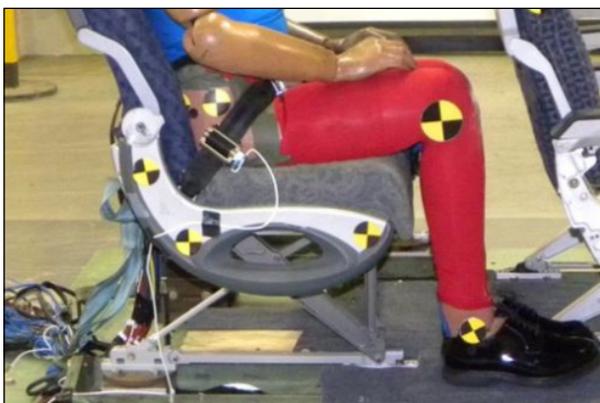
Figure 8. Lower Leg "Vertical" Position

- Vertical: the nominal position used for qualification tests (Fig. 8)

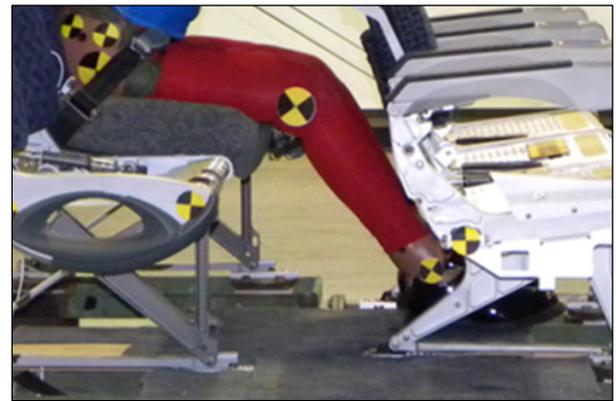
Figure 9. Lower Leg "Forward" Position

- Forward: the feet placed as far forward as possible while remaining flat on the floor (Fig. 9)
- Aft: feet placed as far back as possible, but limited by contact with the baggage bar (Fig. 10) This position has been previously proposed as a means to reduce leg injury [4]
- Unsupported: no floor installed at that seat place. Intended to simulate a short stature occupant whose legs do not touch the floor, and thus will swing forward unimpeded from an initial vertical position (Fig. 11)

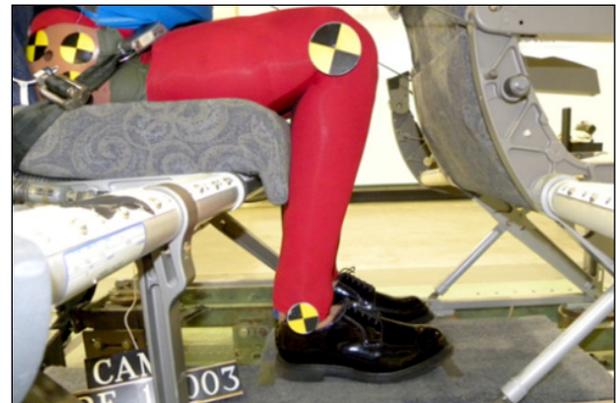
Figure 10. Lower Leg "Aft" Position

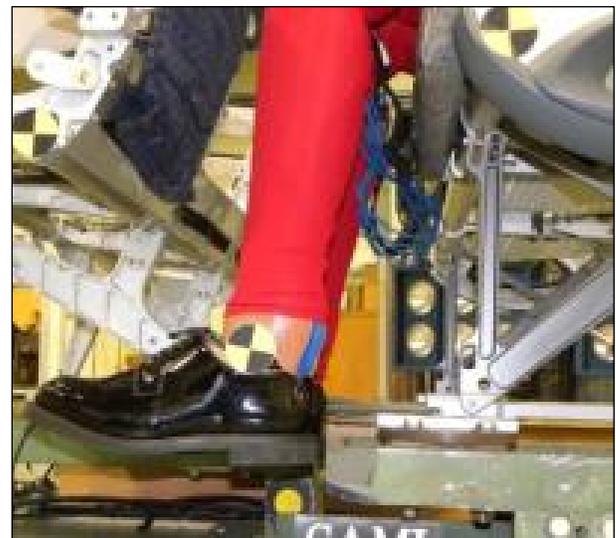
Figure 11. Unsupported Leg Position (No Floor)

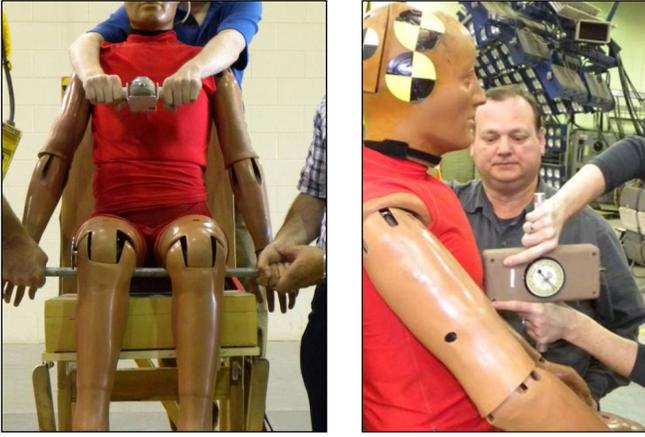
Figure 14. Seating Procedure

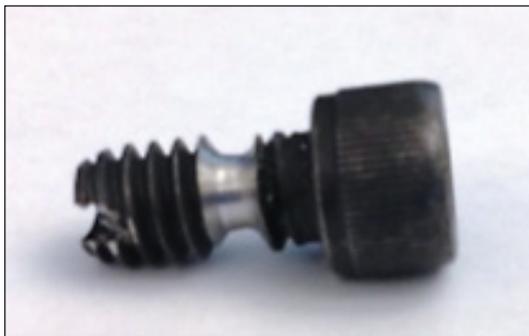
Figure 15. Shear Bolt for Shoulder Injury Evaluation

The FAA Hybrid III ATD does not have instrumentation to measure forces on the shoulder. Since the NTSB had identified shoulder injury as a potential risk for a braced occupant, a means of determining that injury risk was needed for this study. Hyper-extension of the shoulder joint in the sagittal (X-Z) plane was a possible injury mechanism for brace positions that place the hands on the seat back. To determine if it occurred during testing, the bolt securing the FAA Hybrid III's shoulder rotation stop block was narrowed down to 0.133 inches to lower its shear strength to 660 lb (Fig. 15). This would allow the stop block to fail if the torque on the shoulder joint (in the x-z plane) exceeded 990 in-lb. A post-test range of motion and visual inspection indicated whether the bolt had been sheared. This assessment was used to determine if there was potential for shoulder injury, but the torque required to shear the bolt has not been correlated to a specific injury severity.

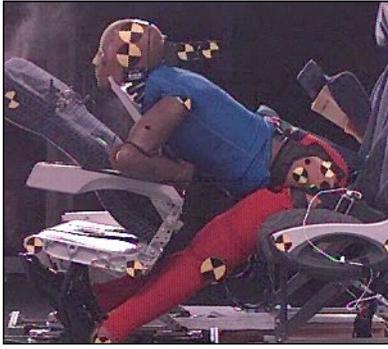
Figure 16. Chin of ATD Catching on Tray Table

In three of the tests, the tray table deployed in a manner that caused it to catch under the ATD's chin. In one case, the table released prior to head impact, and in the other two, the ATD's head struck the tray table latch, freeing the table (Fig. 16). This interaction momentarily interrupted the forward travel of the ATD, resulting in very high neck loads. The combined neck bending-tension criteria  $N_{ij}$  were exceeded in two cases, and it was below the criteria in the third. One of these tests also nearly exceeded the neck tension criteria. Catching the chin on the tray table can produce serious injury. The Hybrid II ATD, typically used in dynamic tests conducted to qualify new seat designs, cannot directly measure the interaction with a tray table that has deployed, leaving conservative qualitative assessments as the only means to ensure the safety of the interaction. The neck instrumentation in the FAA Hybrid III can assess the risk of cervical spine injury due to applied forces, but neither ATD can measure contact forces that could cause serious soft tissue injury such as a collapsed larynx. In the absence of a soft tissue injury assessment method, avoiding impingement onto hard structures may be the best means of preventing neck injury.

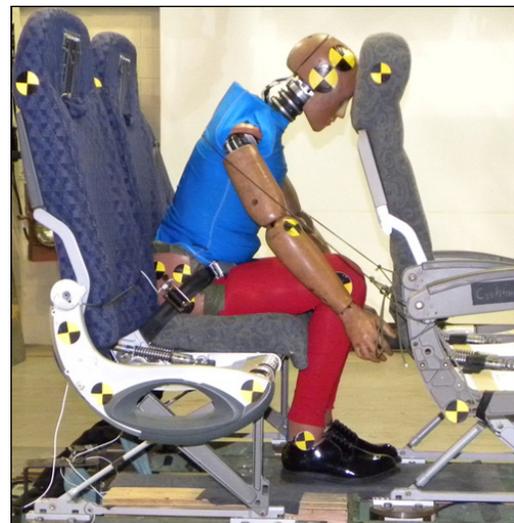
Figure 17. Alternate Brace Position

The occupants place their head directly on the seat back in front of them, and their hands down by the side of their lower legs. The primary factor affecting the effectiveness of the current brace position was the interaction between the occupant's arms and the seat back. To reduce this interaction, the current position was modified by placing the hands down by the lower legs instead of on the seat back (Fig. 17). Because the arms were positioned to prevent them from pushing the seat back forward during the impact, the head remained in contact, which reduced head and neck injury risk. This "alternate" position was successful in reducing head and neck injury risk for all of the seat back types evaluated. This position (when combined with the "Aft" leg position) prevented lower leg contact with the seat in front and produced negligible femur axial compressive forces, lower (positive) femur Y-axis bending forces, and prevented femur contact with the front of the seat frame. Improving performance

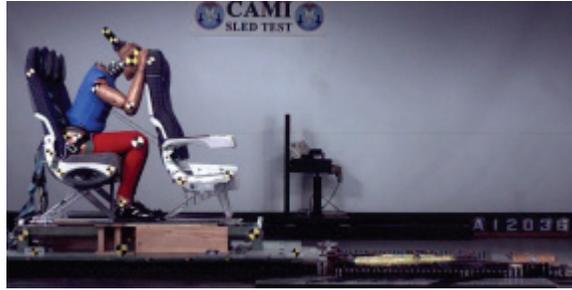
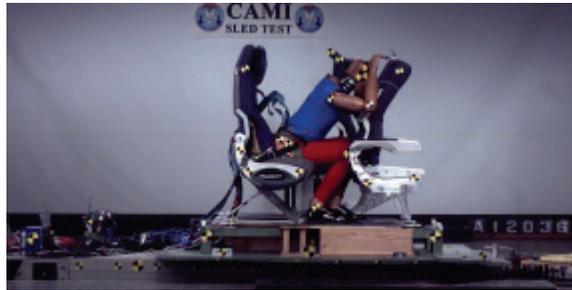
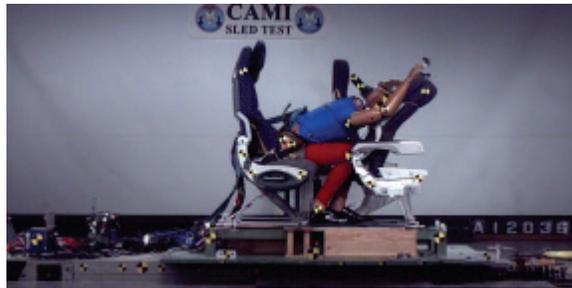
**Braced position with arms on seat back, locked-out seat back, legs back**  
(Figures A1 to A3)

- The ATD is positioned with the torso forward and head against the seat back. The hands are resting on the top of the seat back in front, the legs are back as far as was allowed by the baggage bar.

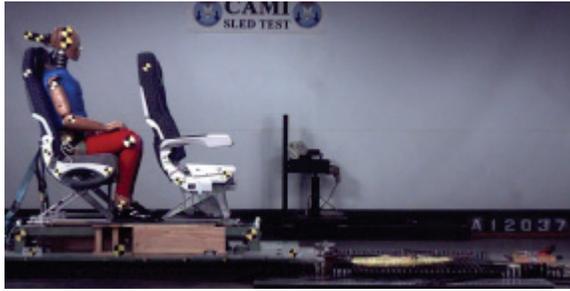
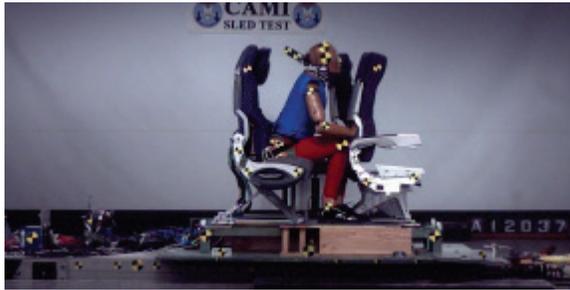
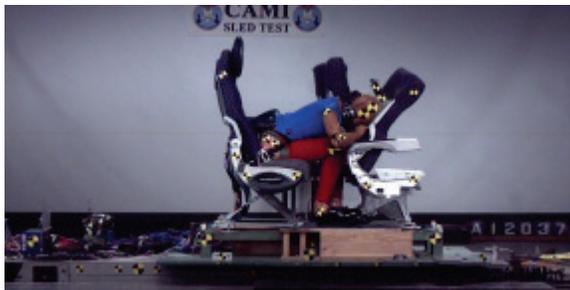
**Upright position with a locked out seat back, legs back**  
(Figures A4 to A6)

- The ATD was positioned with the torso upright and the legs back as far as was allowed by the baggage bar, the hands were placed on top of the thighs.

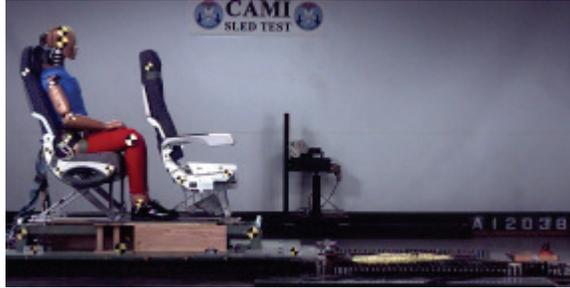
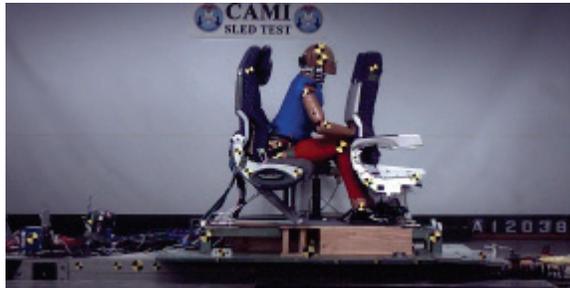
**Upright position with a locked out seat back, legs vertical**  
(Figures A7 to A9)

- The ATD was positioned with the torso upright, the legs vertical, and the hands placed on top of the thighs. This is the initial position used for seat qualification tests.

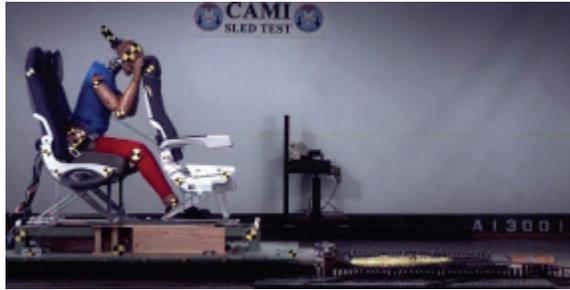
**Braced position with arms on seat back, full break over seat back, legs forward**  
(Figures A10 to A12)

- The ATD is positioned with the torso forward and head against the seat back. The hands are resting on the top of the seat back in front, and the legs are as far forward as possible while still contacting the floor.

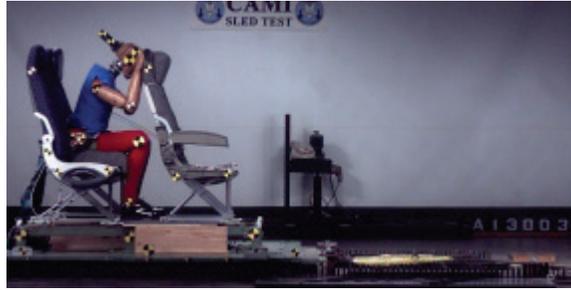
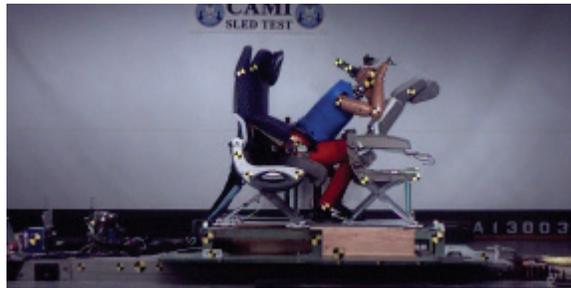
**Braced position with arms on seat back, energy absorbing seat back, legs back**  
(Figures A16 to A18)

- The ATD is positioned with the torso forward and head against the seat back. The hands are resting on the top of the seat back in front, and the legs are back as far as was allowed by the baggage bar.

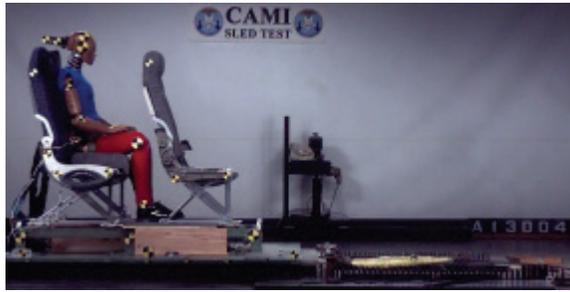
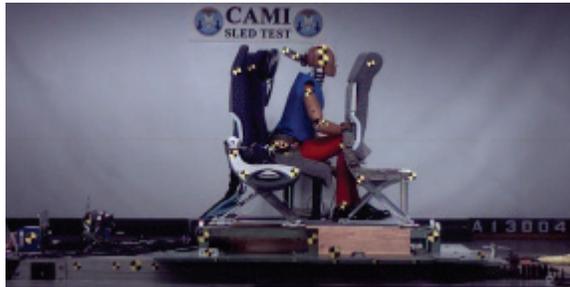
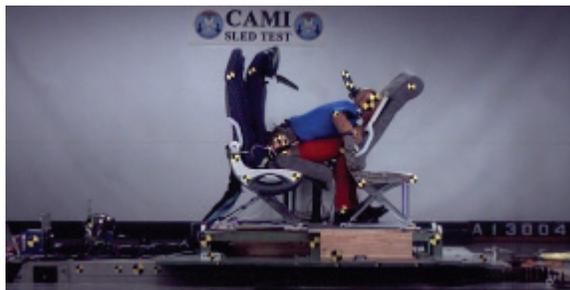
**Upright position, energy absorbing seat back, legs vertical**  
(Figures A19 to A21)

- The ATD was positioned with the torso upright and the legs vertical. The hands were placed on top of the thighs. This is the initial position used for seat qualification tests.

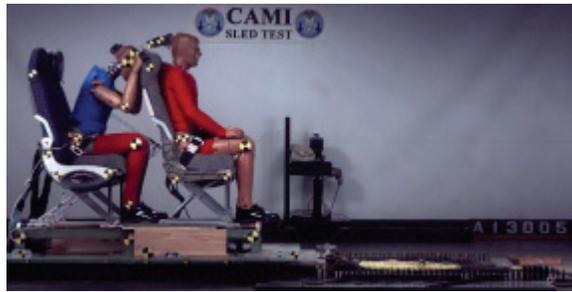
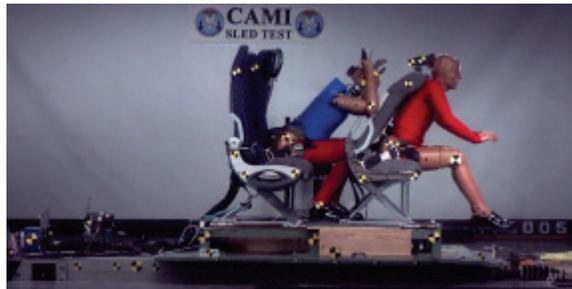
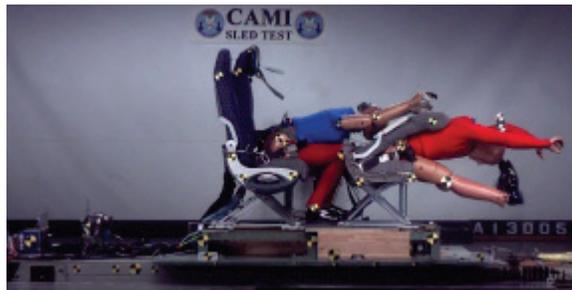
**Braced position with arms on seat back, energy absorbing seat back, legs back, with a front row occupant**  
(Figures A22 to A24)

- The ATD is positioned with the torso forward and head against the seat back. The hands are resting on the top of the seat back in front, and the legs are back as far as was allowed by the baggage bar. This is the same setup and seat configuration as test A13003, but this test also included a front occupant to assess the interaction between the seat back and the occupant.

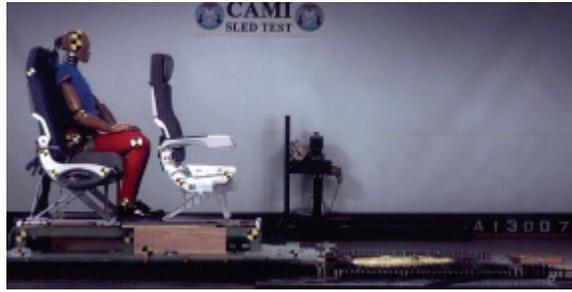
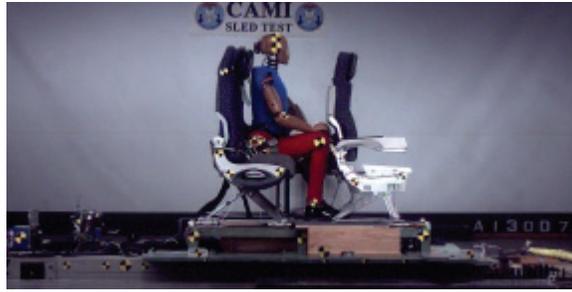
**Upright position, full break-over seat, legs back, and a rigid knee contact plate.**  
(Figures A25 to A27)

- The ATD was positioned with the torso upright and the legs back. The hands were placed on top of the thighs, and the legs were as far back as was allowed by the baggage bar. A vertical rigid plate was attached to the back of the front seat frame in the knee strike zone.

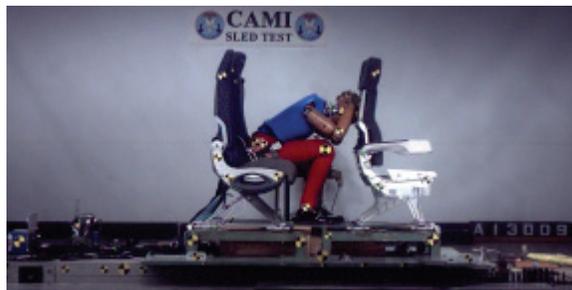
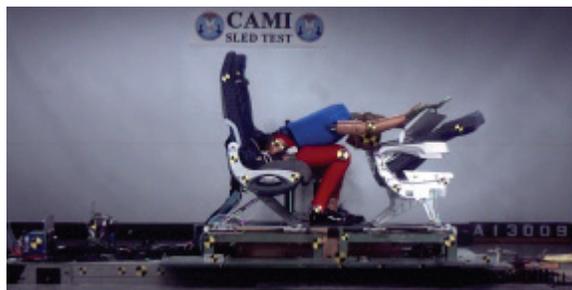
**Pike position with hands on top of head, locked-out seat back, and legs back**  
(Figures A31 to A33)

- The ATD is positioned with the torso as far forwards as it can go with the abdominal insert removed. This position aligns the neck with the horizontal impact vector. The hands are on the back of the head taped together to stay in place and the legs back as far as allowed by the baggage bar. The seat pitch was increased to 38 inches to provide the necessary space for a 50<sup>th</sup> percentile occupant to assume this position. This setup was intended to emulate a small occupant that cannot brace against the seat back in front when seats are installed at a typical economy class pitch.

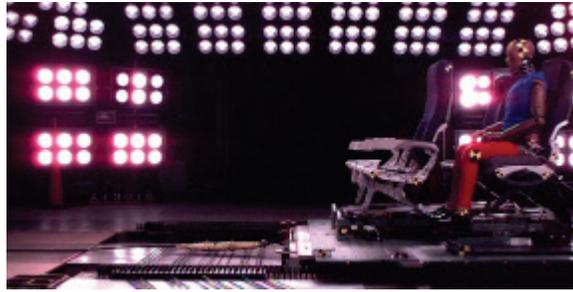
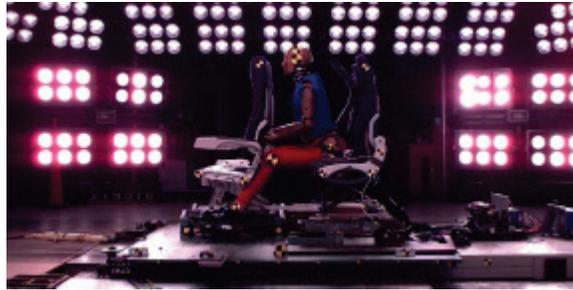
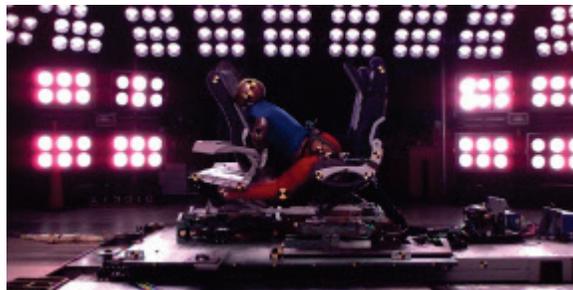
(Figures A34 to A36)

- The ATD was positioned with the torso upright and hands on top of the thighs. No floor was installed, allowing the legs to dangle vertically to emulate a shorter occupant whose feet will not contact the floor. The seat pitch (34 inches) was chosen to maximize the ankle velocity at the time of contact between the lower leg and the seat frame aft cross tube.

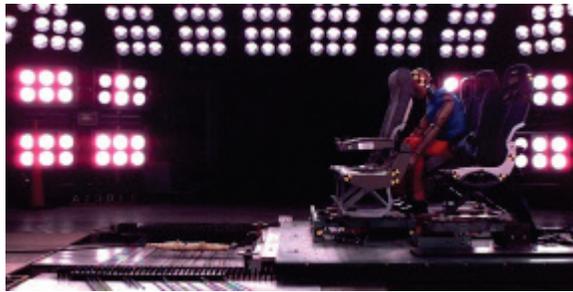
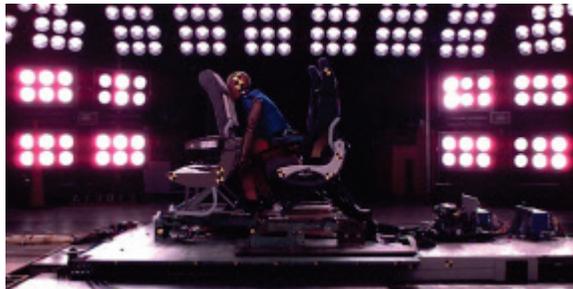
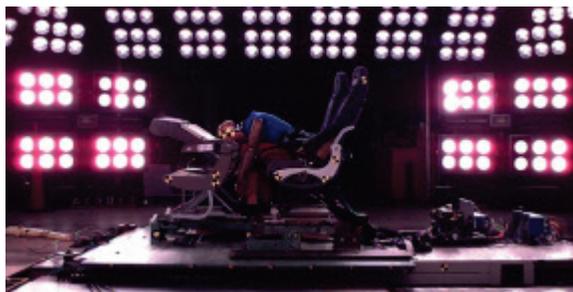
**Braced position with arms at side of legs, energy absorbing seat back, legs back**  
(Figures A36 to A38)

- The ATD is positioned with the torso forward and head against the seat back. The hands are down at the side of the legs, and the legs are back as far as allowed by the baggage bar.
- As the ATD and seat back moved forward, the head remained in contact with the seat back. The arms contacted the bottom of the seat back and seat frame but did not appear to influence the motion of the seat back. This interaction produced a very low HIC of 224 and all the other recorded values were below the criteria limits.
- The right foot did not slide forward and the left foot slid forward until the lower leg was nearly vertical. The knees translated forward and contacted the seat back without generating significant femur compression. As the torso and pelvis rotated forward, a positive Y-axis moment was generated in the right and left femurs but both were relatively low.

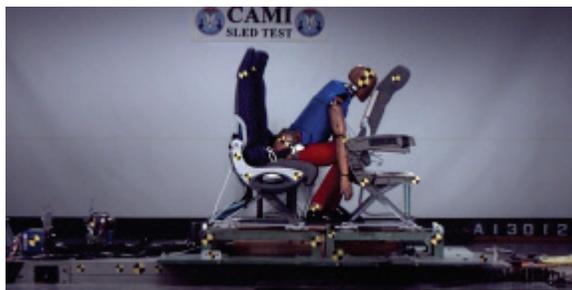
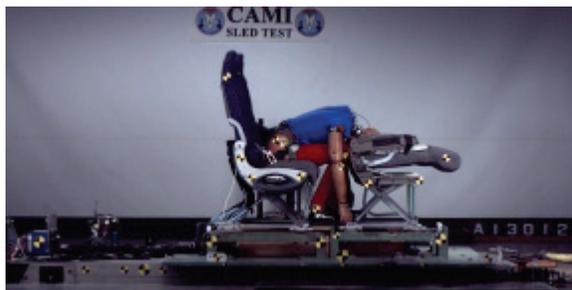
**Braced position with arms at side of legs, full break-over seat back, legs back**  
(Figures A39 to A41)

- The ATD is positioned with the torso forward and head against the seat back. The hands are down at the side of the legs, and the legs are back as far as allowed by the baggage bar.

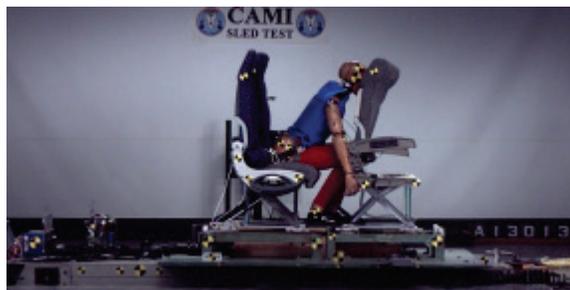
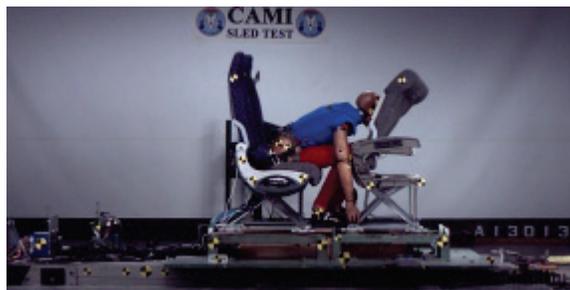
**Braced position with arms at side of legs, locked out seat back, legs back**  
(Figures A42 to A44)

- The ATD is position with the torso forward and head against the seat back. The hands are down at the side of the legs, and the legs are back as far as allowed by the baggage bar.
- As the ATD and seat back moved forward, the head remained in contact with the seat back. The arms contacted the bottom of the seat back and seat frame but did not appear to influence the motion of the seat back. This interaction produced a very low HIC of 167, and all the other recorded values were below the criteria.
- The right foot did not slide forward and the left foot slid forward until the lower leg was nearly vertical. The knees translated forward and contacted the seat back without generating significant femur compression. As the torso and pelvis rotated forward, a positive Y-axis moment was generated in the right and left femurs but both were relatively low.
