DOT/FAA/AM-20/03
Office of Aerospace Medicine
Washington, DC 20591

Use of an Enhanced Flight Vision System (EFVS) in Lieu of Low-Visibility Operations/Surface Movement Guidance and Control System (LVO/SMGCS) Infrastructure

October 2019

Final Report

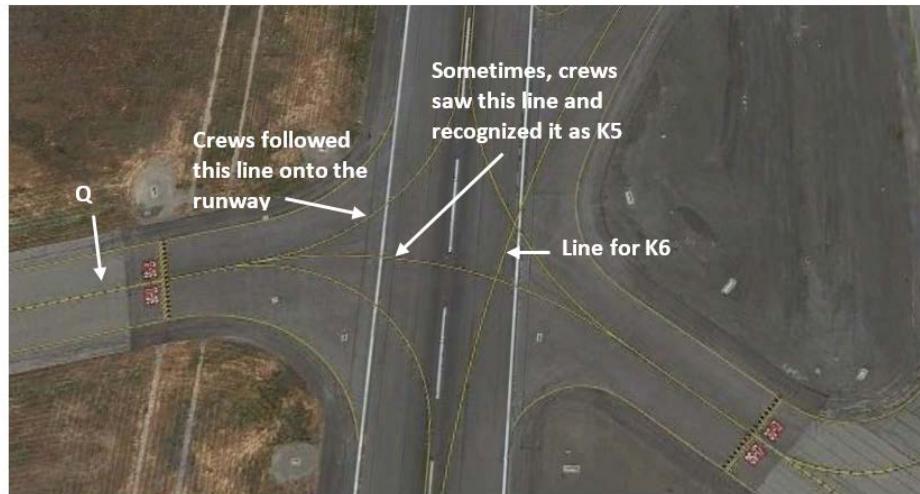
Figure 4. Layout of intersection 2 and lead-on/lead-off lines.

In intersection 2, flight crews coming off taxiway Q turned left on the runway and started looking for a lead-off line for taxiway K6. However, once the flight crew turned on the runway, the line for K6 was already behind them.

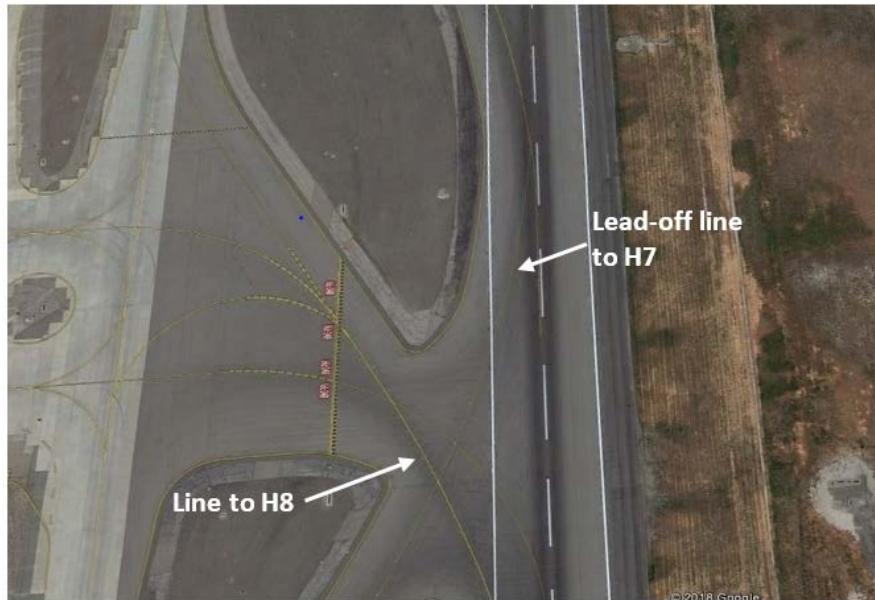
Figure 5. Layout of intersection 3 and lead-on/lead-off lines.

At intersection 3, flight crews exited the runway by following the lead-off line for taxiway H7. There was no lead-off line for taxiway H8, but it did intersect with H7. However, if the flight crew waited to see the taxi line for H8 to make the turn, it would probably be too late to make the hard right turn onto H8.
