1. Report No. FAA-AM- 78-6	2. Government Accession No.	3. Recipient's Catalog No.	
4. Title and Subtitle  EVALUATION OF SEATING AND RESTRAINT SYSTEMS AND ANTHROPOMORPHIC DUMMIES CONDUCTED DURING FISCAL YEAR 1976		5. Report Date

6. Performing Organization Code	
		8. Performing Organization Report No.	
7. Author(s) Richard F. Chandler and Edwin M. Trout			
9. Performing Organization Name and Address  FAA Civil Aeromedical Institute P.O. Box 25082 Oklahoma City, Oklahoma 73125		10. Work Unit No. (TRIS)

EVALUATION OF SEATING AND RESTRAINT SYSTEMS  
AND ANTHROPOMORPHIC DUMMIES  
CONDUCTED DURING FISCAL YEAR 1976

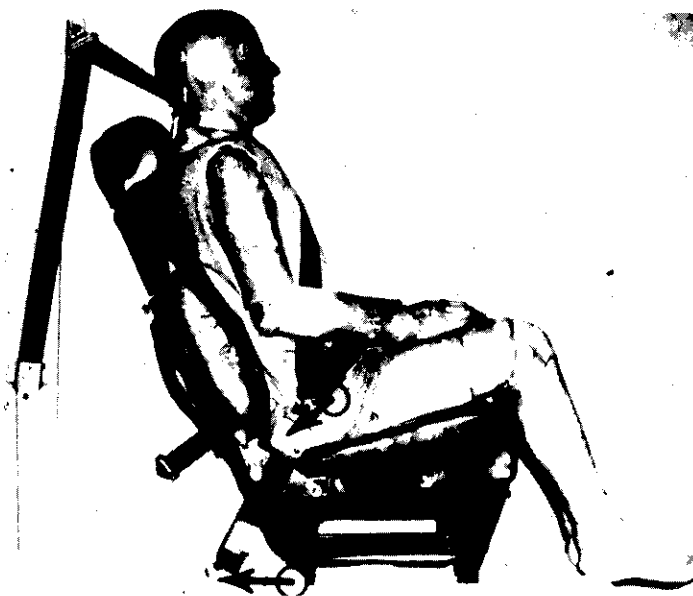
Figure 8. Modifications to restraint included relocation of buckle to the side of the hip and movement of inboard anchorage point to the rear. Initial locations are shown by circles.

After the second test, the attachment for the upper torso restraint guide was reinforced. On the third test, rotation of the dummy torso from under the diagonal belt was noted (Figure 6). This rotation was corrected by shortening the length of webbing that carried loads from both the shoulder belt and the lapbelt. Further improvement was obtained by relocating the inboard lapbelt anchorage 5 in to the rear. Tests were then completed to a 28-g level without further changes (Figure 7). The changes made in the restraint system are shown in Figure 8. Data collected on the final test indicated that survival without irreversible injury would have been accomplished from an equivalent crash. However, the energy stored in the long upper torso restraint strap aggravated the potential for injury during rebound and the elongation of that strap allowed the head to move into the vicinity of the instrument panel, a potential injury source.

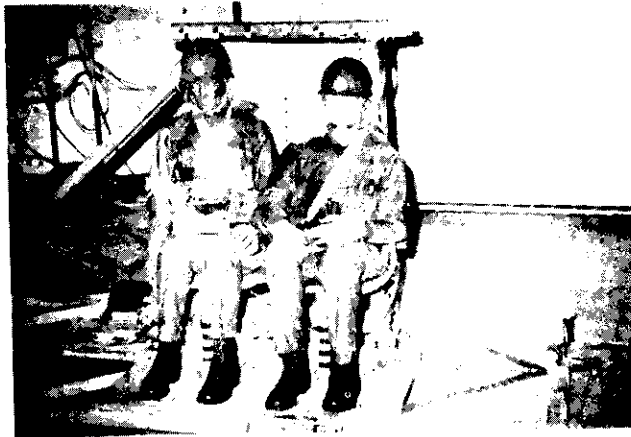
Figure 9.

Both forward-facing and rearward-facing versions of the seat were tested in orientations that produced direct lateral loading (Figure 9), combined forward and lateral loading (Figure 10), and combined forward, lateral, and downward loading (Figure 11).

The tests are summarized in Table 3. Structural failures continued to occur in the first two orientations. These were primarily associated with the Invertube energy absorbers relative to weld joints, end fittings, and instability. Failures also occurred in the restraint system and in the energy-absorbing cables. Performance in the combined loading configuration (Figure 11) was better, although the performance of the energy absorption system was shown to be sensitive to the weight of the occupants. On the next-to-last test, the seat moved down and forward into contact with the dummies' legs, an action that could cause incapacitating injury.

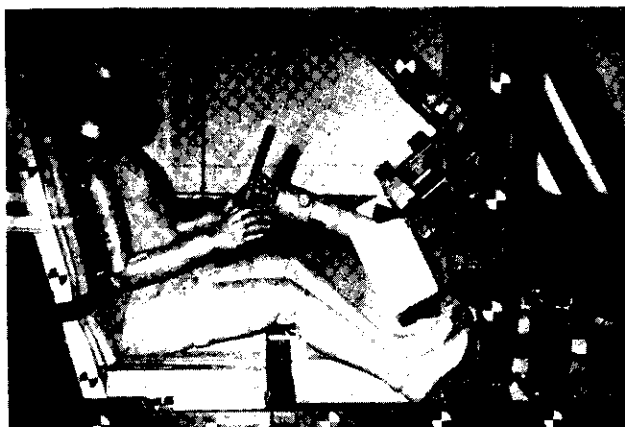
Figure 18.

This program was conducted to evaluate the performance of automotive-type energy-absorbing steering column assemblies so that the feasibility of their use as aircraft control columns could be determined. Initial static testing on the columns indicated that the columns stroked at between 350 and 500 lb of force when loaded axially. Initial dynamic tests positioned the column in a conventional automobile configuration and used an unrestrained anthropomorphic dummy (Figure 18). Crushable knee bolsters provided a contact surface to prevent knee damage. It was found that the column would "lock" because of the eccentric load application and transmit up to 2,400 lb of force with minimal column stroke. Efforts to increase the bearing area and alleviate locking conditions on the column were of little improvement, increasing the stroke displacement only from 1 in to 4 in. The fourth, fifth, and sixth tests used a dummy with lapbelt so that the chest contacted the column in a manner more conducive to producing axial loads. Although the column stroke increased to more than 7 in, peak chest decelerations were not significantly reduced. Data are shown in Table 7. It was concluded that the energy-absorbing steering column is sensitive to eccentric loading and would require further development to eliminate this sensitivity before consideration of aircraft application is warranted.

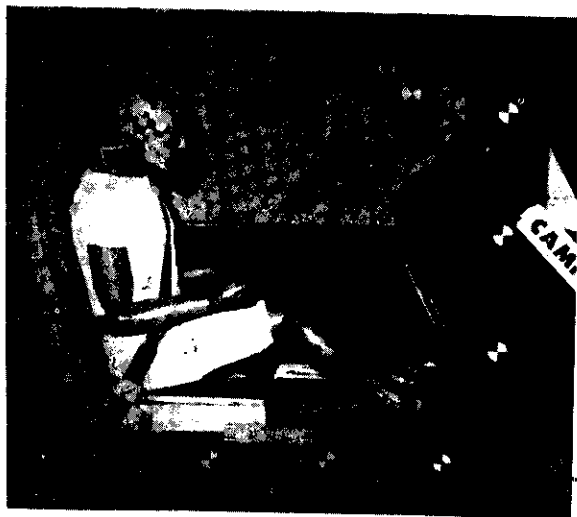
Figure 19.

The tests on these dummies consisted of sled tests using a standard lapbelt and single-diagonal-belt upper torso restraint (Figures 19, 21, and 23) and a preinflated air bag and plastic foam knee bolster restraint (Figures 20, 22, and 24). Component tests included head drops onto a steel plate from 10-in and 35-in heights (Figure 25); pendulum impact tests of the head and neck assemblies (Tables 8 and 9); impact tests of the thorax at two different impact velocities (Figure 26); static load tests of the thorax 15 in below the vertex of the head, 18 in below and 3 in to the left of the vertex of the head, 18 in below and 3 in to the right of the vertex of the head; and static load tests of the abdomen assembly (Figures 27 and 28). These tests are repeated to obtain an indication of the mean value and standard deviation of the results.

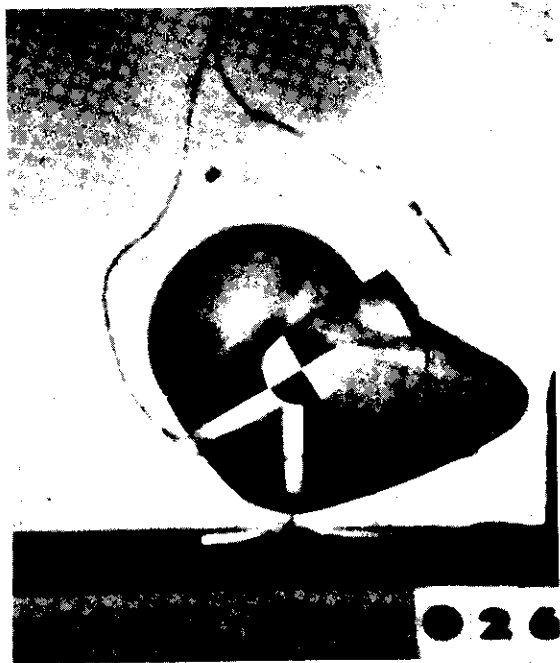
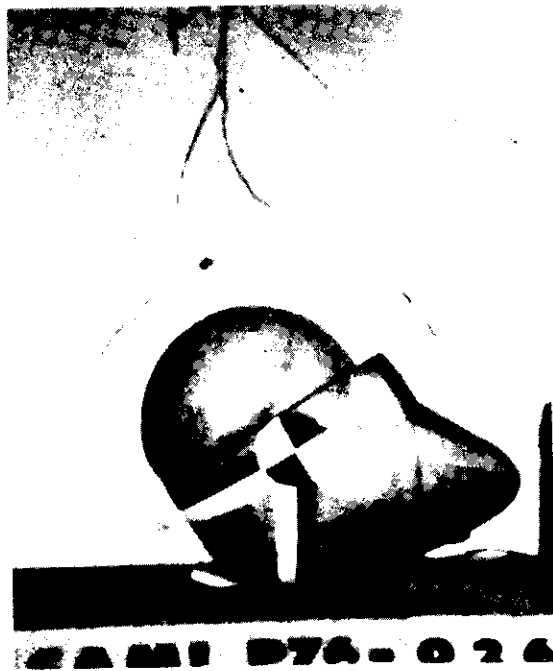
In the head impact test procedure, the head is dropped onto a 2-in steel plate from heights of 10 and 35 in, and acceleration is measured at the center of mass. This test is shown in Figure 29. Note that although the head impacts at a point directly below the center of mass, an eccentric force is generated during the impact that causes the head to rotate. The effects of this rotation will not be distinguished by the accelerometer installation in the head. The results of these tests are shown in Figure 30.

Figure 29. Head impact test.
