# METAL FATIGUE

## RECOGNITION

by Frank R. Stone, Jr.

CIVIL AERONAUTICS BOARD • BUREAU OF SAFETY

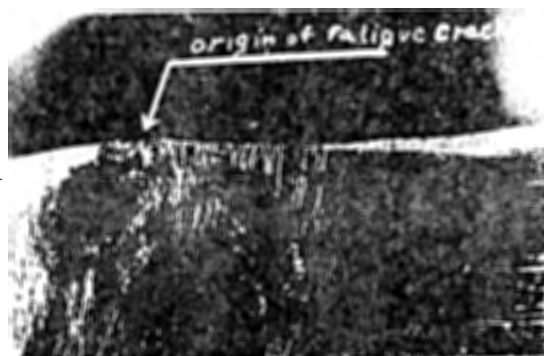
FIGURE 4b.—Corrosion on side of blade, clearly visible.

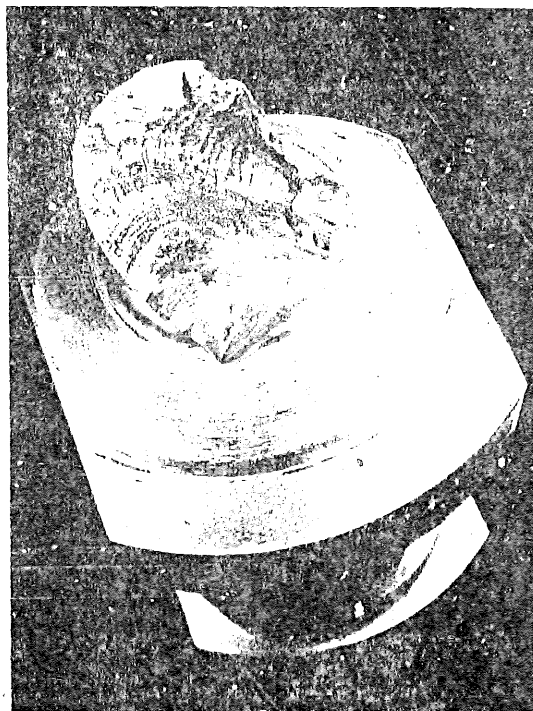
FIGURE 12.—Fatigue failure of a punch-press shaft which was subjected to torsion and bending loads. The fatigue crack originated at a sharp fillet at a change in section.
