Final Report

On the accident on **1st June 2009**
to the **Airbus A330-203**
registered **F-GZCP**
operated by **Air France**
flight AF 447 Rio de Janeiro - Paris

BEA

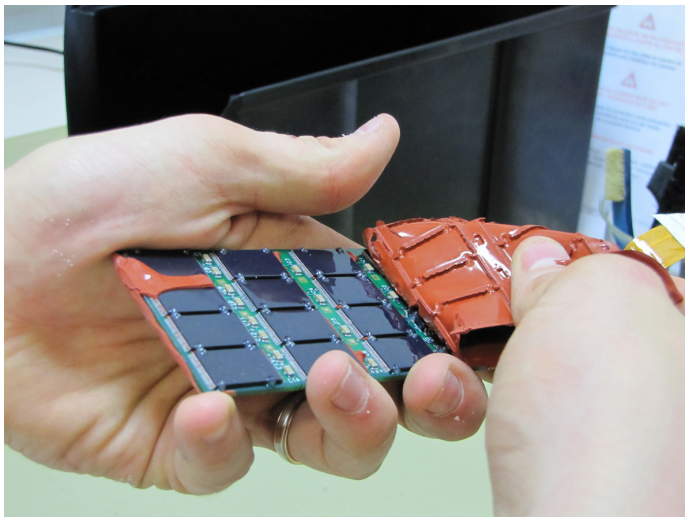
Figure 20: Removal of internal protective layers

The memory board was cleaned. Visual inspection did not reveal any damage to the board. The board was placed in an oven for 36 hours in order to remove the moisture in the components and the printed circuit board. The impedance measurements that were then made on the input connector were in accordance with the measurements made on reference units.

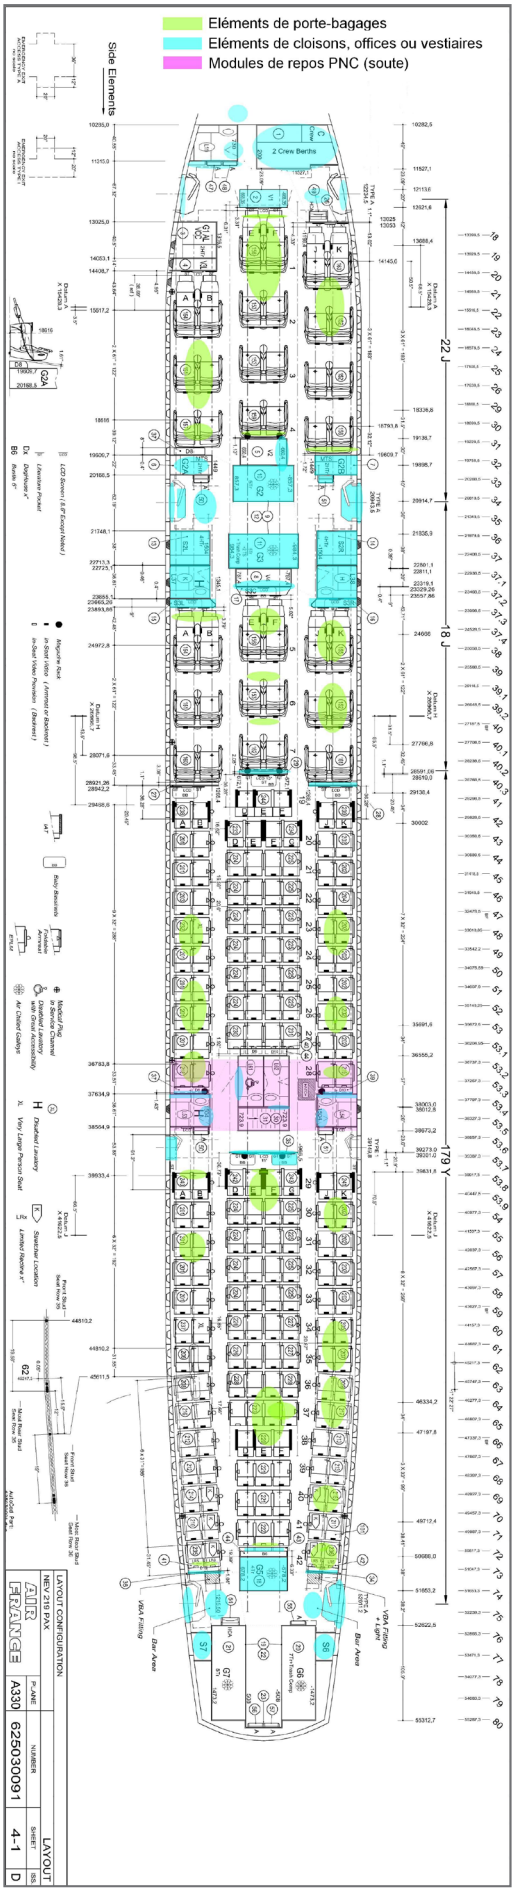
Figure 34: Position of the cabin part debris recovered in relation to the aircraft layout

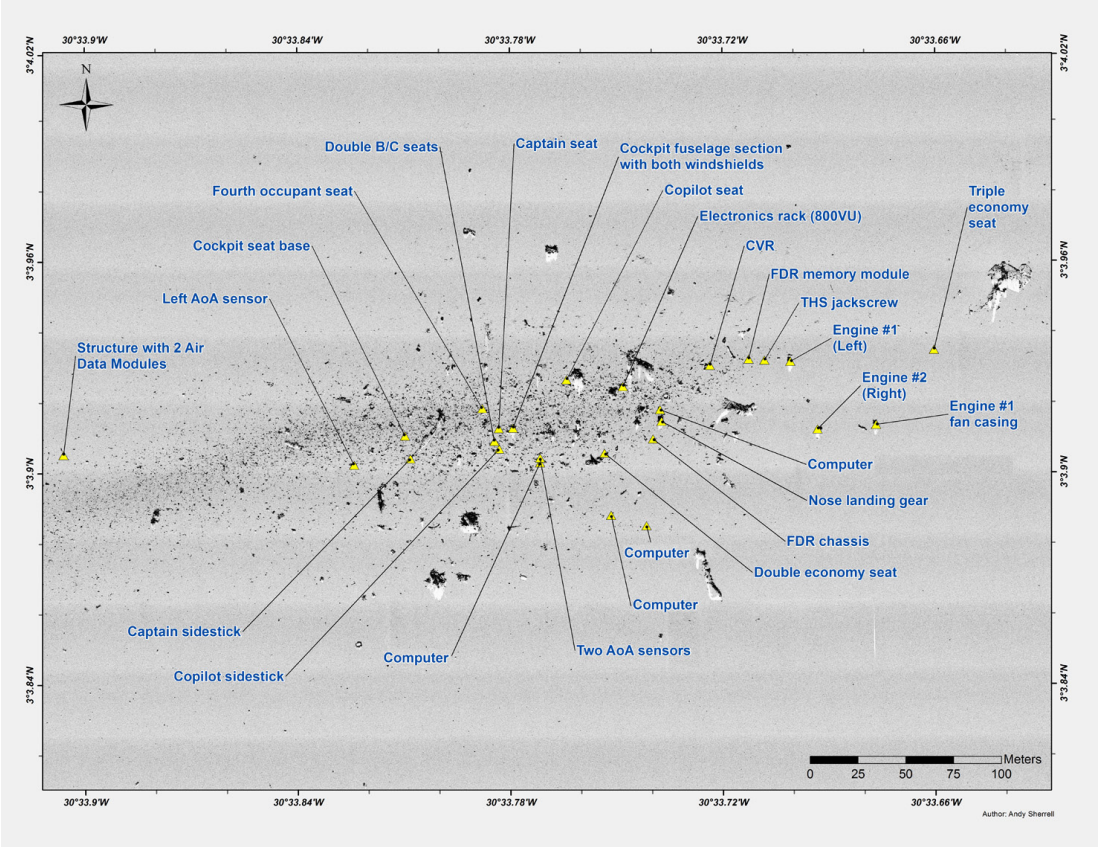
Figure 59: Cartography of the parts subsequently brought to the surface

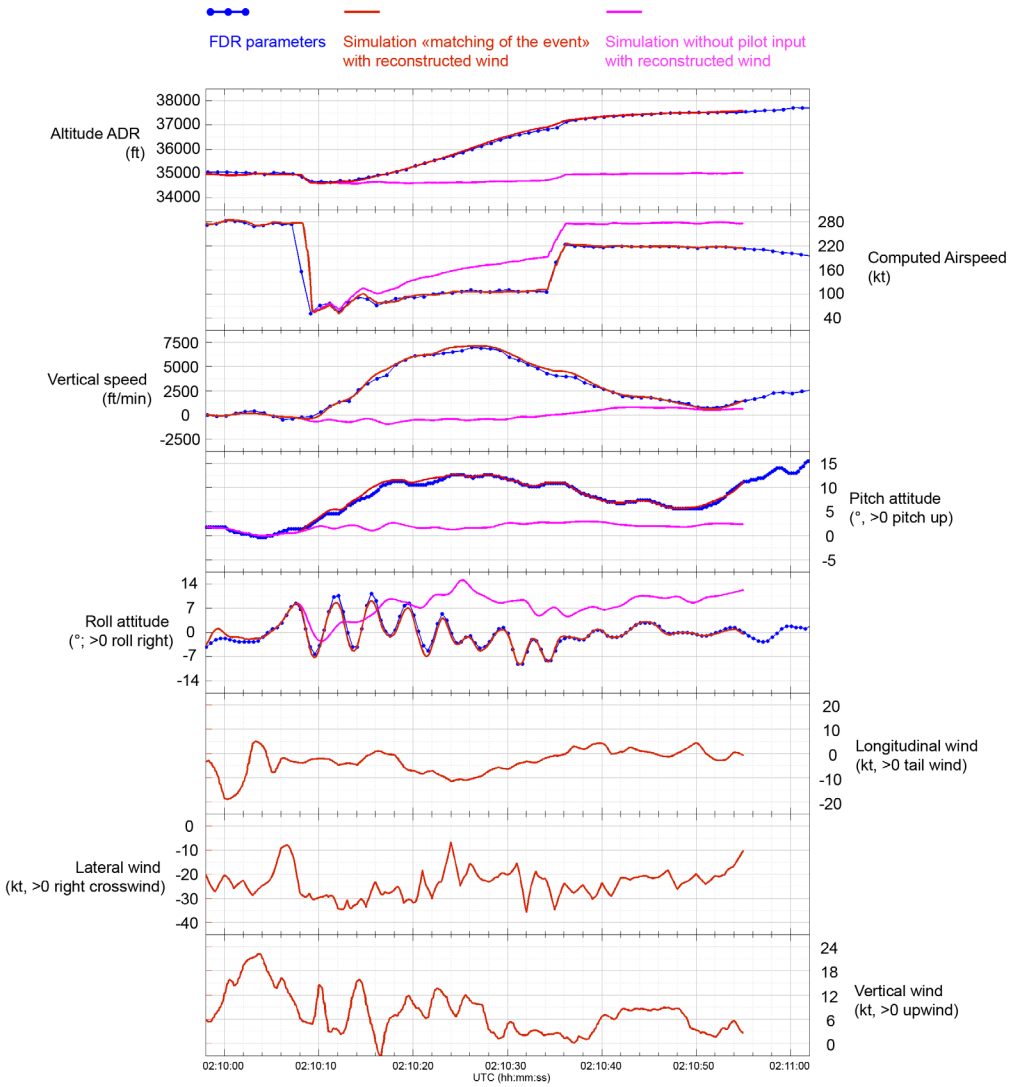
- From about 15 seconds before disconnection, the autopilot countered aerological disturbances whose intensity would be defined as "light" on the ICAO scale (variations in vertical acceleration of less than 0.5 g);
- When the autopilot disengaged, a concomitant lateral gust caused the aircraft to depart from its flight path with a roll to the right;
- The subsequent roll movements resulted from the inputs by the PF;
- The aircraft's movements in the longitudinal axis were primarily due to the inputs by the PF, with the exception of small variations due to the aerology (variations in normal acceleration of about 0.2 g);
- The turbulence eased as from about 2 h 10 min 30 s;
- With no PF inputs, the aircraft would have gradually rolled further to the left but the variations in pitch attitude and altitude would have been small.

Figure 64: Comparison between recorded parameters and the simulation

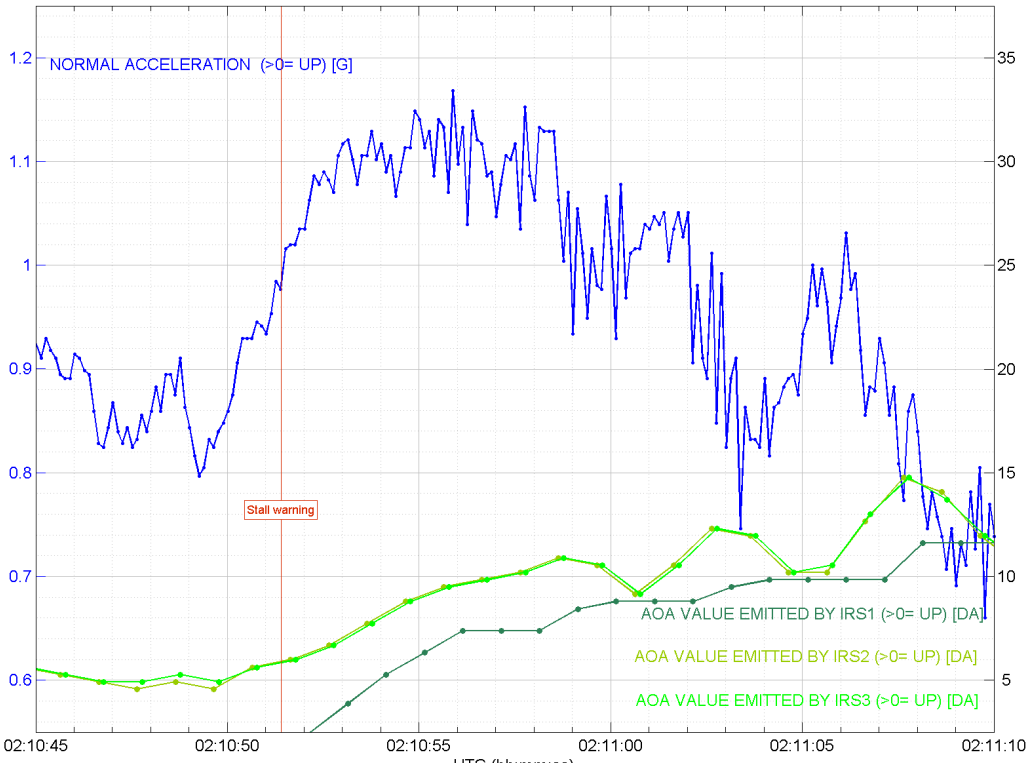
At 2 h 10 min 51, when the aircraft was at about 37,500 ft and still climbing, the stall warning was triggered (see 1.16.3.2). A change in the recorded normal acceleration behaviour was demonstrated from 2 h 10 min 53, at an angle of attack about 1 to 2 degrees greater than the warning activation threshold.

Figure 66: Evolution of normal acceleration recorded at the time of activation of the stall warning

This modification of the behaviour resulted in the appearance of a high frequency component of an amplitude increasing to up to about 0.1 g peak-to-peak, and with a signature that is very different from a turbulence signature of aerological origin. Furthermore, there is a noise on track 1 of the CVR, at about 2 h 10 min 55, which may be the impact of the microphone striking a panel, heard at a stable frequency.
