PB96-91040I
NTSB/AAR-96/01
DCA95MA001

AIRCRAFT ACCIDENT REPORT

IN-FLIGHT ICING ENCOUNTER AND LOSS OF CONTROL
SIMMONS AIRLINES, d.b.a. AMERICAN EAGLE FLIGHT 4184
AVIONS de TRANSPORT REGIONAL (ATR)
MODEL 72-212, N401AM
ROSELAWN, INDIANA
OCTOBER 31,1994

VOLUME 1: SAFETY BOARD REPORT

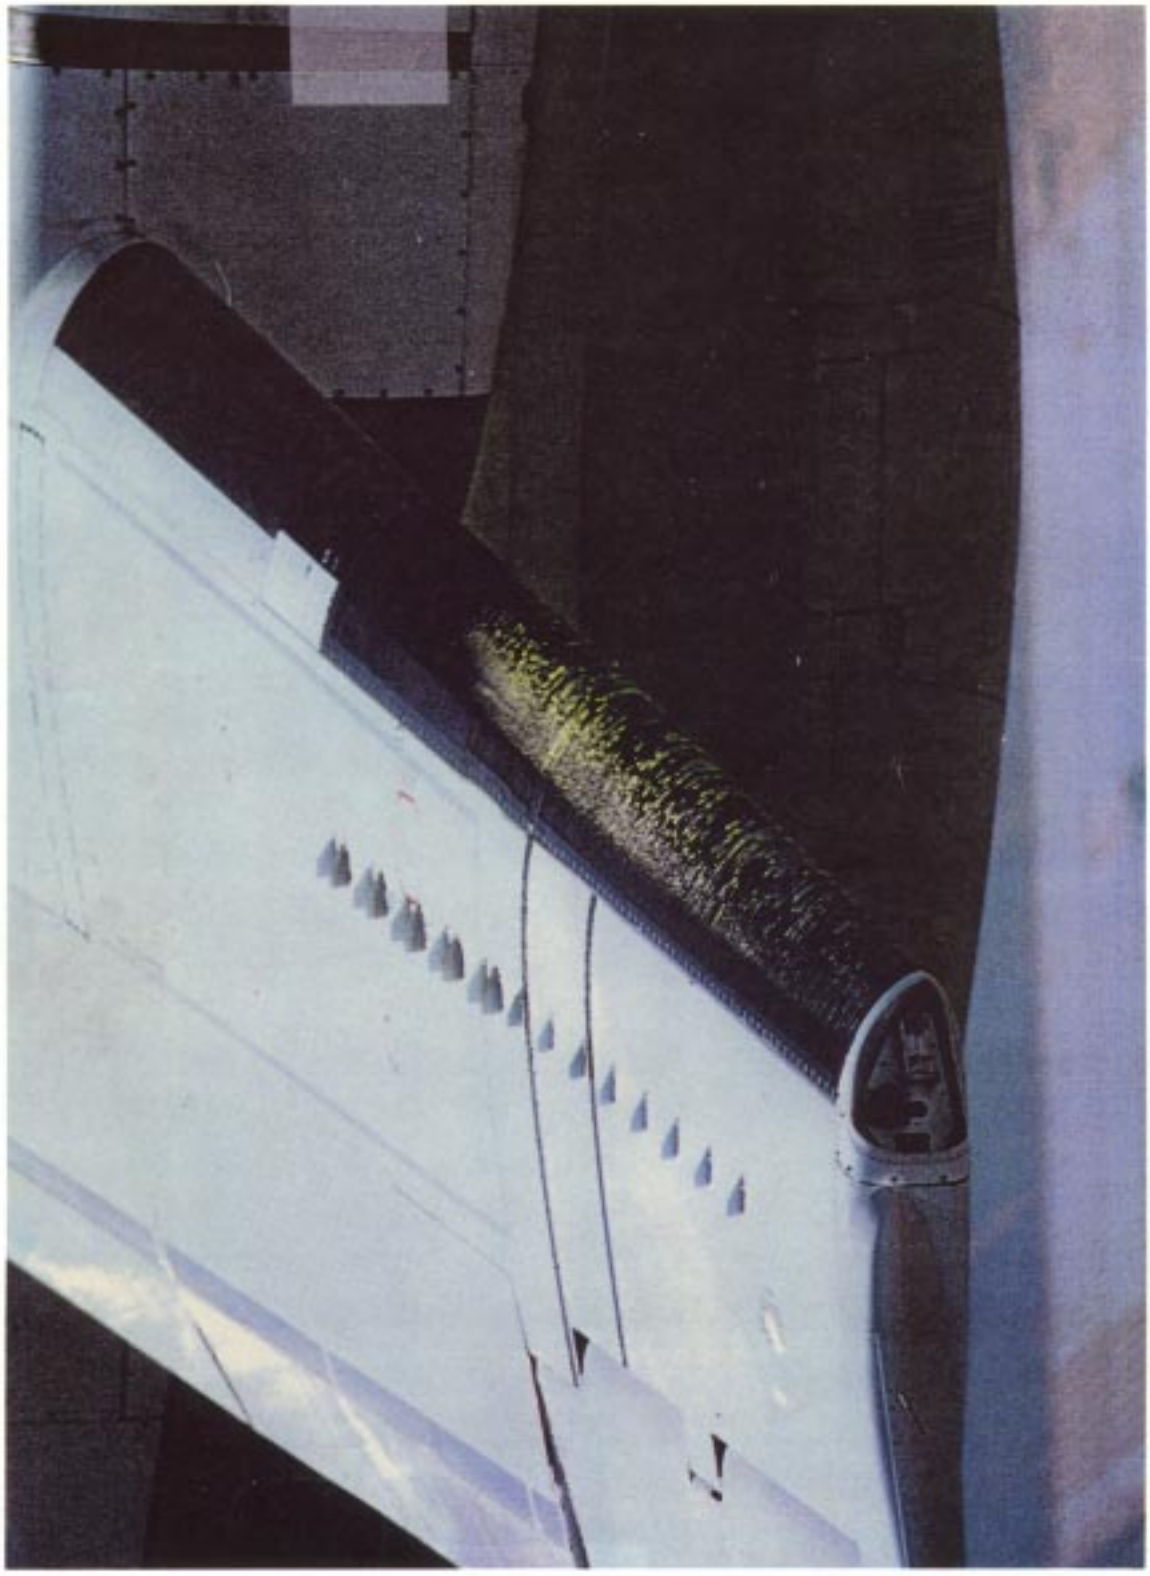
FLIGHT 13 TEST 10 (A.5.88)

RIGHT AILERON -200 μ –FLAP 15

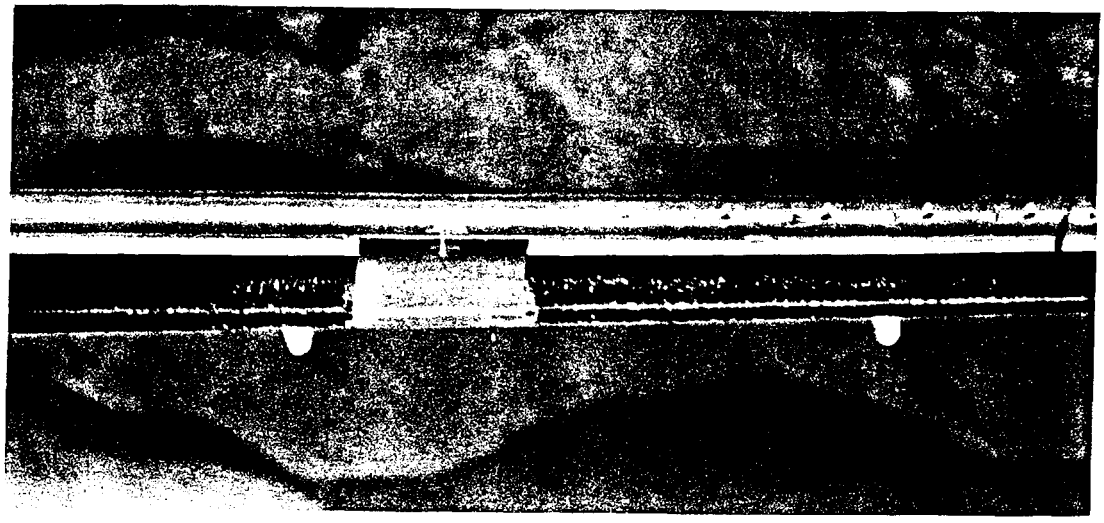
70 Micron exposure

- At no time were there any changes in handling characteristics other than a small lateral imbalance that would be expected with ice accretion occurring on only one wing tip.

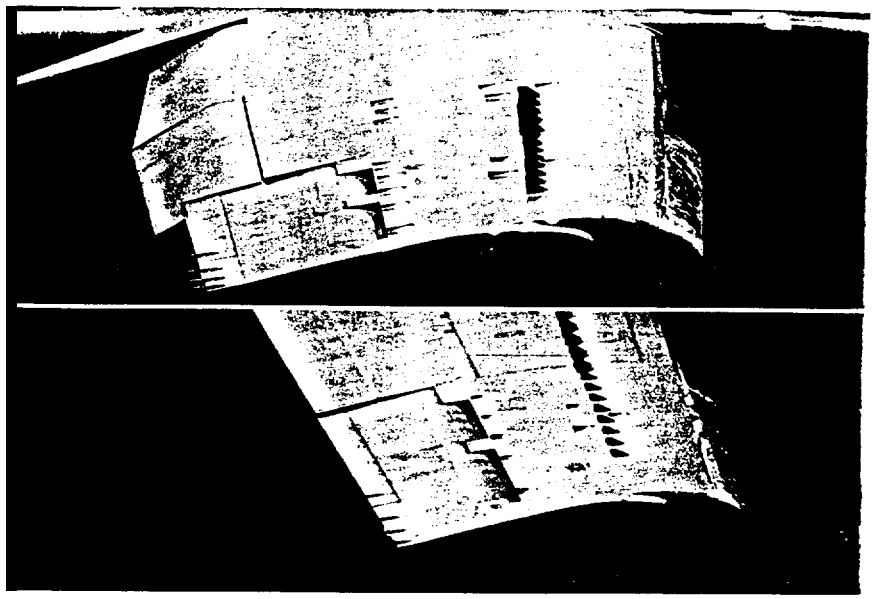
FLAPS 0°

Ice Accretion Pattern

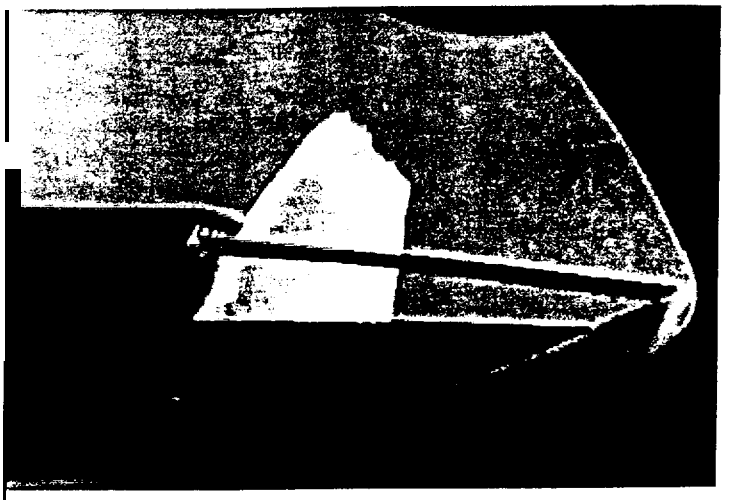
Ice Evidence Probe

The maximum lateral forces noted, even with the asymmetric ice accretion, were approximately 35-to-40 pounds.

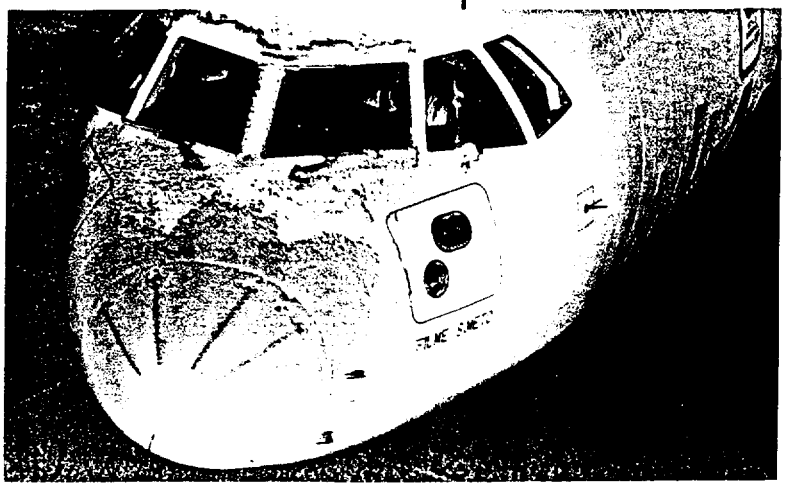
After 30 seconds of exposure.

After one minute of exposure.
