Pilot/Race 177, *The Galloping Ghost*  
North American P-51D, N79111  
Reno, Nevada  
September 16, 2011

**Accident Brief**

NTSB/AAB-12/01  
PB2012-916203

# Aircraft Accident Brief

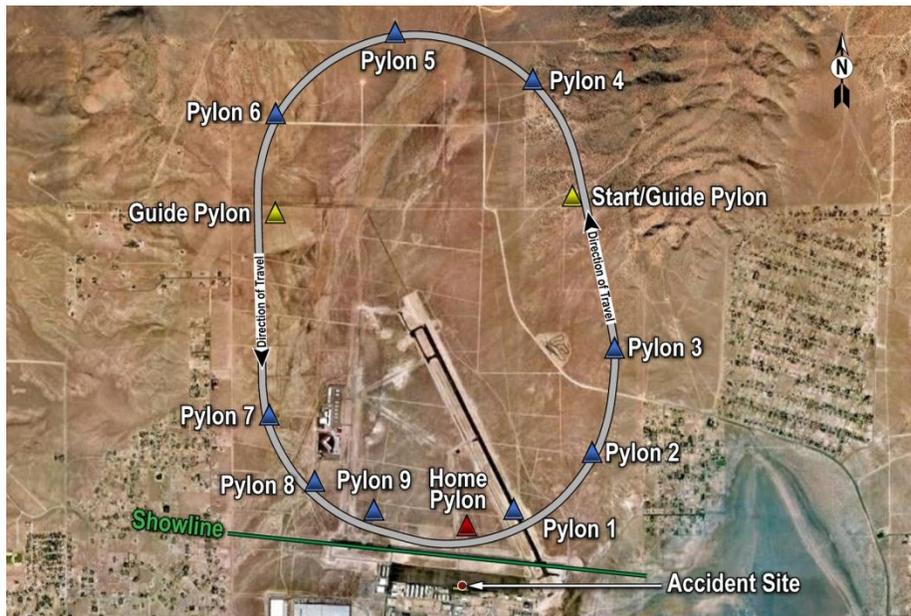
**Figure 1.** Diagram of the NCAR unlimited class race course at RTS, showing relative locations of pylons and the accident site.

The accident airplane was in third place during the third lap of the six-lap race, trailing the second-place airplane (*Voodoo*, another experimental P-51D) by about 4.5 seconds and the lead airplane (*Strega*, also an experimental P-51D) by about 8.8 seconds. The accident airplane was traveling about 445 knots as it passed pylon 8 (see figure 1) and experienced a left roll upset

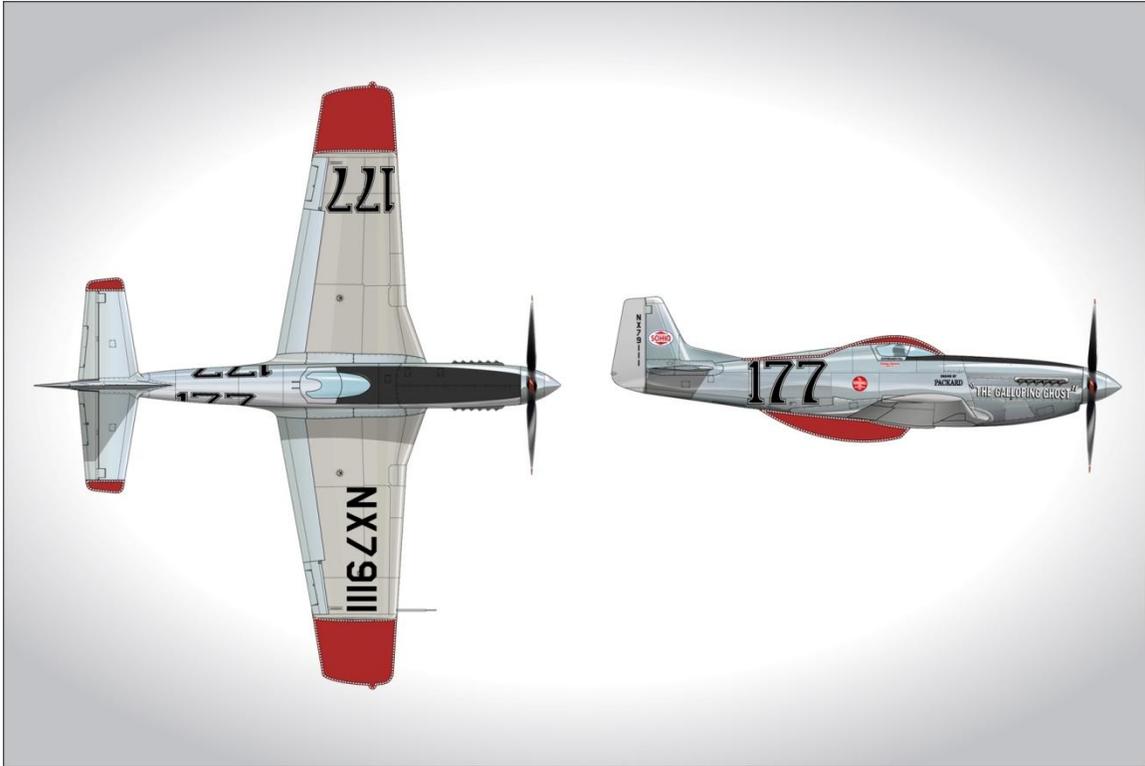
**Figure 2.** Illustration of the accident airplane with stock P-51D dimensions shown in red.

The outboard section of each wing was removed, and a new wingtip with an end plate was installed. The airplane's modified wingspan was about 28 feet 10 inches (compared to the stock wingspan of 37 feet 5/16 inch), which was the shortest wingspan of any modified P-51D racing in 2011. Each aileron was shortened to about 3 feet (from a stock length of about 7 feet) and had two hinges (a stock aileron has three). The right aileron trim tab was removed, and the trim for the left aileron was run by an electric trim motor installed at the wing root (as opposed to the stock manual trim system). The horizontal stabilizer and elevators were equipped with modified flat end caps that reduced the horizontal stabilizer span to about 12 feet 1 inch (from a stock span of 13 feet 2 1/8 inches). (See figure 2.)

Modifications to the elevator counterweights, upper rudder counterweight, vertical stabilizer incidence, horizontal stabilizer incidence, and rudder were discovered during the postaccident wreckage examination. The horizontal stabilizer, elevators, and trim tabs were of all-metal construction but were modified with up to 1/8 inch of filler material on the upper and lower skins that smoothed the surfaces. The left elevator counterweight weighed 26 pounds, and the right elevator counterweight (with some of the elevator structure and outboard hinge assembly still attached) weighed 27.5 pounds. Available documentation for the stock elevator counterweight specified a maximum total weight of 13.75 pounds. The vertical stabilizer's leading edge was offset to the right of the airplane's longitudinal axis by means of a tapered shim installed between the vertical stabilizer rear spar and the empennage structure (the stock P-51D's vertical stabilizer is offset to the left of the airplane's longitudinal axis). The rudder was modified to remove the stock trim tab and its associated control cables and to cover the trim-tab cutout with fabric. The modified upper rudder counterweight weighed 25 pounds. Available documentation for the stock upper rudder counterweight specified a maximum total weight of 16.6 pounds. The horizontal stabilizer incidence was increased from the stock value of 0.5° leading edge up to 0.91° leading edge up through the installation of a shim between the forward attach points and the fuselage.

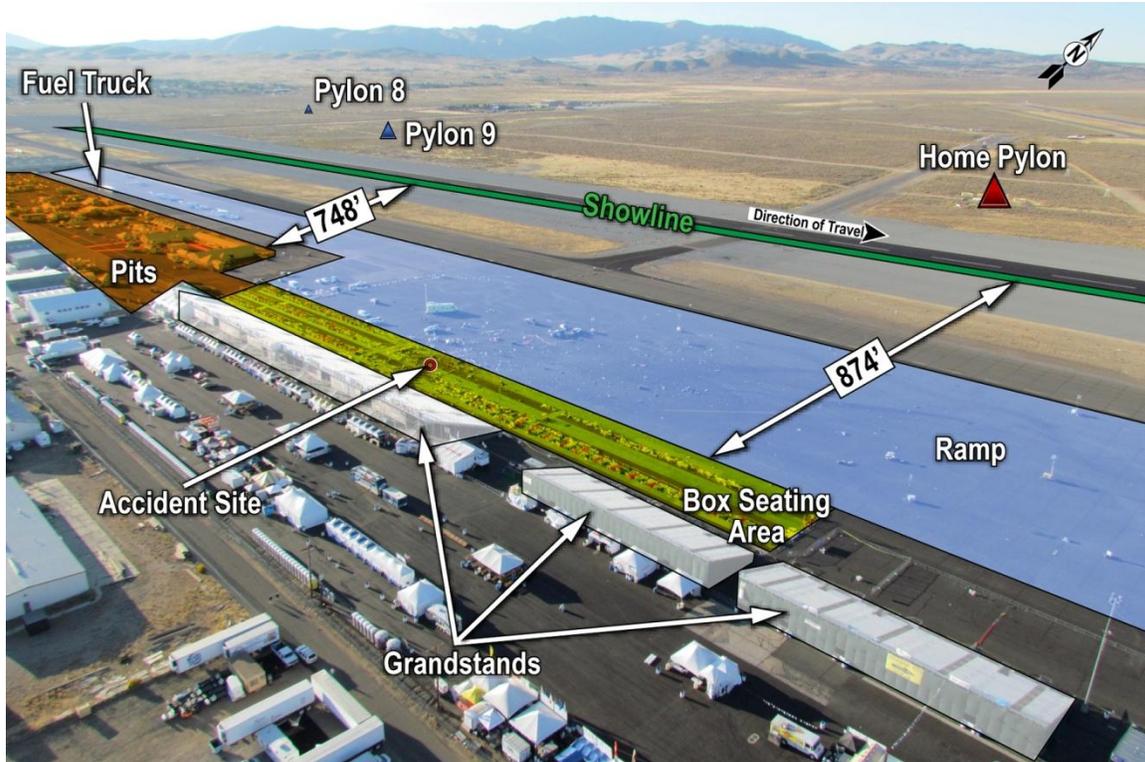
**Figure 3.** NCAR ramp area layout with accident site depicted.

Ten people on the ground were fatally injured and dozens of others sustained minor to serious injuries when the airplane collided with the airport ramp in the spectator box seating area and scattered wreckage debris in the box seating area, ramp, and grandstands. The edge of the box seating area was 874 feet south of the showline, the edge of the pit area (where many other spectators were located) was 748 feet south of the showline, and a fuel truck was parked on the ramp near the pits (see figure 3). Racing airplanes were expected to fly parallel to the showline on the north side.

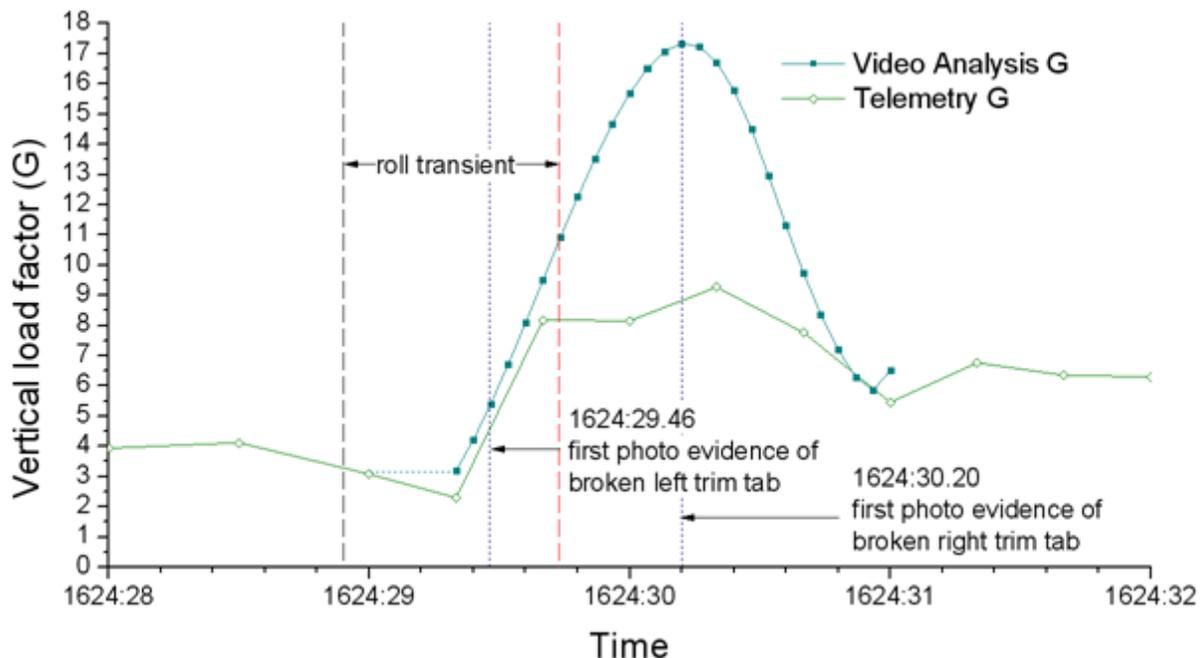
**Figure 11.** Airplane’s vertical acceleration during upset over time. Times that correspond with specific photographs are noted.

Telemetry data were time-correlated with the results of the video study calculations that determined the airplane's roll, pitch, and heading angles and vertical load factors throughout the upset event. During the roll upset and the onset of the pitch-up maneuver, the airplane's onboard accelerometer recorded a greater than 5-G jump in vertical acceleration within about 0.3 second. The video study established that, during the pitch-up maneuver, the maximum vertical load factor reached about 17.3 G about 0.47 second after the airplane reached its maximum left bank angle. Figure 11 shows the vertical acceleration leading up to, during, and after the roll upset as

determined through the video study calculations and the telemetry data (the telemetry data were subject to the accelerometer’s limitations).<sup>34</sup>
