Crash of Cessna 500, N113SH
Following an In-Flight Collision with Large Birds
Oklahoma City, Oklahoma
March 4, 2008

NTSB/AAR-09/05
PB2009-910405

Crash of Cessna 500, N113SH,
Following an In-Flight Collision with Large Birds,
Oklahoma City, Oklahoma,
March 4, 2008

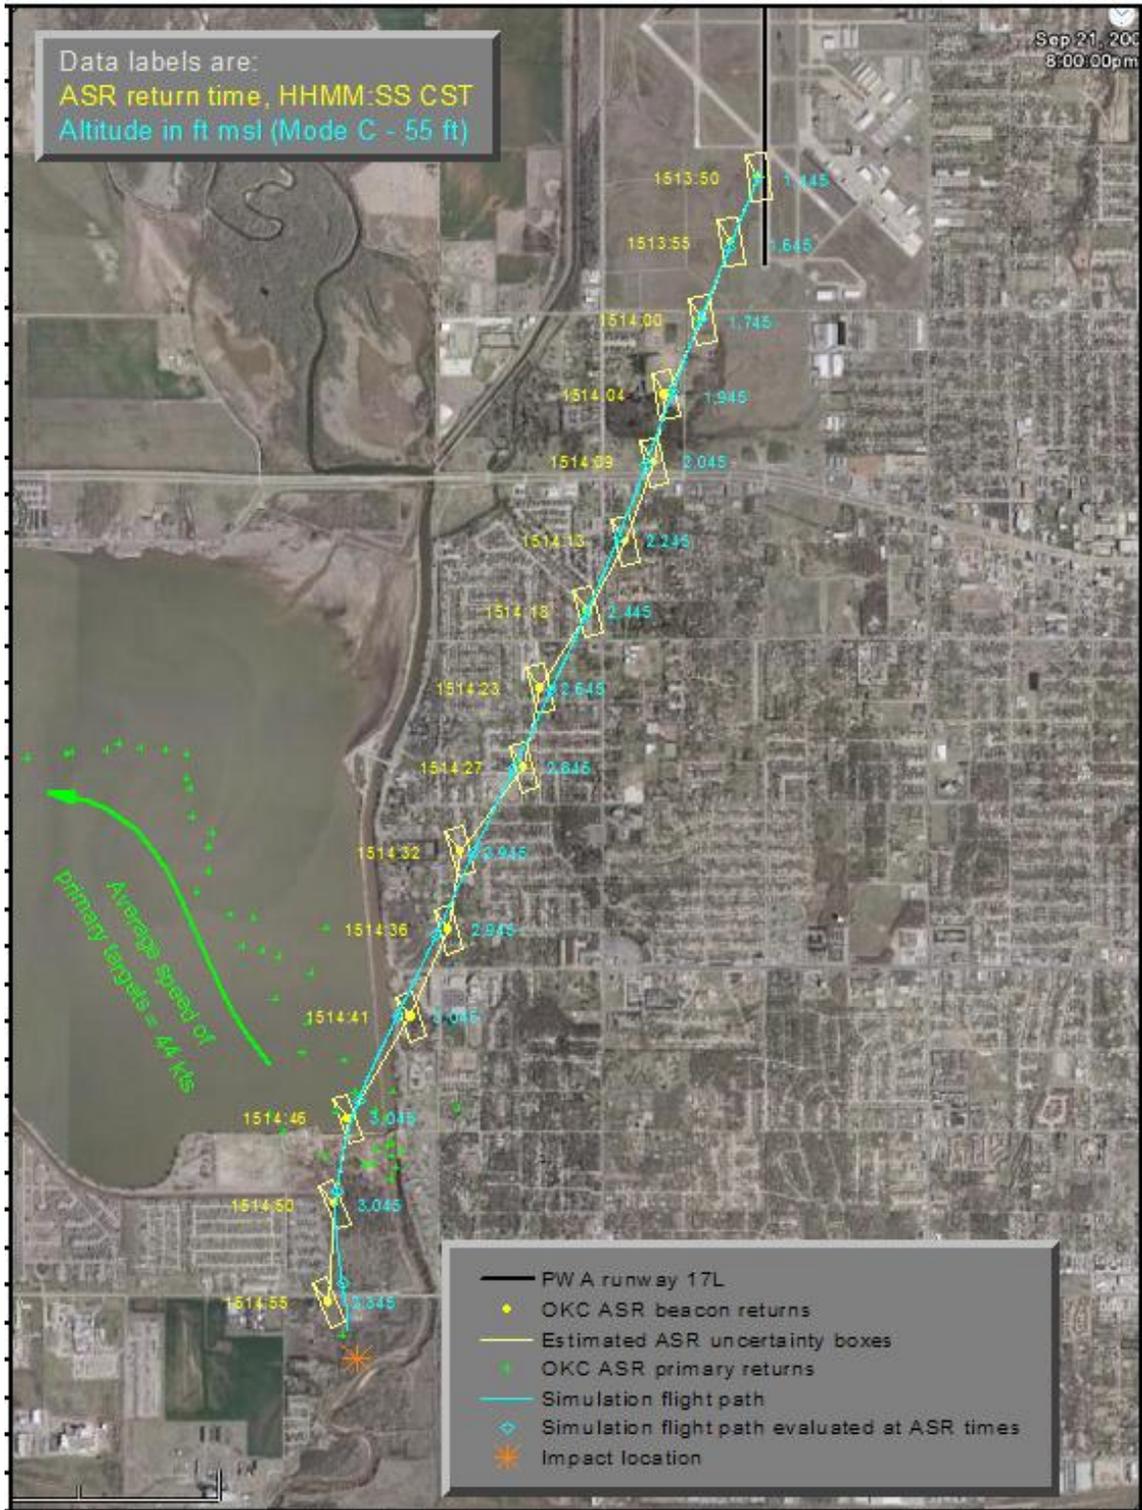
Review of available OKC ASR data, which included both primary and secondary returns,⁴² showed that the radar observed 5,985 primary targets in its coverage area during a 10-minute period about the time of the accident.⁴³ Of these thousands of primary targets, postaccident processing of the data identified that, between 1512:00 and 1514:59, 19 intermittent primary returns appeared within a 0.35-nautical-mile radius of the accident airplane's track over the southeast corner of Lake Overholser. About 1514:45, the airplane was headed south-southwest at an altitude of about 3,050 feet and was traveling about 190 kts calibrated airspeed (KCAS) when its flight track intersected the flight track of the primary returns. About that time, the airplane entered a rapid descent, and the primary returns moved from the area of the intersection toward the northwest, over Lake Overholser. (See figure 4.) Birds, such as the American white pelican, are capable of reflecting primary radar returns.

Figure 4. Plot showing primary and secondary radar returns with overlay of the simulation flight path.

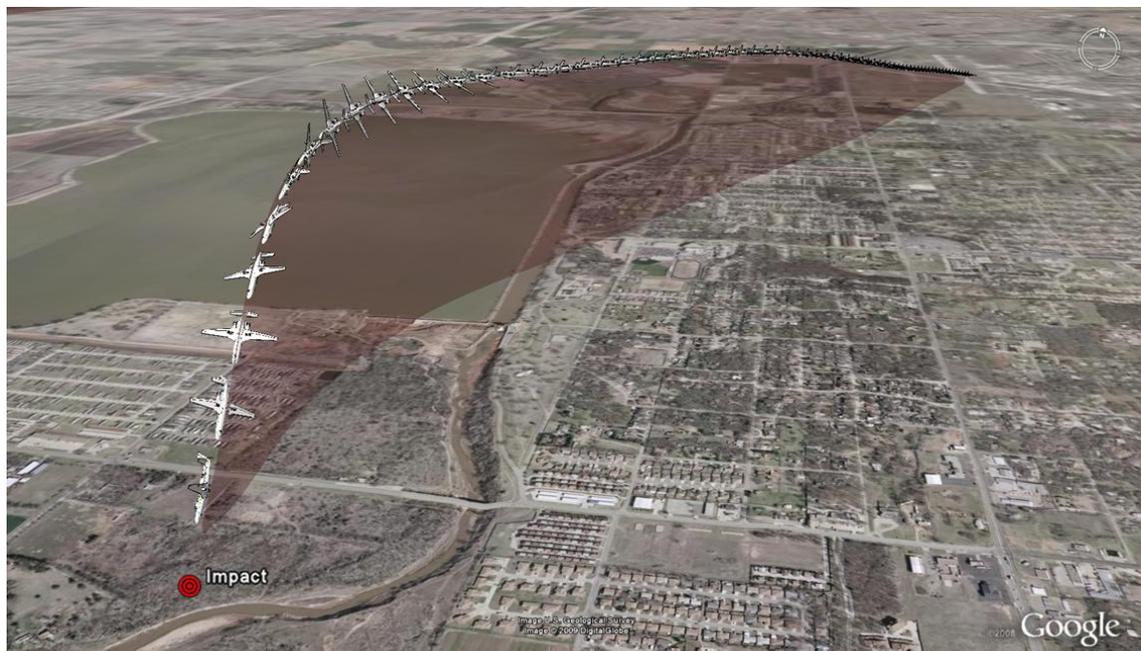
The simulation provided a reasonable estimate of the accident airplane's performance during the climb and a plausible scenario for the track and orientation of the airplane during its descent; the estimated airplane performance and scenario are generally consistent with the known information. In particular, the simulation required a left roll of the airplane and a turn to the southeast to move from the last radar returns toward the accident site; this left roll is consistent with witnesses' observations of the accident airplane. (See figure 5.) Further, for the simulated airplane to then move toward the right to achieve a track of 185° at impact (the orientation of the debris path at the accident site) with a descent angle consistent with the video footage of the accident airplane and with the position of the wreckage at the accident site, the simulated airplane's left roll had to continue through the inverted position.

Figure 5. Simulation-based illustration of the airplane's descent and left roll through the inverted position.

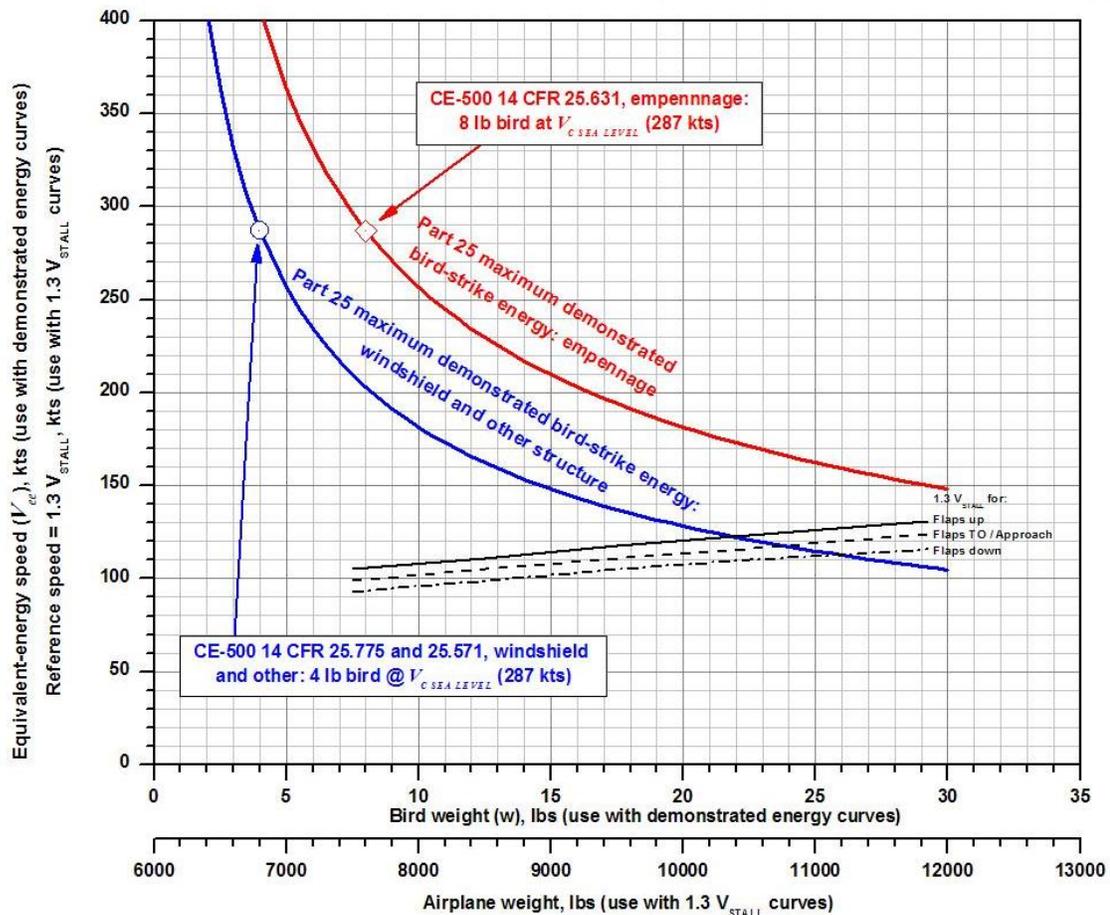
For example, figure 6 shows how these two sets of airspeeds can be illustrated for an airplane like the Cessna 500. The figure shows two bird-strike energy speed curves: The blue line corresponds to the certification standard for the airplane’s windshield, wing, and other structures (which are based on an impact from a 4-lb bird at 287 kts), and the red line corresponds to the certification standard for the empennage (which uses an 8-lb bird at 287 kts). The figure also shows the exemplar airplane’s minimum safe airspeed (defined as 1.3 times the stall speed), as a function of weight, in various flap configurations (shown in solid, dashed, or dotted black lines).

Figure 6. Exemplar reference chart showing airplane speed and bird-weight relationships for equivalent bird-strike energy.

Using this chart, if a pilot of the exemplar airplane operating at a gross weight of 11,200 lbs were concerned about the possibility of a collision on the airplane's wing structure with birds as large as 10 lbs during a flaps-up climb, then the pilot might choose an airspeed between about 129 to 180 kts until reaching an altitude where the risk of a bird strike is reduced; the limits of this range represent the airplane's minimum safe airspeed for the specified gross weight and the maximum airspeed that would allow for a collision with a 10-lb bird while remaining below the airplane's bird-strike energy for the wing structure demonstrated in compliance with regulations.⁷⁰ Similarly, using the same airplane scenario but assuming a 20-lb bird, the chart
