Crash During Experimental Test Flight  
Gulfstream Aerospace Corporation GVI (G650), N652GD  
Roswell, New Mexico  
April 2, 2011

NTSB/AAR-12/02  
PB2012-910402

# Aircraft Accident Report

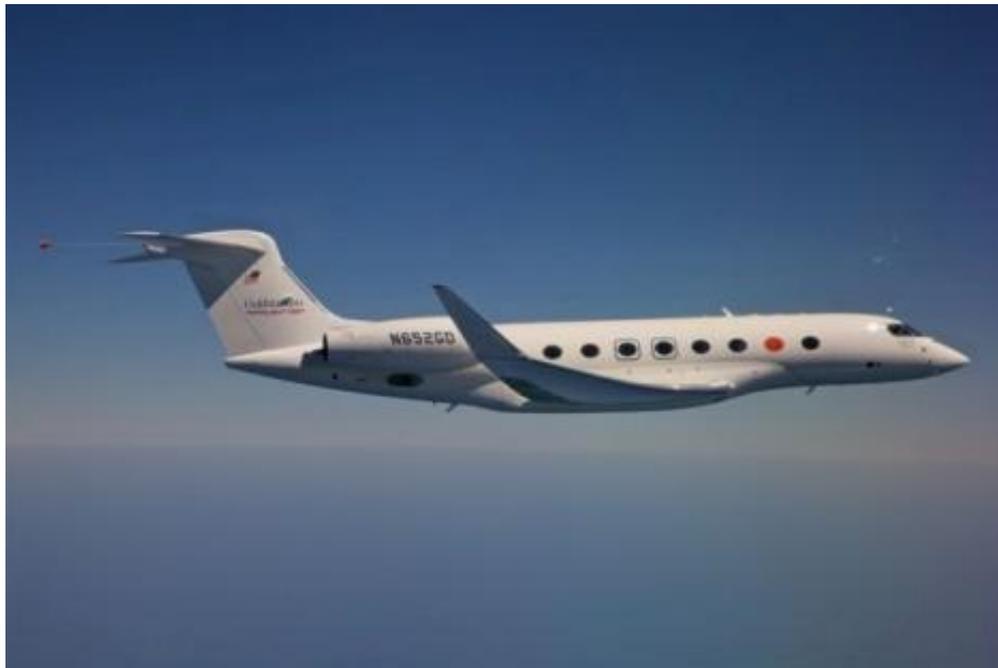
**Figure 1.** G650 airplane.

Gulfstream was performing field performance flight testing to (1) gather data to support type certification of the G650 under 14 CFR Part 25, “Airworthiness Standards for Transport Category Airplanes,”<sup>4</sup> and (2) develop takeoff and landing speed schedules and distances for the G650 airplane flight manual. Takeoff performance tests began in October 2010; table 1 shows the takeoff performance test flight schedule through the date of the accident flight.<sup>5</sup> Figure 1 shows the G650 airplane (specifically, N652GD before the accident).

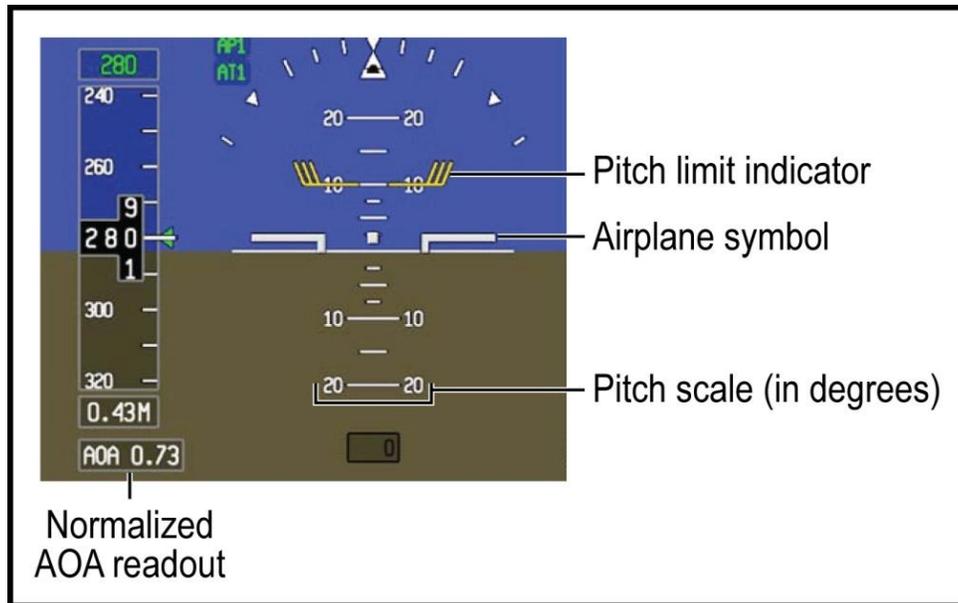
**Figure 2.** Pitch limit indicator.

The takeoff performance flight tests were being conducted with an angle-of-attack (AOA) limiter function disabled. The AOA limiter function was intended to be the primary stall protection system for the G650 (instead of a traditional stick pusher) once the airplane was certificated. The development of the AOA limiter software was not completed, so Gulfstream intended that the stick shaker would provide test pilots with a tactile warning of an impending stall. In addition, the pitch limit indicator (PLI)<sup>6</sup> on the primary flight display would provide the pilots with a visual indication of an impending stall. Figure 2 shows a representative PLI (as depicted in Gulfstream's draft G650 aircraft operating manual).

Note: The PLI is displayed when the normalized AOA is greater than 0.7. Normalized AOA is a measure of the usable AOA range of an airplane, with a normalized AOA of 1.0 corresponding to the reference stall AOA in free air and a normalized AOA of 0.0 corresponding to the zero-lift AOA in free air. This figure is presented for information purposes only and is not intended to depict the flight conditions on the day of the accident.

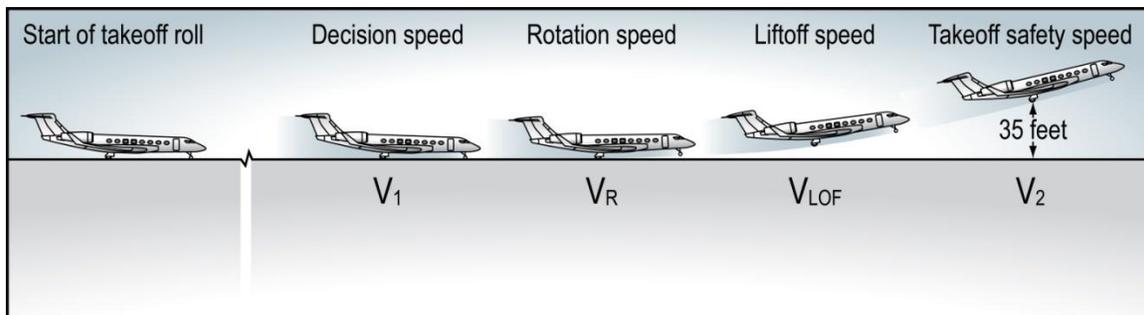
**Figure 3.** Takeoff airspeeds.

based on the free-air (out-of-ground-effect) stall speeds of the airplane,<sup>15</sup> as determined by previous flight testing, and the Part 25 takeoff speed requirements. Figure 3 depicts the takeoff airspeeds in relation to the airplane's progress along a runway.
