Crash During Nonprecision Instrument
Approach to Landing
Execuflight Flight 1526
British Aerospace HS 125-700A, N237WR
Akron, Ohio
November 10, 2015

NTSB/AAR-16/03
PB2016-104168

Aircraft Accident Report

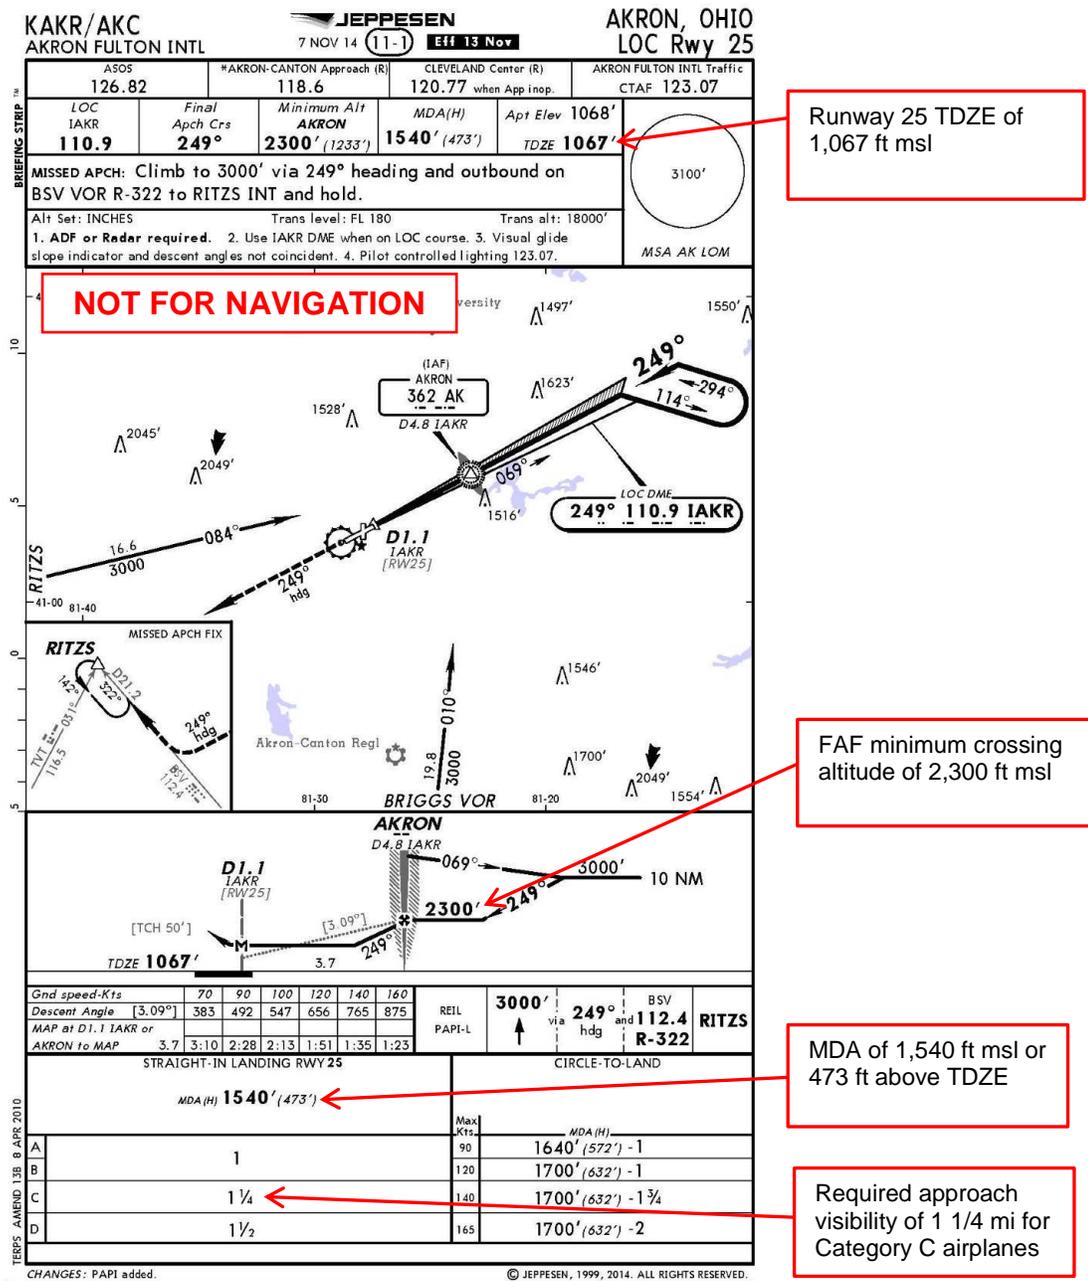
Figure 1. Instrument approach chart for the localizer approach to runway 25 at Akron Fulton International Airport at the time of the accident.

Review of the instrument approach chart for the localizer 25 approach at AKR (figure 1) indicated that an AKR weather forecast that called for a ceiling lower than 2,132 ft or a visibility lower than 3 1/4 mi for at least 1 hour before and after the estimated time of arrival at AKR required that an alternate airport be filed for the flight.³¹ Based on the TAF for CAK issued at 0900 and the AIRMET Sierra issued at 0945, an alternate airport was required by 14 *CFR* 135.223.
