Collision with Terrain  
Hageland Aviation Services, Inc.  
dba Ravn Connect Flight 3153  
Cessna 208B, N208SD  
Togiak, Alaska  
October 2, 2016

NTSB/AAR-18/02  
PB2018-100871

# Aircraft Accident Report

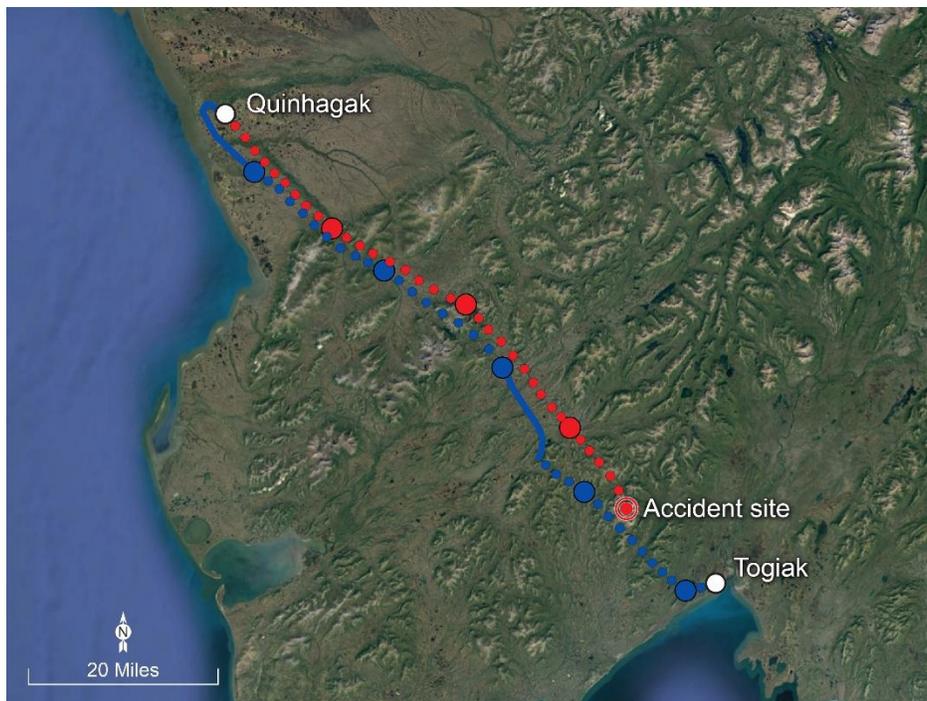
A second Hageland flight crew, consisting of a PIC and a safety pilot, in a Cessna 208B departed PAQH about 2 minutes after the accident flight.<sup>5</sup> According to Spidertracks and automatic dependent surveillance-broadcast (ADS-B) data for that airplane, the second flight crew's route was initially similar to the route and altitude of the accident flight. (No ADS-B data were available for the accident airplane because the equipment was inoperative, which is discussed in section 1.3.1.) The data showed that, as the second flight approached the mountainous terrain, at 1156, it diverted more toward the south, which allowed it to remain over lower terrain than the route the accident flight followed (see figure 1).

**Figure 1.** Topographic map depicting accident flightpath in red and the path flown by the second company crew in blue.

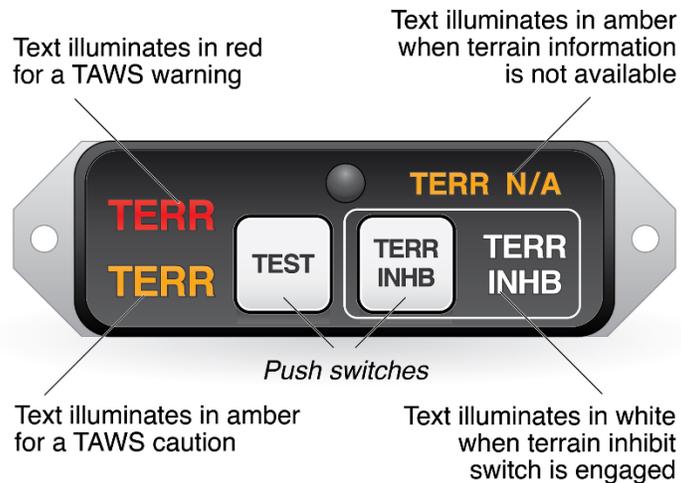
The terrain awareness annunciation control unit also provided a test feature that enabled pilots to push a test switch to activate the TAWS computer's self-test. (See section 1.8.2.5 for information about Hageland's guidance to pilots on TAWS use.) The unit's amber TERR N/A lamp would illuminate if terrain information was not available (see figure 4).

**Figure 4.** Drawing of the terrain awareness annunciation control unit with all annunciation lamps and the test and terrain inhibit switches labeled.

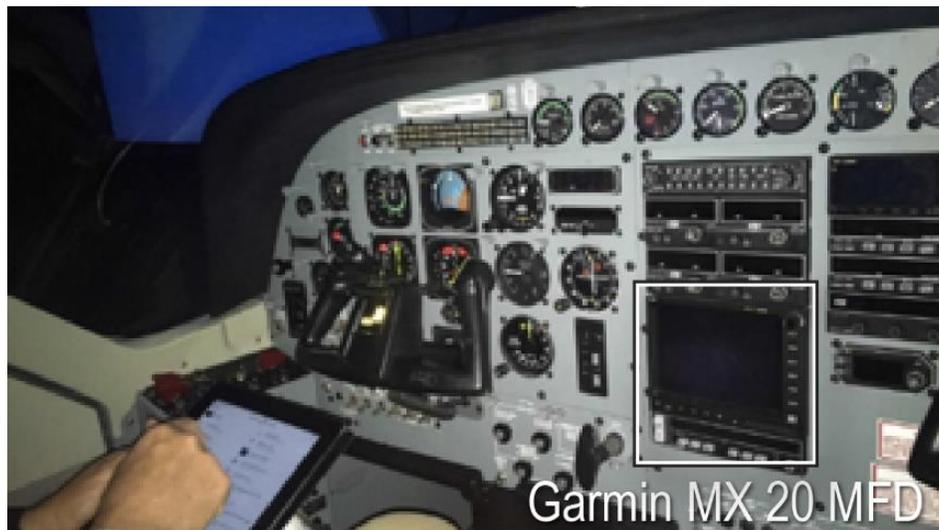
The simulator was equipped with a Garmin MX 20 MFD that displayed terrain information for each scenario that was accurate for each location flown (and used symbology generally similar to that of the accident airplane's Garmin GMX 200 MFD). (See figure 7.) The view out the cockpit windows provided basic visual cues of generic terrain, rather than a realistic visual depiction of area mountainous terrain. The simulator was not equipped with a TAWS. According to Hageland's single-engine program manager, for a scenario that requires responding to a TAWS alert, the simulator instructor will verbally tell the pilot, "Okay, your TAWS warning just went off."

**Figure 7.** Instrument panel of the Cessna 208B flight simulator.

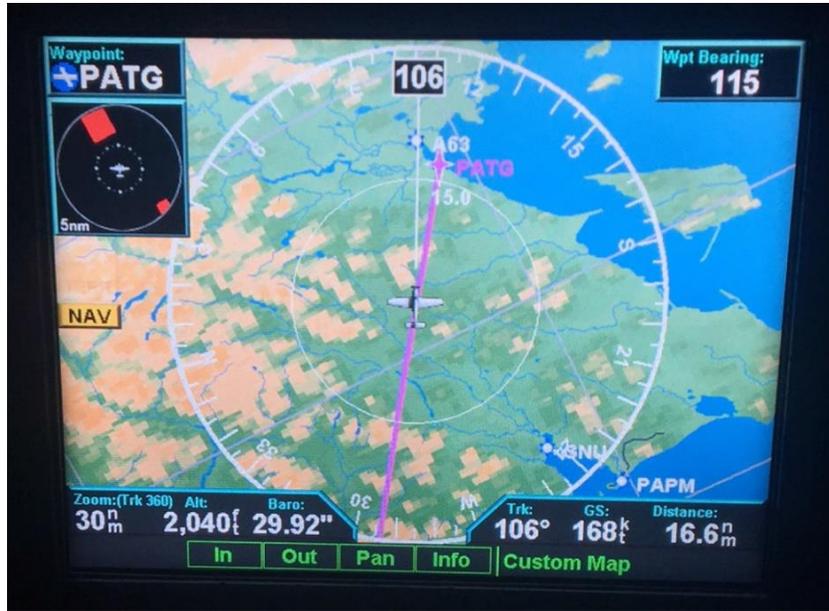
When using the custom map function, a terrain thumbnail appeared in the upper left corner of the display to depict in red the relative location of terrain within 5 nm of the airplane's position that may present a collision risk (see figure 8). A flashing white terrain advisory flag (showing the text "TERR") also appeared on the left side of the display below the thumbnail during the simulation but was not captured in the photograph due to the timing of the flag's flash and the screen freeze. (An example of a terrain advisory flag is shown in figure 9.)

**Figure 8.** Photograph of the simulator’s Garmin MX 20, using the custom map function.

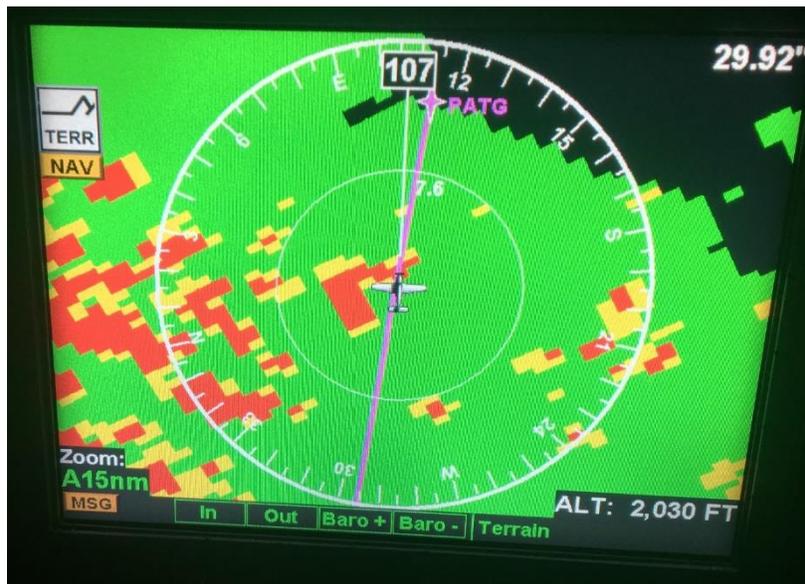
When using the MFD’s terrain function, the display depicted in red and yellow the location of terrain that may present a collision risk. A flashing white terrain advisory flag (showing the text “TERR”) also appeared on the left side of the display (see figure 9).

**Figure 9.** Photograph of the simulator’s Garmin MX 20, using the terrain function.
