**AIRCRAFT ACCIDENT REPORT**

**UNITED AIR LINES, INC.**

**Boeing 737, N9031U**

**REPORT NUMBER: NTSB-AAR-73-16**

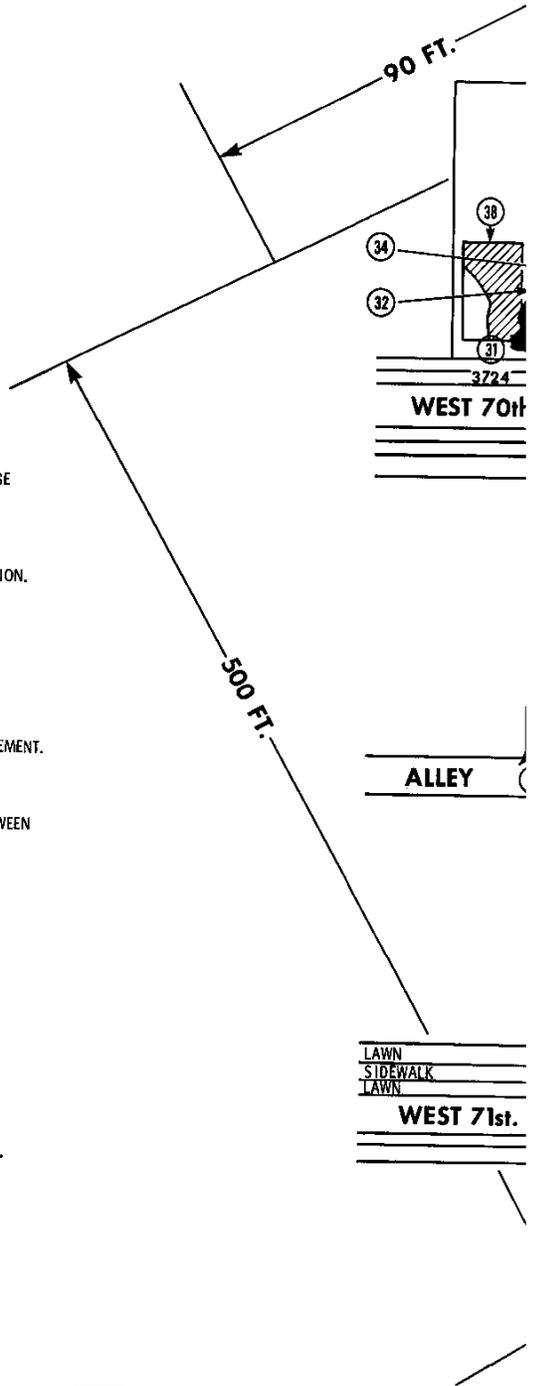
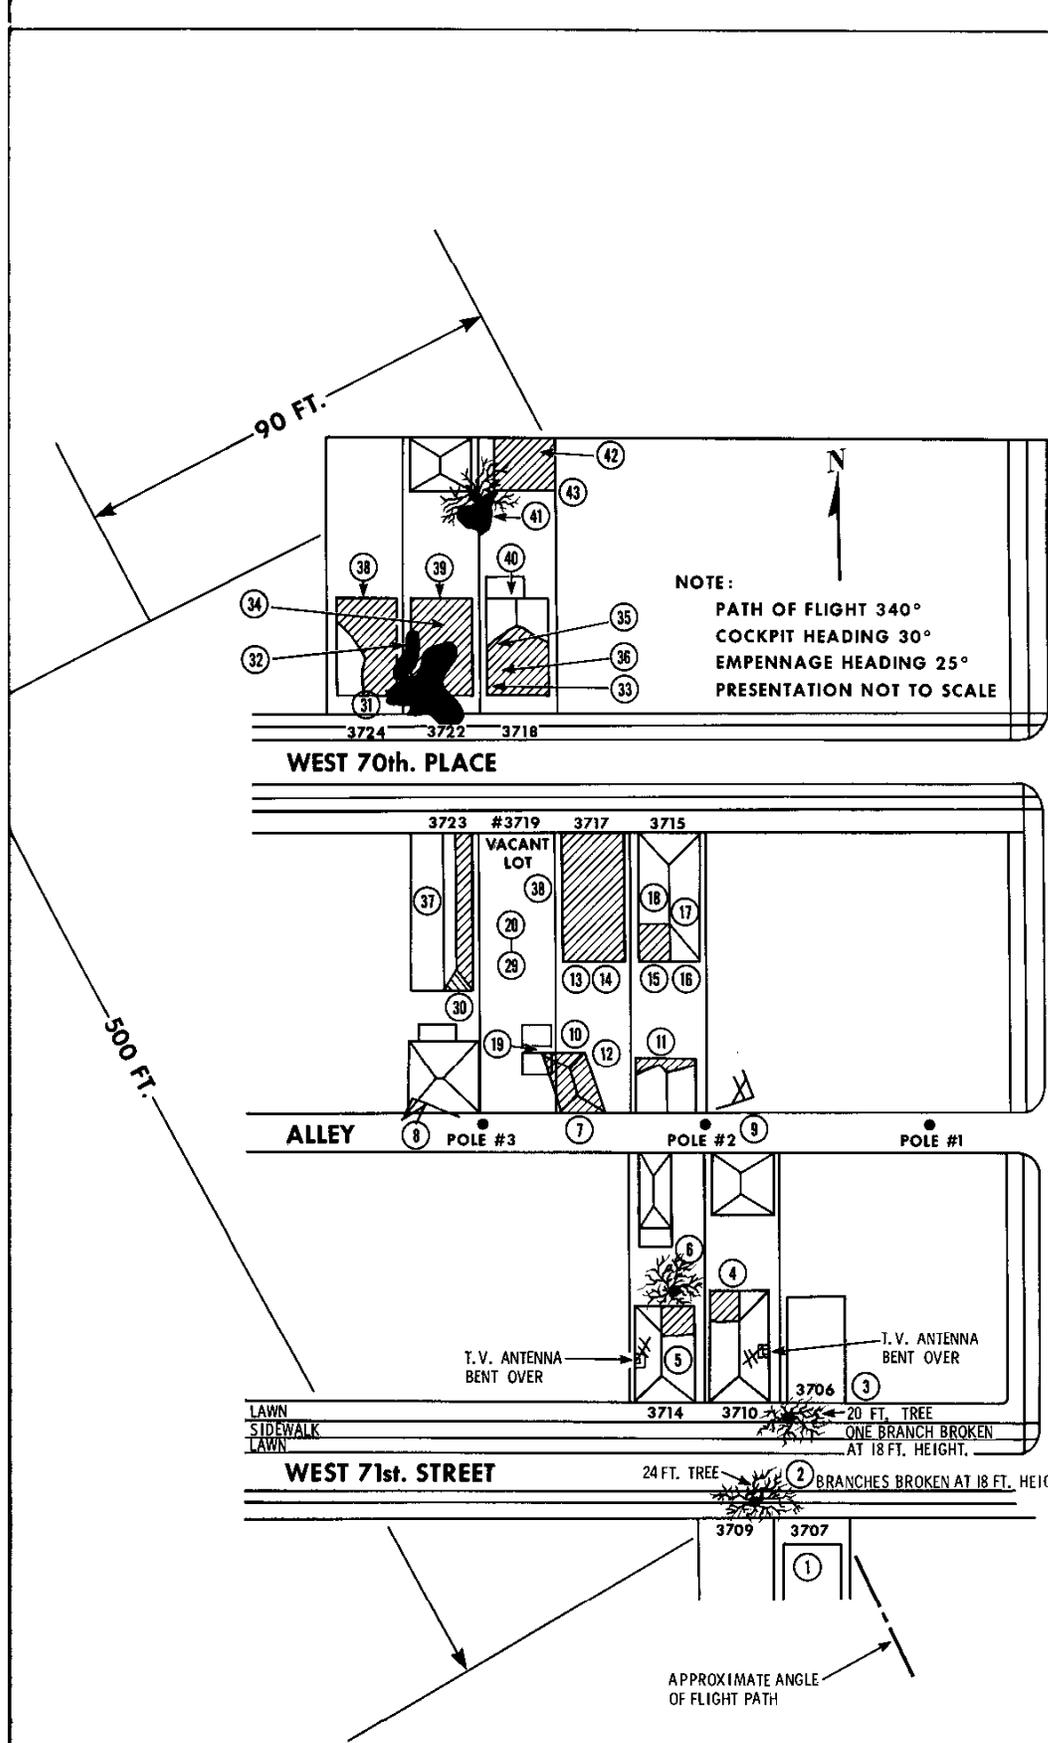
- ① FIRST EVIDENCE OF HOUSE DAMAGE. SHINGLES FROM FRONT ROOF PEAK ON GROUND. SECOND FLOOR FRONT STORM WINDOW OFF. FIRST FLOOR FRONT PICTURE WINDOW OUTER PANE DETACHED.

- ② TREE IN FRONT LAWN EXHIBITED BROKEN BRANCHES AT A HEIGHT OF APPROXIMATELY 18 FEET. TREE HEIGHT APPROXIMATELY 24 FEET.
- ③ TREE HAD BROKEN BRANCH AT A HEIGHT OF APPROXIMATELY 18 FEET. TREE APPROXIMATELY 20 FEET IN HEIGHT.

- ④ LEFT ELEVATOR TIP FOUND ON ROOF. NORTHWEST CORNER OF ROOF DAMAGED.
- ⑤ NORTHEAST CORNER OF ROOF DAMAGED.
- ⑥ NUMEROUS LIMBS OF TREE BROKEN.
- ⑦ SECTION OF LEFT HORIZONTAL STABILIZER SKIN, P/N 65-47536-50L. SECTION OF LEFT ELEVATOR, P/N 65-47512-3.

- ⑧ POLE SNAPPED OFF APPROXIMATELY 3 FEET 6 INCHES ABOVE GROUND. UPPER SECTION ON GARAGE ROOF.
- ⑨ POLE SNAPPED APPROXIMATELY 11 FEET 8 INCHES ABOVE GROUND. UPPER SECTION IN BACK YARD.  
NOTE:  
TELEPHONE CABLE LOCATED 20 FEET ABOVE GROUND LEVEL.  
ELECTRICAL CABLE LOCATED TOP OF POLE. POLES MEASURED APPROXIMATELY 34 FEET IN HEIGHT.  
CABLES FAILED IN TENSION.

- ⑩ NORTH SECTION OF GARAGE ROOF DAMAGED. GARAGE MOVED OFF FOUNDATION.
- ⑪ NORTH SECTION OF GARAGE ROOF CAVED IN.
- ⑫ LEFT HORIZONTAL STABILIZER AND ELEVATOR SECTION.

- ⑬ SECTION OF RIGHT HAND OUTBOARD MID FLAP.
- ⑭ HYDRAULIC LINE AND FITTING.
- ⑮ RIGHT WING TIP INCLUDING TANK VENT.
- ⑯ SECTION OF LEADING EDGE SLAT, SECTION OF FLAP TRACK, AND TWO FUEL TANK PLATES FOUND IN BASEMENT.

- ⑰ SOUTHWEST CORNER OF HOUSE DAMAGED.
- ⑱ SECTION OF RIGHT WING LEADING EDGE FOUND BETWEEN HOUSES.
- ⑲ SECTION OF LEFT HORIZONTAL STABILIZER.
- ⑳ SECTION OF FLAP TRACK INCLUDING JACK SCREW.

- ㉑ SECTION OF FLAP TRACK FAIRING.
- ㉒ FLAP MID FLAP SECTION AND JACK SCREW.
- ㉓ OXYGEN FILLER AND GAUGE.
- ㉔ RIGHT HAND STRUT DOOR P/N 65-52202-36.
- ㉕ STRUT DOOR P/N 65-52201-88.

- ㉖ SECTION OF SKIN WITH STRINGERS, P/N 65-55726-5.
- ㉗ SKIN AND RIB SECTION.
- ㉘ SECTION OF SKIN WITH LOUVRE.
- ㉙ FUEL TANK PLATE, P/N 65-46446-1 (2 EACH).  
NOTE:  
ITEMS 20 THROUGH 29 NOT IN ORIGINAL LOCATION. FOUND IN STREET AND ON SIDEWALK OF LOT 3719 WEST 70th PLACE.
