AIRCRAFT ACCIDENT REPORT

SATURN AIRWAYS, INC.
LOCKHEED L-382, N14ST
SPRINGFIELD, ILLINOIS

MAY 23, 1974

REPORT NUMBER: NTSB-AAR-75-5

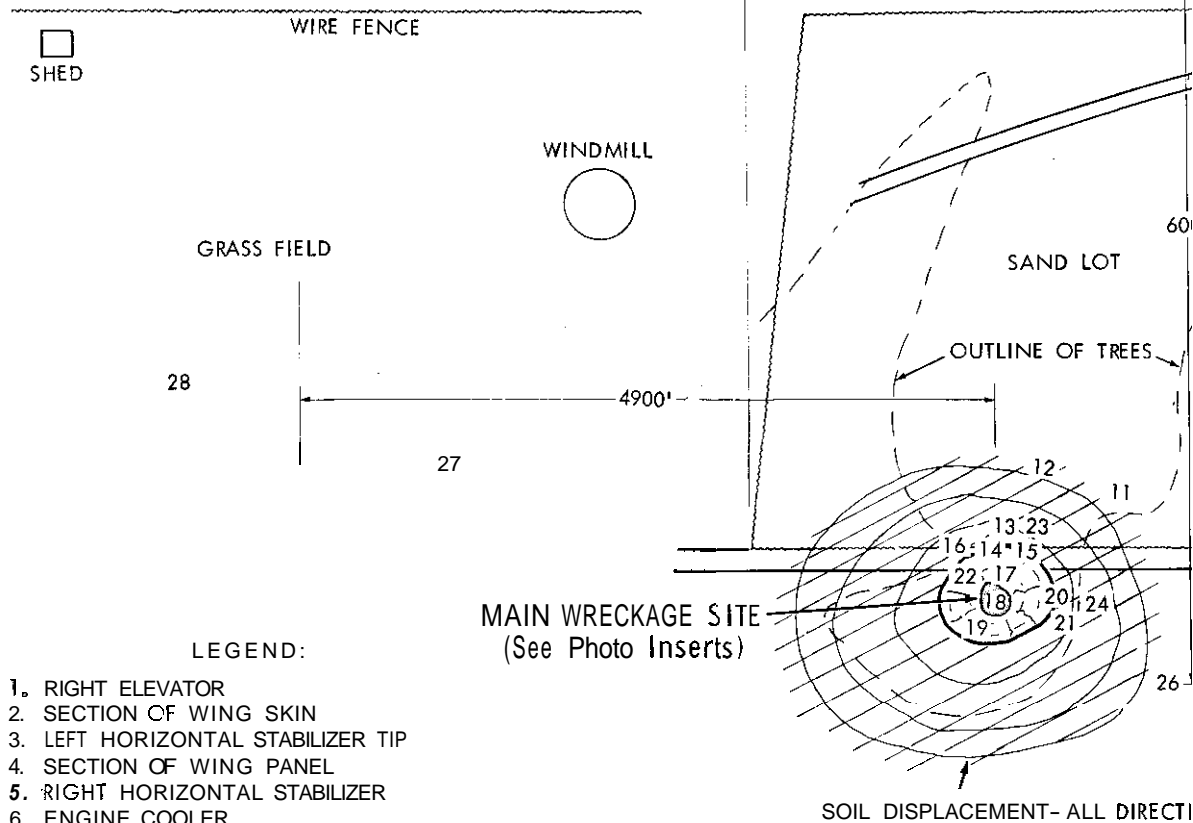
**WRECKAGE DISTRIBUTION CHART
SATURN AIRWAYS INC.
LOCKHEED MODEL L-382
N14ST/S/N 4225 DCA 74-A-21
NEAR SPRINGFIELD ILLINOIS
MAY 23, 1974**

1. RIGHT ELEVATOR
2. SECTION OF WING SKIN
3. LEFT HORIZONTAL STABILIZER TIP
4. SECTION OF WING PANEL
5. RIGHT HORIZONTAL STABILIZER
6. ENGINE COOLER
7. HORIZONTAL STABILIZER SKIN
8. LEFT HORIZONTAL STABILIZER SPAR SECTION
9. LEFT HORIZONTAL STABILIZER SECTION
10. LEFT HORIZONTAL STABILIZER SECTION
11. SECTION OF RUDDER
12. RUDDER TIP
13. VERTICAL STABILIZER STRUCTURE
14. VOICE RECORDER
15. FLIGHT RECORDER
16. VERTICAL STABILIZER SKIN
17. NO. 2 ENGINE AND PROPELLER CRATER
18. MAIN IMPACT CRATER
19. NO. 4 ENGINE AND PROPELLER CRATER
20. COCKPIT
21. PIECE OF RADOME
22. ITEMS FOUND IN AND ADJACENT TO MAIN CRATER
 - a. MAIN GEAR
 - b. NOSE GEAR
 - c. CARGO FLOOR STRUCTURE
 - d. FUSELAGE STRUCTURE
23. MAIN WHEEL ASSEMBLY MINUS TIRE
24. CONTROL QUADRENT
25. PIECE OF SKIN
26. PIECE OF SKIN
27. RIGHT WING SECTION
28. RIGHT WING FRONT SPAR
29. VOR
30. LEFT WING PANEL

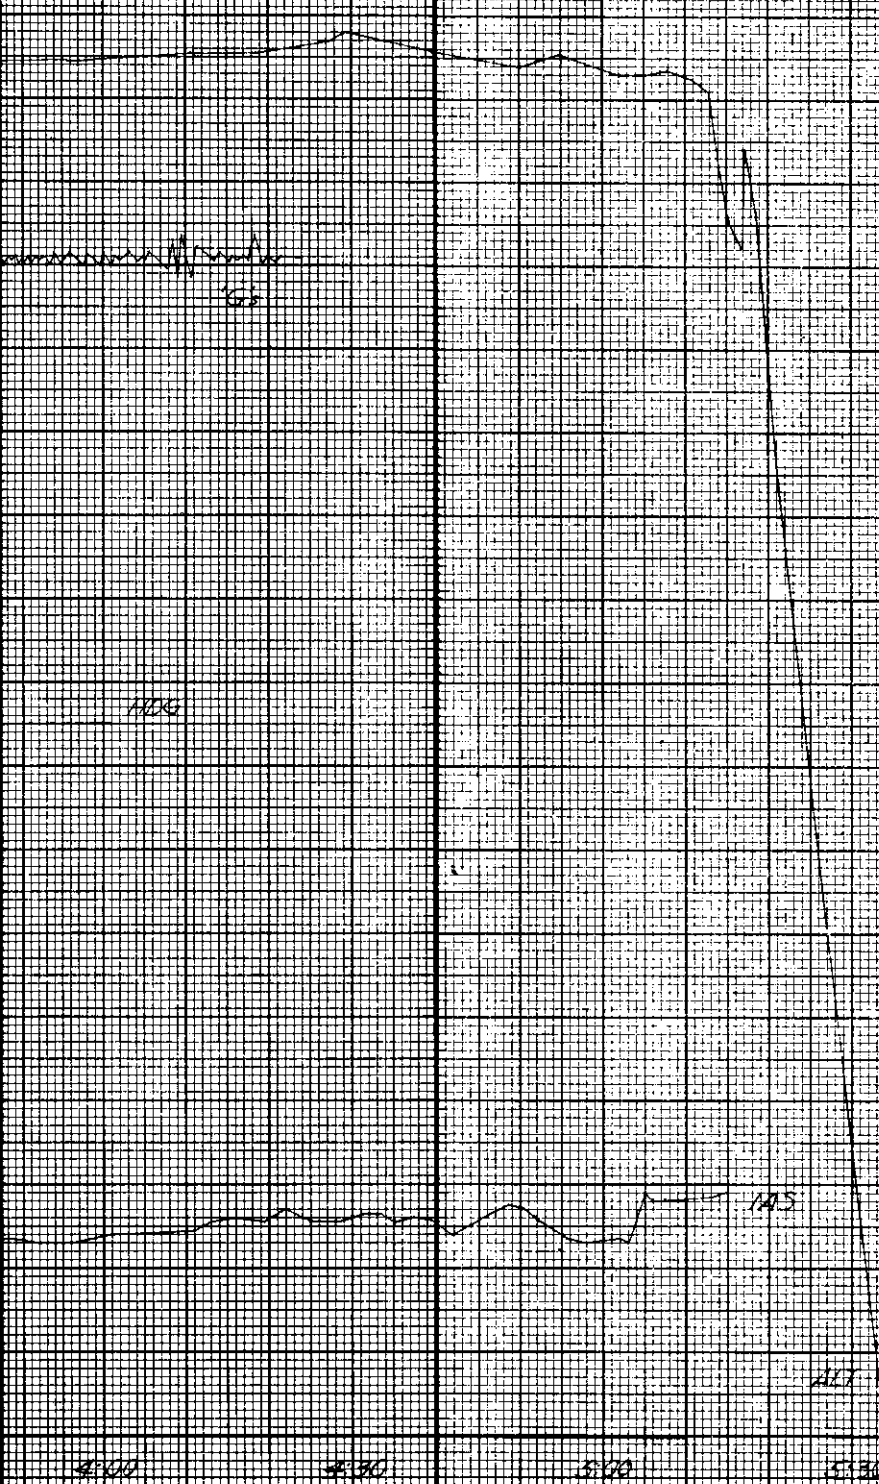
SOUTHERN AIRWAYS, LOCKHEED MODEL C-130
N1437, SPRINGFIELD, ILLINOIS, MAY 23, 1974
WINGTIGHT STRUCTURAL FAILURE
FLIGHT DATA RECORDER GRAPH
THIS GRAPH PREPARED BY C. J. JAMES
