| 4. Title and Subtitle Aircraft Accident Report -<br>New York Airways, Inc., Sikorsky S-61L, N619PA<br>Pan Am Building Heliport, New York, New York<br>May 16, 1977 | | | | 5. Report Date<br>October 13, 1977 | |

AIRCRAFT ACCIDENT REPORT

NEW YORK AIRWAYS, INC.  
SIKORSKY S-61L, N619PA  
PAN AM BUILDING HELIPORT  
NEW YORK, NEW YORK  
MAY 16, 1977

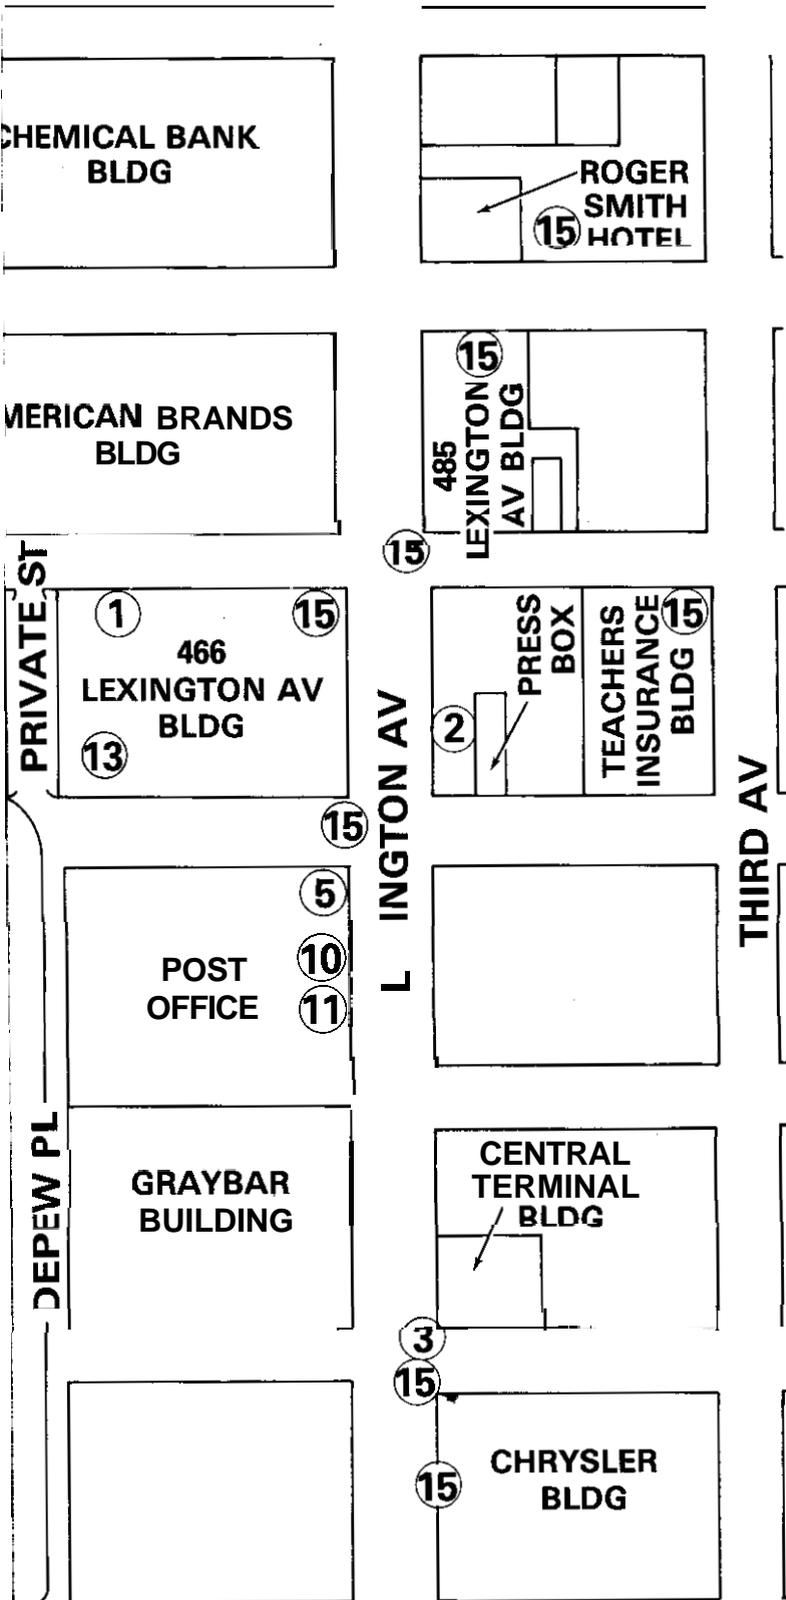
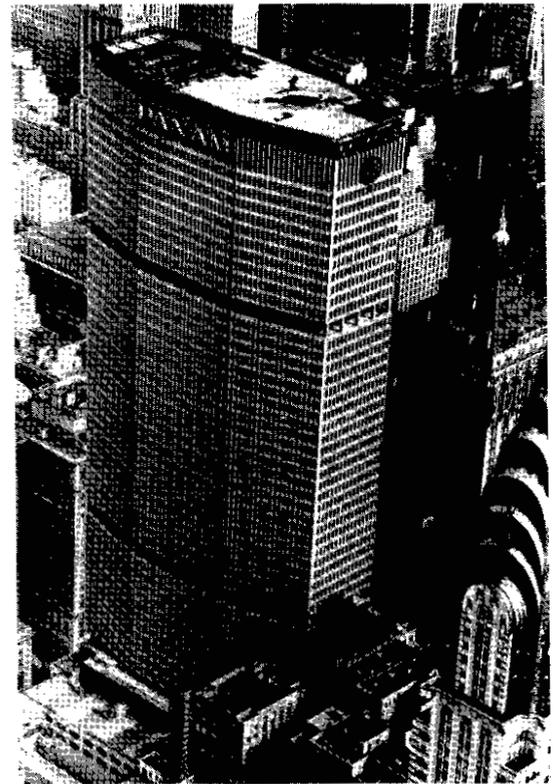
**Wreckage Distribution Chart  
New York Airways Inc.  
Sikorsky S-61L N619PA  
Pan Am Building Rooftop Heliport  
Manhattan, New York  
May 16, 1977**

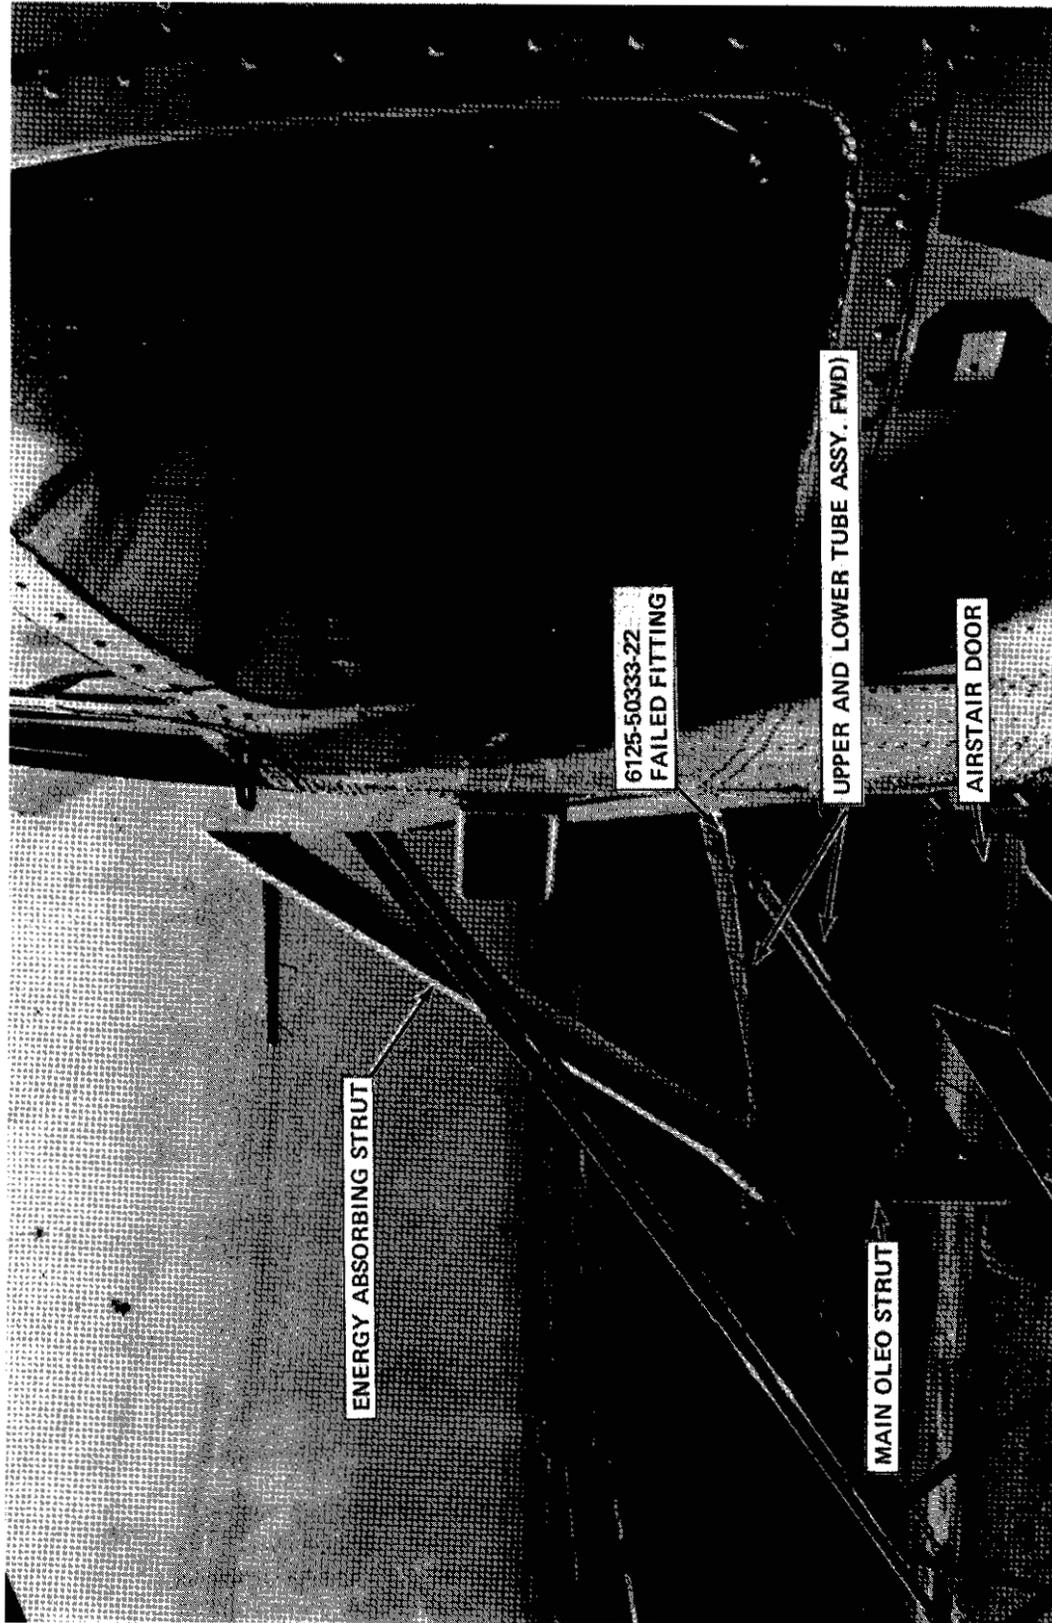
APPENDIX E FIGURE 1

Right main landing gear - S-61L-N619PA photographed on  
Pan Am Building rooftop heliport (prior to May 16, 1977 accident date)

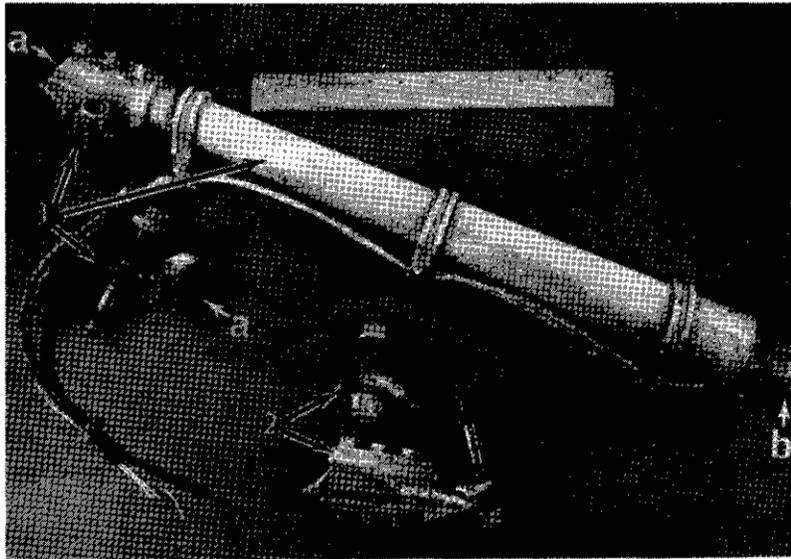
Figure 1. Overall view of the components, as received.  
1.) Forward main landing gear fitting and tube assembly.  
2.) Aft main landing gear inboard fitting with portion of tube.

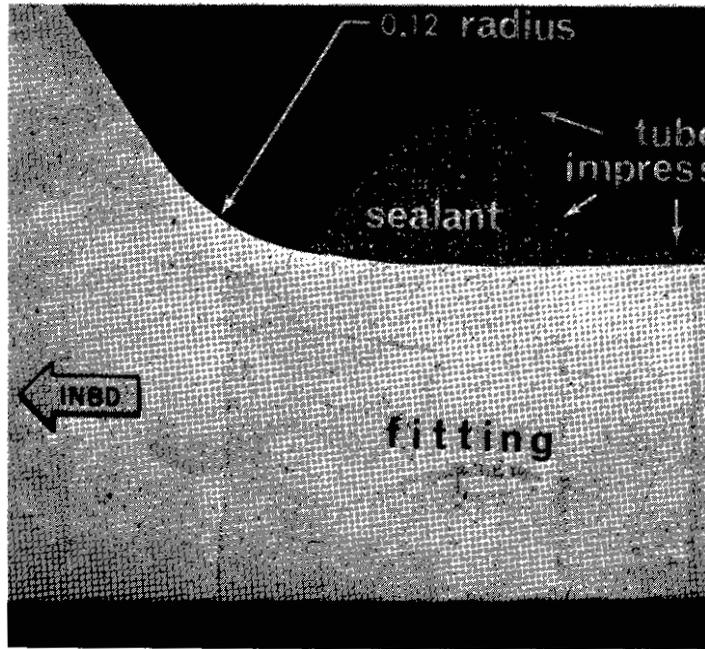
Figure 9. Longitudinal section through the fitting radius at a location diametrically opposite the fatigue origin. X10 unetched
