NATIONAL TRANSPORTATION SAFETY BOARD

AIRCRAFT ACCIDENT REPORT

PACIFIC SOUTHWEST AIRLINES, INC.,
B-727, N533PS AND

GIBBS FLITE CENTER, INC.,
CESSNA 172, N7711G

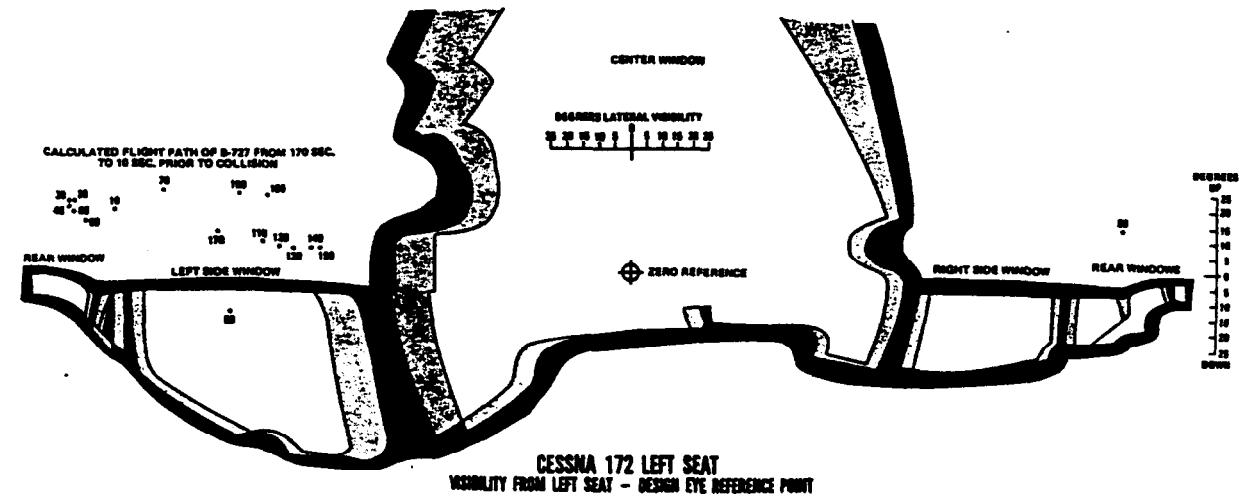
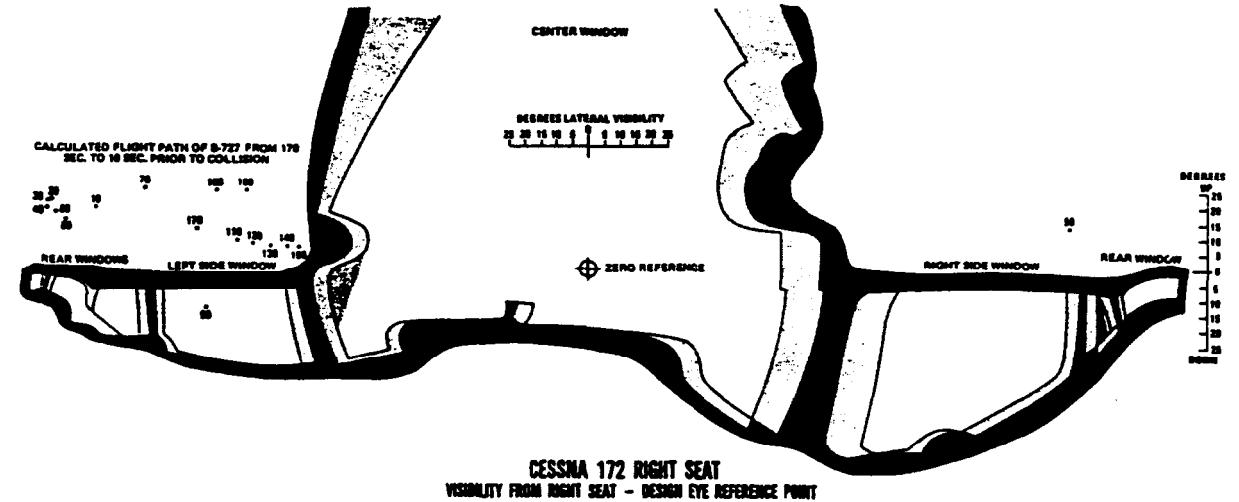
NOTE: BLACK AREAS REPRESENT OBSTRUCTED VISION.
SHADED AREAS REPRESENT MONOCULAR VISION.
CLEAR AREAS REPRESENT BINOCULAR VISION.
