NATIONAL TRANSPORTATION SAFETY BOARD

AIRCRAFT ACCIDENT REPORT

SKY TRAIN AIR, INC.
GATES LEARJET 24, N44CJ
FELT, OKLAHOMA
OCTOBER 1, 1981

NTSB-AAR-82-4

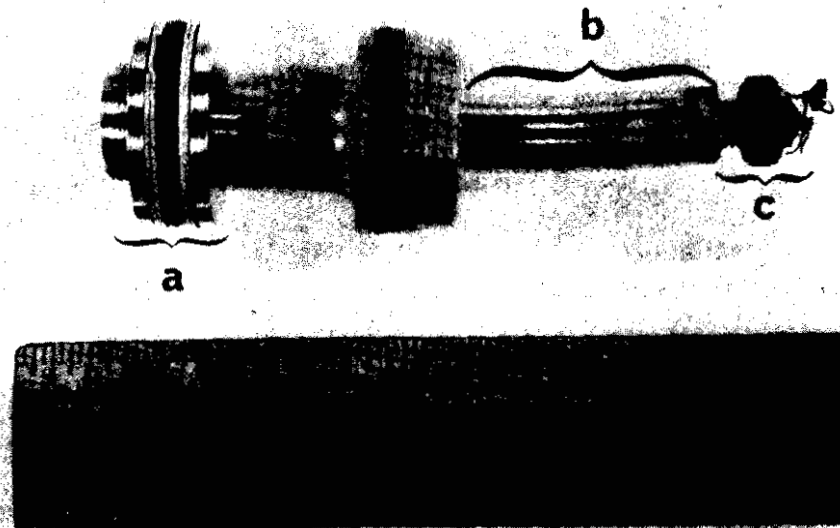
Examination of the wing spoiler actuator by the Safety Board's metallurgical laboratory disclosed that the piston rod-end broke from overload bending forces (figure 2). The actuator gland was driven sufficiently into the cylinder to shear the setscrew. Impact marks on the exterior of the actuator barrel (see figure 3) had deformed the inside wall of the barrel (see figure 4). The piston (see figure 5) was jammed within the distorted area 0.65 inch from its fully retracted position which indicates that the actuator piston had been moved by impact forces into the spoiler retract direction when the piston became jammed. The position in which it was jammed correlated with an extended spoiler deflection angle of 20.5°. The deflection angle, in turn, corresponded to the position the spoiler would seek due to opposing air loads at an airspeed of 369 knots. This speed is 69 knots above the maximum airspeed (V_{mo}) for the aircraft. However, it was not possible to determine what portion of the distance that the piston had moved from the progressive forces associated with the impact breakup sequence.

Figure 5.—View of (a) piston, (b) rod, and (c) rod end, after disassembly.
