AIRCRAFT ACCIDENT REPORT

EASTERN AIRLINES FLIGHT 935
LOCKHEED L-1011-384, N309EA,
NEAR COLTS NECK, NEW JERSEY,
SEPTEMBER 22, 1981

NTSB-AAR-82-5

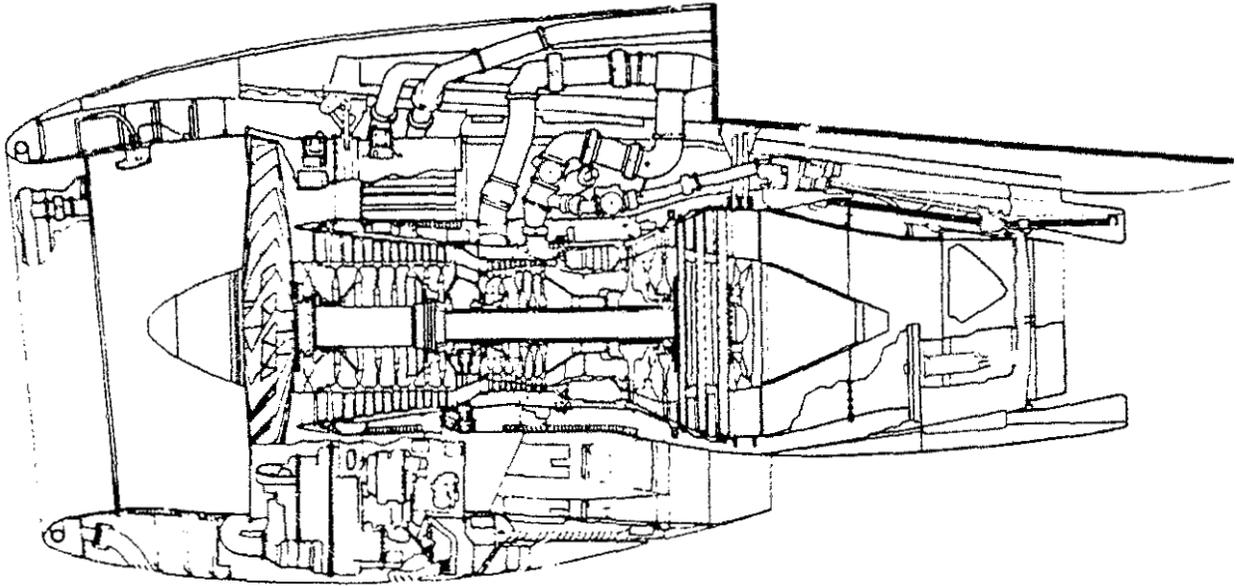
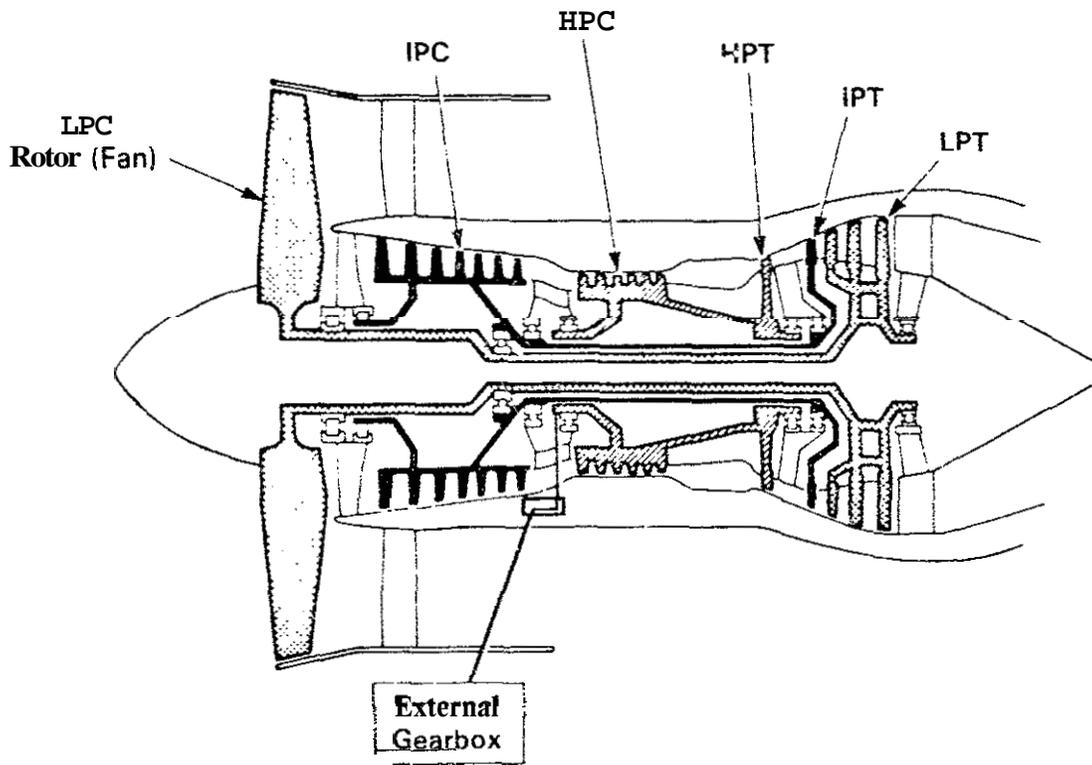
Figure 2. -- Propulsion System General Arrangement and Main Rotating Assemblies.

The engine has six rotating assemblies: the low-pressure compressor (LPC) rotor or fan, the intermediate-pressure compressor (IPC), the high-pressure compressor (HPC), the high-pressure turbine (HPT), the intermediate-pressure turbine (IPT), and the low-pressure turbine (LPT). (See figure 2.)

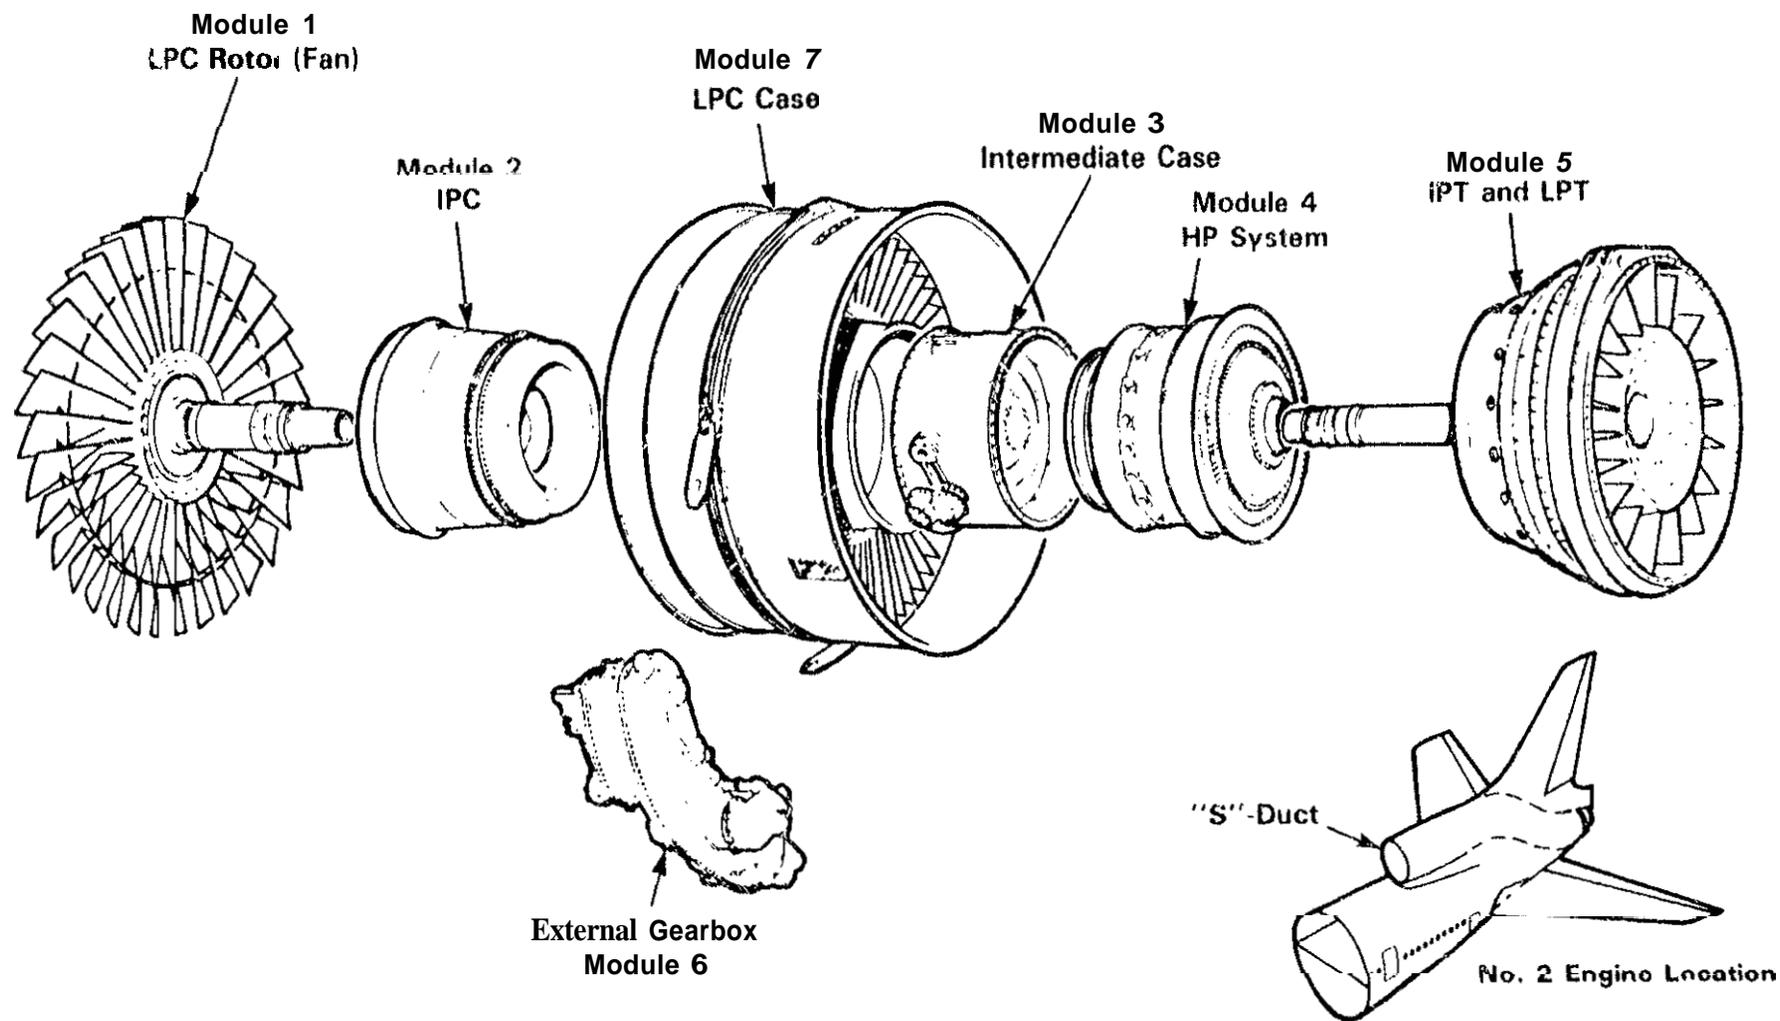
Figure 3. --- Module Breakdown Of Engine.

Engine Modules--The engine has been designed to break down into seven major modules. These are: (See figure 3.)

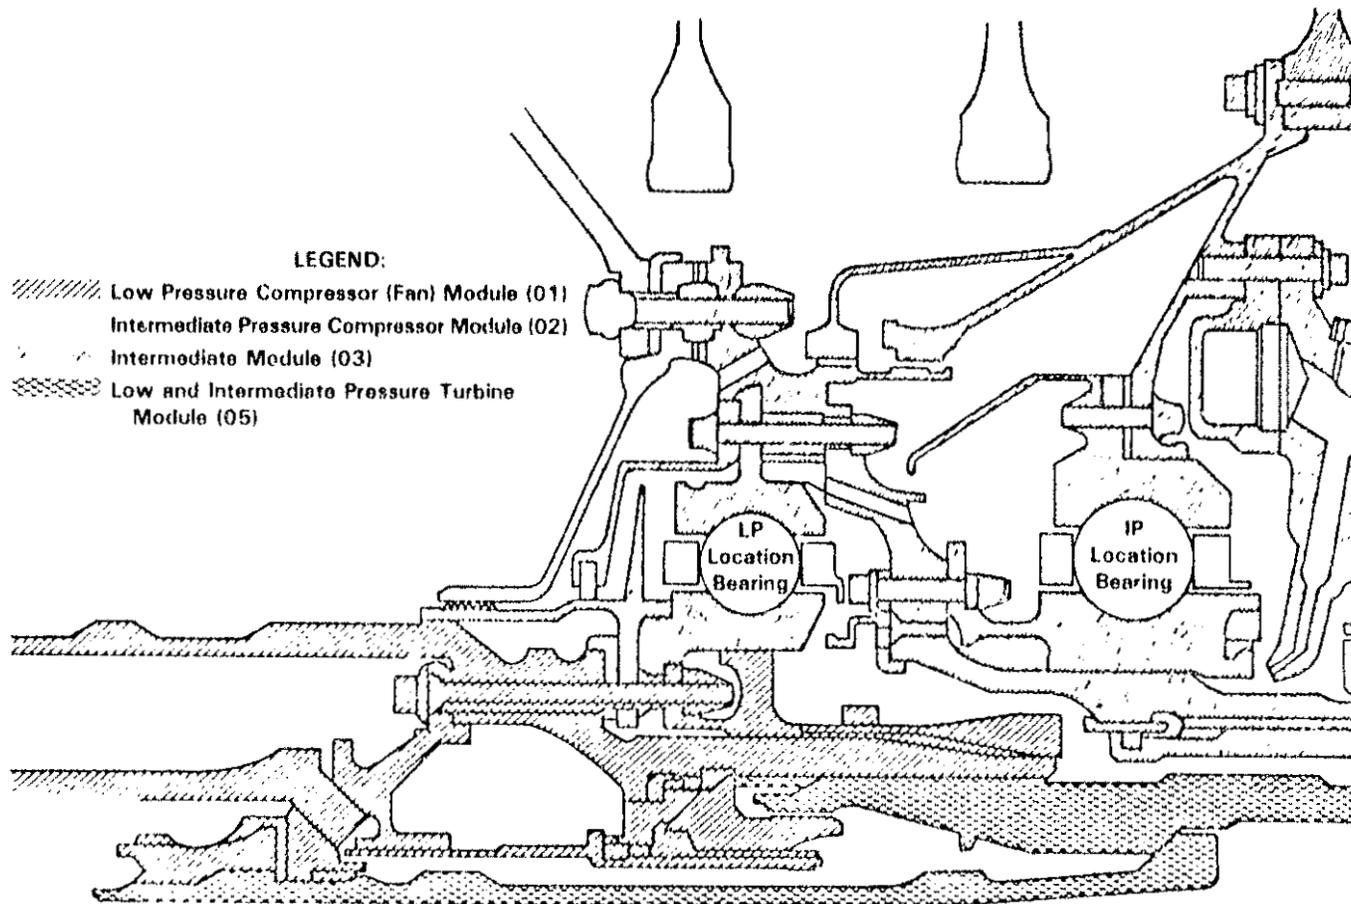
Figure 4. -- RB-211-22B Module Arrangement.

The compressor rotor shaft has five titanium discs in the forward section and two steel discs forming the rear section. Titanium rotor blades are used throughout. The rear stub shaft is splined and locked to the IPT shaft. (See figure 4.)

The front air seal knife edge fins of the low-pressure location bearing (LPLB) air and oil seal were rubbed down to about 50 percent of their normal height; the fins had rubbed against the IPC rear stubshaft coupling.

The front and rear faces of the hydraulic seal fin were rubbed; the front face was rubbed by the piston ring seal housing to about 0.600 inch from the fin tip. The rear face was rubbed by the front face of the LPLB bail cage.

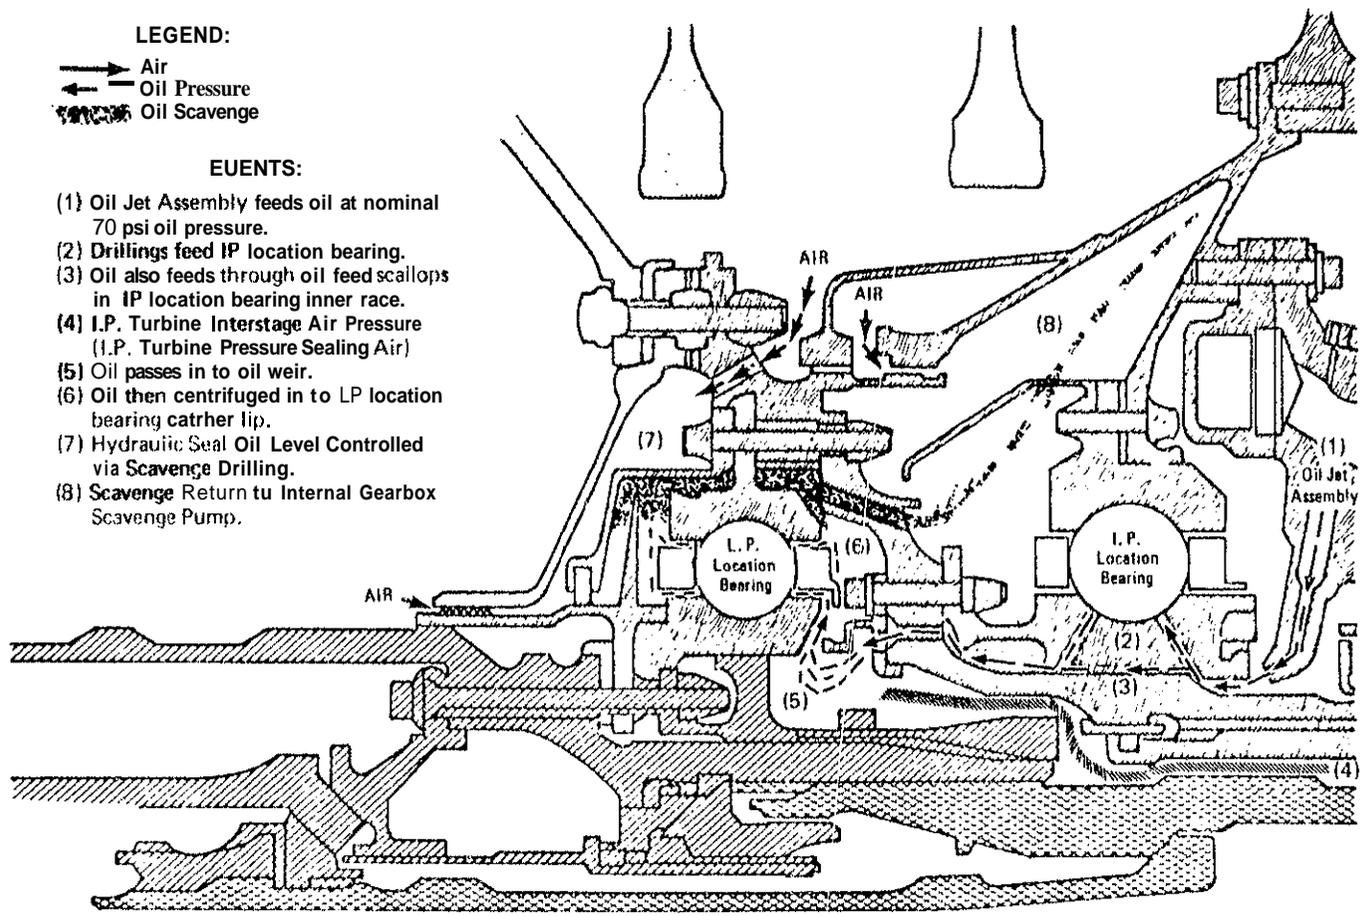
Figure 6. -- LPLB Normal Oil Supply and Scavenge.

Nominal total lubrication system capacity is 36.7 quarts of oil, including 23.7 quarts in the tank; consumption is 0.95 quarts/hour. A single-gear pump in the external gearbox supplies pressurized oil to the engine via a pressure filter. If the filter becomes blocked, the element is bypassed automatically and the engine oil filter pressure warning light illuminates on the flight deck. Low-pressure and intermediate-pressure location bearings are supplied by a single oil jet. (See figure 6.) This jet sprays oil toward an annular slot formed between the IPC stubshaft and the IPLB inner race; typical catch efficiency is 60 percent for the RB-211 engine. Under centrifugal forces, part of the oil entering the slot passes outward through a passage in the IPLB inner race to supply the bearing; the remaining oil passes forward and outward to a weir through holes in the IPC stubshaft and in the weir flange. The oil supply must cross the two flanged joints between the IPLB inner race and the rear IPC stubshaft and between the stubshaft and the oil weir to reach the weir. A lip on the aft side of the LPLB cage catches oil being thrown outward after spilling over the weir lip for LPLB lubrication. Cage passages distribute oil within the bearing.
