NATIONAL TRANSPORTATION SAFETY BOARD

AIRCRAFT ACCIDENT REPORT

PILGRIM AIRLINES FLIGHT 458
deHAVILLAND DHC-6-100, N127PM
NEAR PROVIDENCE, RHODE ISLAND
FEBRUARY 21, 1982

NTSB-AAR-82-7

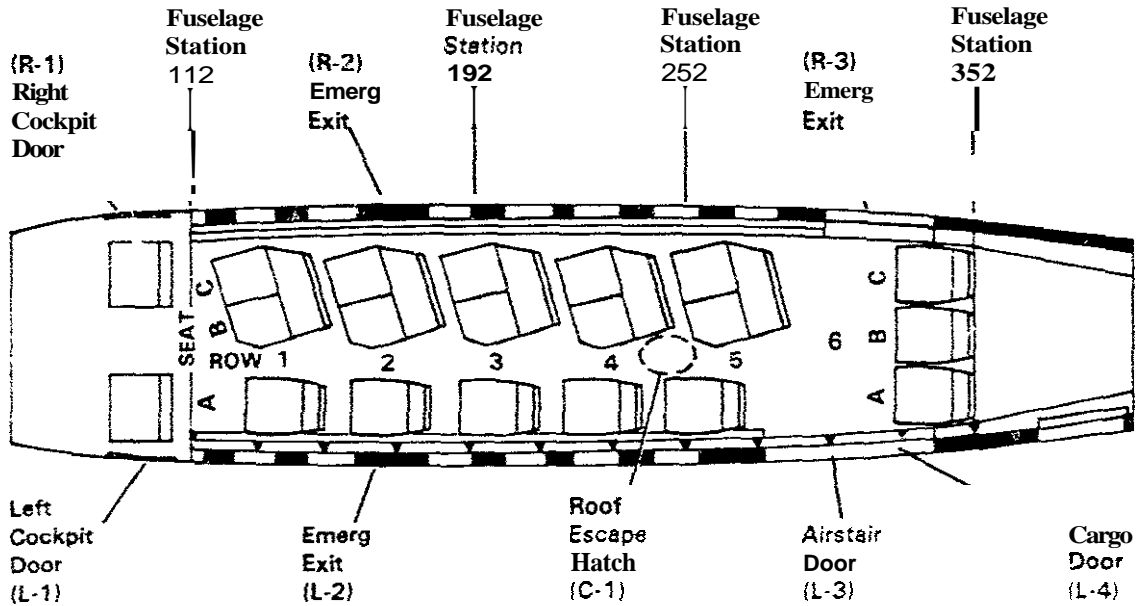
APPENDIX D
SEATING DIAGRAM

SEAT	OCCUPANT	INJURY	OCCUPANT EXITED VIA
LEFT COCKPIT	T. PRINSTER	SERIOUS	L-1 (THROUGH WINDOW IN DOOR)
RIGHT COCKPIT	L. HOGG	SERIOUS	R-2 (OPENED R-2)
ROW 1 SEAT A	UNOCCUPIED		
SEAT B	UNOCCUPIED		
SEAT C	UNOCCUPIED		
ROW 2 SEAT A	ADULT MALE, 51	MINOR	L-4*
SEAT B	16-YEAR-OLD BOY	SERIOUS	R-2 (TRIED TO OPEN EXIT)
SEAT C	ADULT FEMALE, 46	SERIOUS	R-2 (ASSISTED FROM AIRCRAFT)
ROW 3 SEAT A	ADULT FEMALE, 59	FATAL	
SEAT B	UNOCCUPIED		
SEAT C	UNOCCUPIED		
ROW 4 SEAT A	ADULT MALE, 47	SERIOUS	L-4* (TRIED TO OPEN L-3)
SEAT B	UNOCCUPIED		
SEAT C	ADULT MALE, 35 (UNOCCUPIED) AT IMPACT	SERIOUS	L-4*
ROW 5 SEAT A	ADULT FEMALE, 26 (BLIND)	SERIOUS	L-4* (ASSISTED FROM AIRCRAFT)
SEAT B	UNOCCUPIED		
SEAT C	AWLT MALE, 26	SERIOUS	L-4* (THROUGH "HOLE") (TRIED TO OPEN L-3)
ROW 6 SEAT A	9-YEAR-OLD GIRL	SERIOUS	L-4* (PULLED FROM AIRCRAFT)
SEAT B	UNOCCUPIED		
SEAT C	17-YEAR-OLD BOY	SERIOUS	L-4* (PULLED FROM AIRCRAFT)

*It is not clear from passenger interviews whether the "hole" referred to by the occupant of 5-C and others was a hole in the side of the cabin or the partially opened/damaged cargo door, L-4

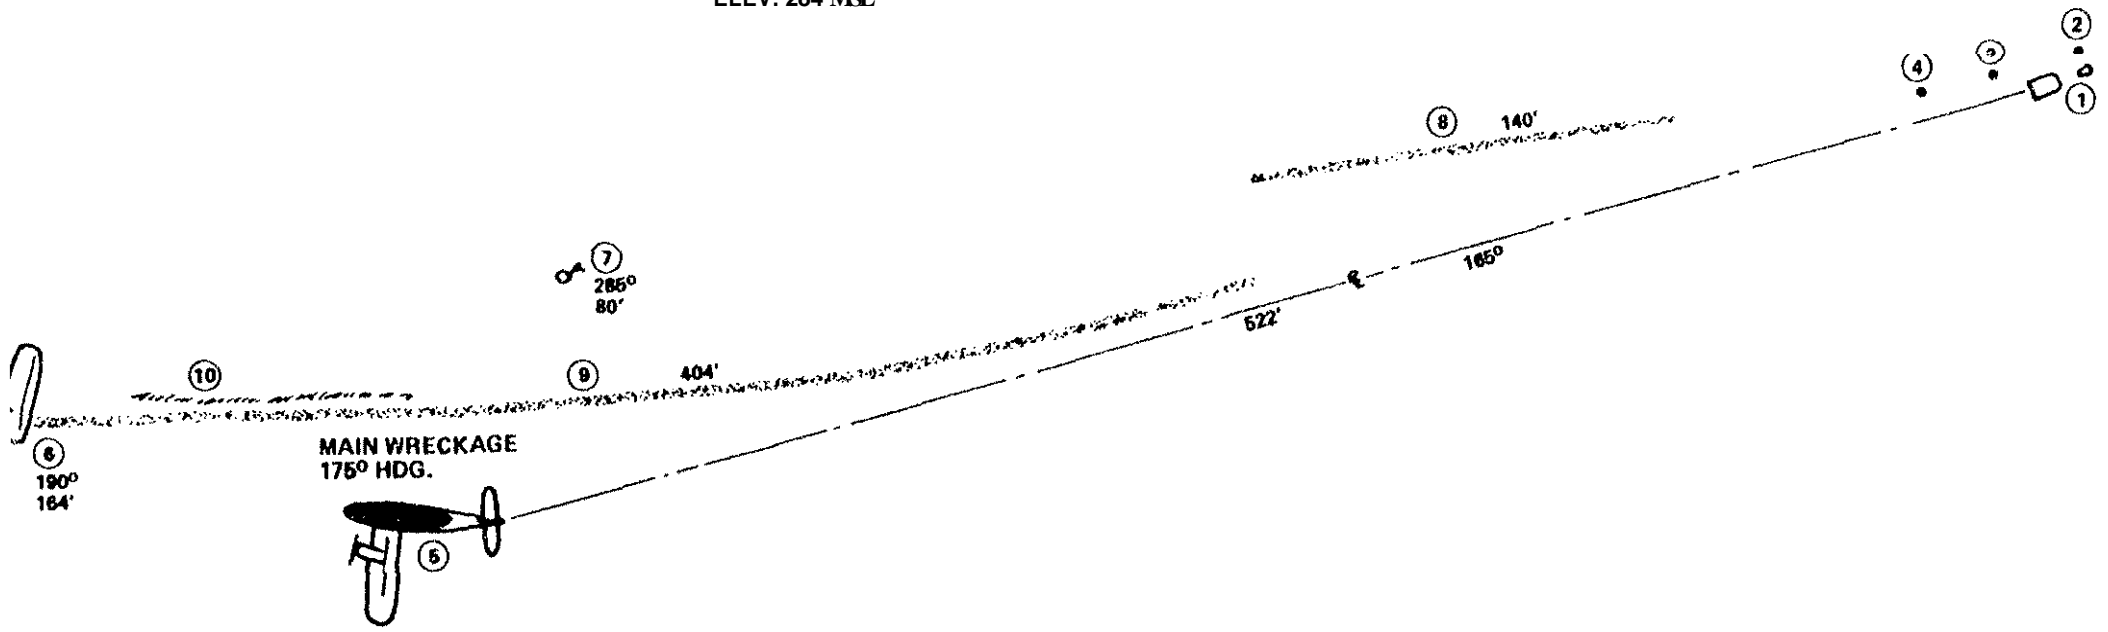
ACCIDENT SITE COORDINATES
LAT. 41°47'26" N
LONG. 71°38'10" W
ELEV. 284 MSL
