# NATIONAL TRANSPORTATION SAFETY BOARD

## AIRCRAFT ACCIDENT REPORT •

EMPIRE AIRLINES  
FLIGHT 141, PIPER PA-31, N546BA  
ITHACA, NEW YORK  
JANUARY 5, 1982

NTSB-AAR-82-11

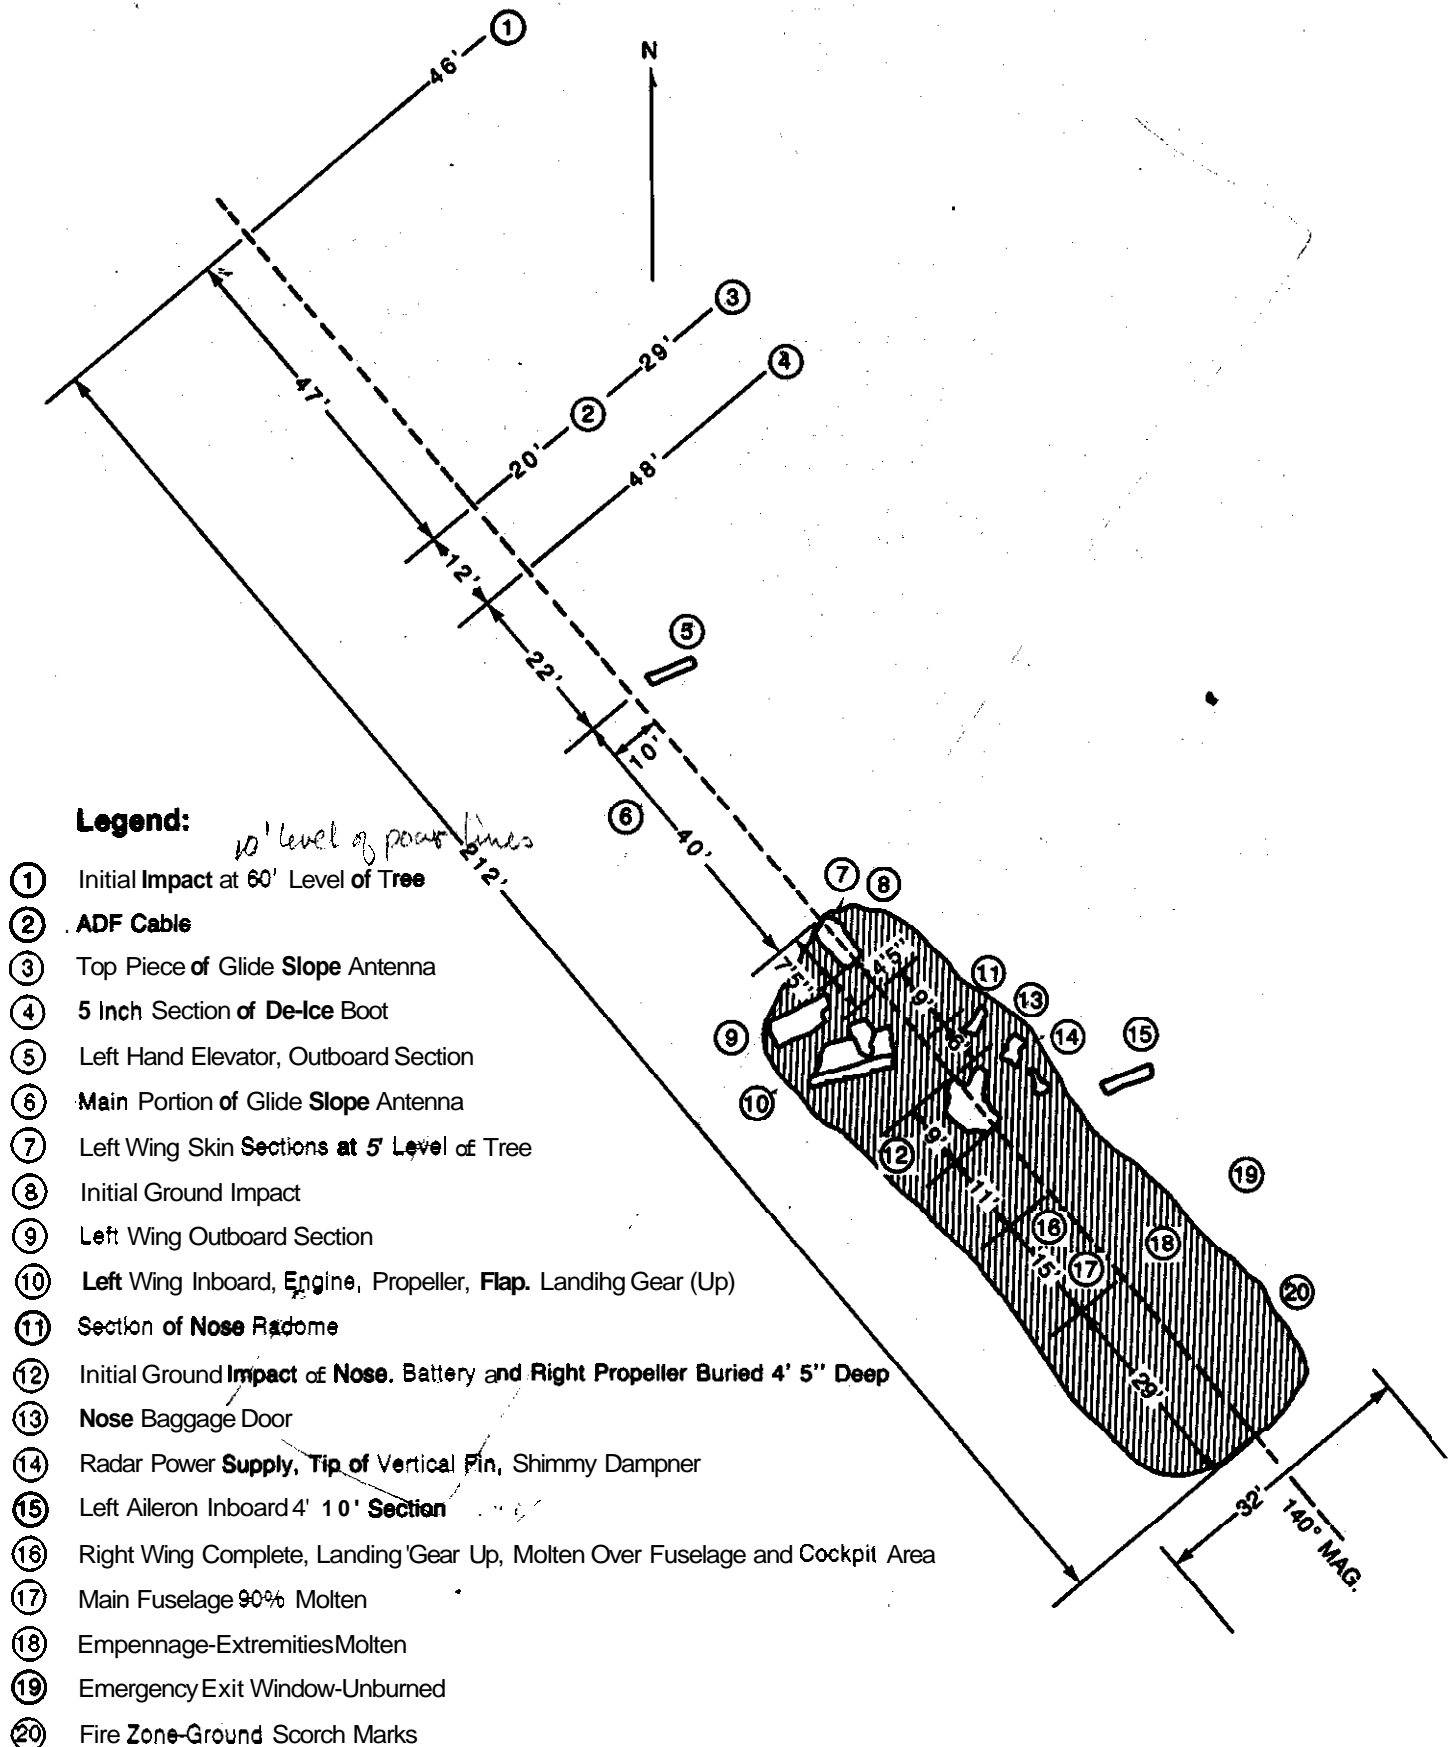
## WRECKAGE DISTRIBUTION CHART

The airplane first hit the trees about 60 feet above ground level. The airplane first hit the ground about 120 feet horizontally from initial tree impact. The pattern of damage to the trees indicated that the airplane passed through the trees with an 80° to 90° left wing-down bank angle and a 24° nosedown pitch angle.

The disintegration of the airplane was extensive. Parts of all major sections of the structure and of the flight control surfaces were identified at the wreckage site. The intense ground fire consumed about 85 percent of the fuselage, wings, and empennage; the landing gear ~~was~~ found retracted.

The left wing flap jackscrew assembly remained intact and attached to wing and flap structure. The jackscrew was found in the retracted position. The cable assembly was intact and attached to the jackscrew transmission unit. The inboard female spline component of the left flap flexible cable was found separated from the cable and from the male splines of the flap motor. The internal splines of the female component were worn, and the male spline rotated within the female spline when the two were mated and turned by hand.

The right wing flap jackscrew was found separated from wing and flap structure. The jackscrew was extended and 24 of 28 threads were exposed. Full flap extension was 40°, so that the position of the jackscrew indicated that the right wing flap was extended about 3° down. Both jackscrews could be turned by hand.
