AIRCRAFT ACCIDENT REPORT

SUN WEST AIRLINES FLIGHT 104,
PIPER PA-31-350 (T-1020), N41070
DURANGO-LaPLATA COUNTY AIRPORT,
DURANGO, COLORADO
DECEMBER 31, 1981

NTSB-AAR-82-13

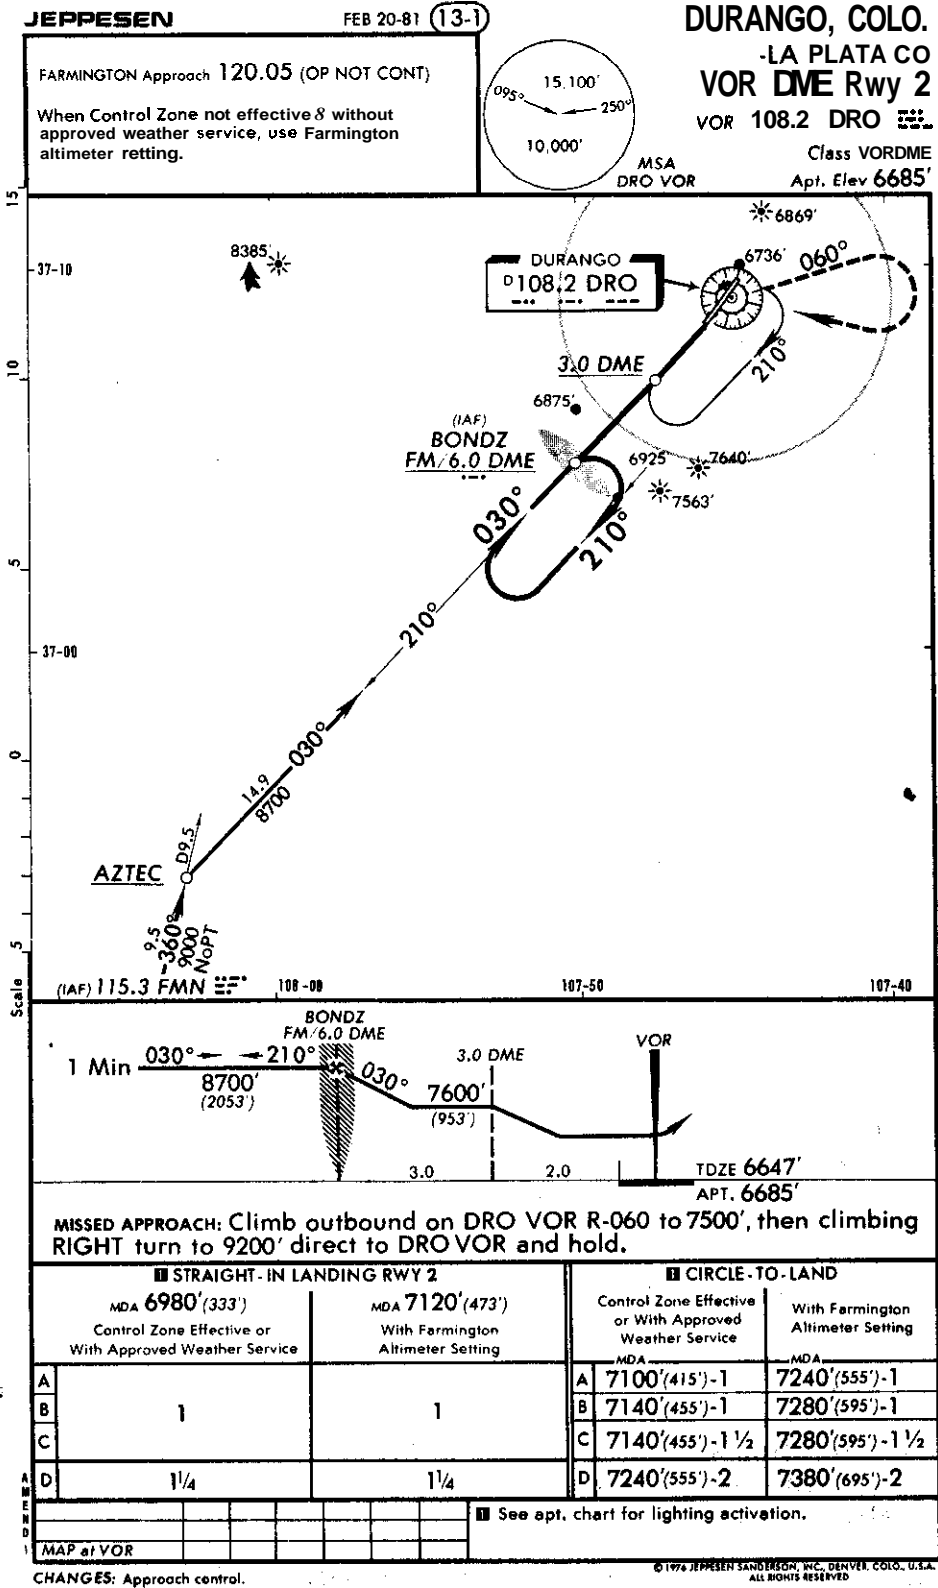
Figure 1.—Terminal Instrument Approach Procedure for runway 2.

At **1941:29**, Denver ARTCC requested more current Durango weather from Frontier Airlines Flight **815**, which was approaching Durango and was in radio communication with company personnel at the airport. The Frontier pilot complied and radioed the weather to Sun West Flight **104**. The current weather was reported as "indefinite ceiling **400** obscured, visibility 1 mile, light snow and fog, wind calm, altimeter **29.81**." Flight **104** acknowledged receipt of this weather at **1945:46**. Flight **104** was cleared for a VOR DME **4/** approach to runway **2** at Durango Airport at **1951:37**. Radar service was terminated by Denver ARTCC at **1953:30** when the airplane was about 3 miles northeast of Aztec Intersection. (See figure 1.)
