AIRCRAFT ACCIDENT REPORT

COIN ACCEPTORS, INC.
CESSNA MODEL 551, CITATION II, N2CA
MOUNTAIN VIEW, MISSOURI
NOVEMBER 18, 1982

NTSB/AAR-83/04

Adopted: July 19, 1983

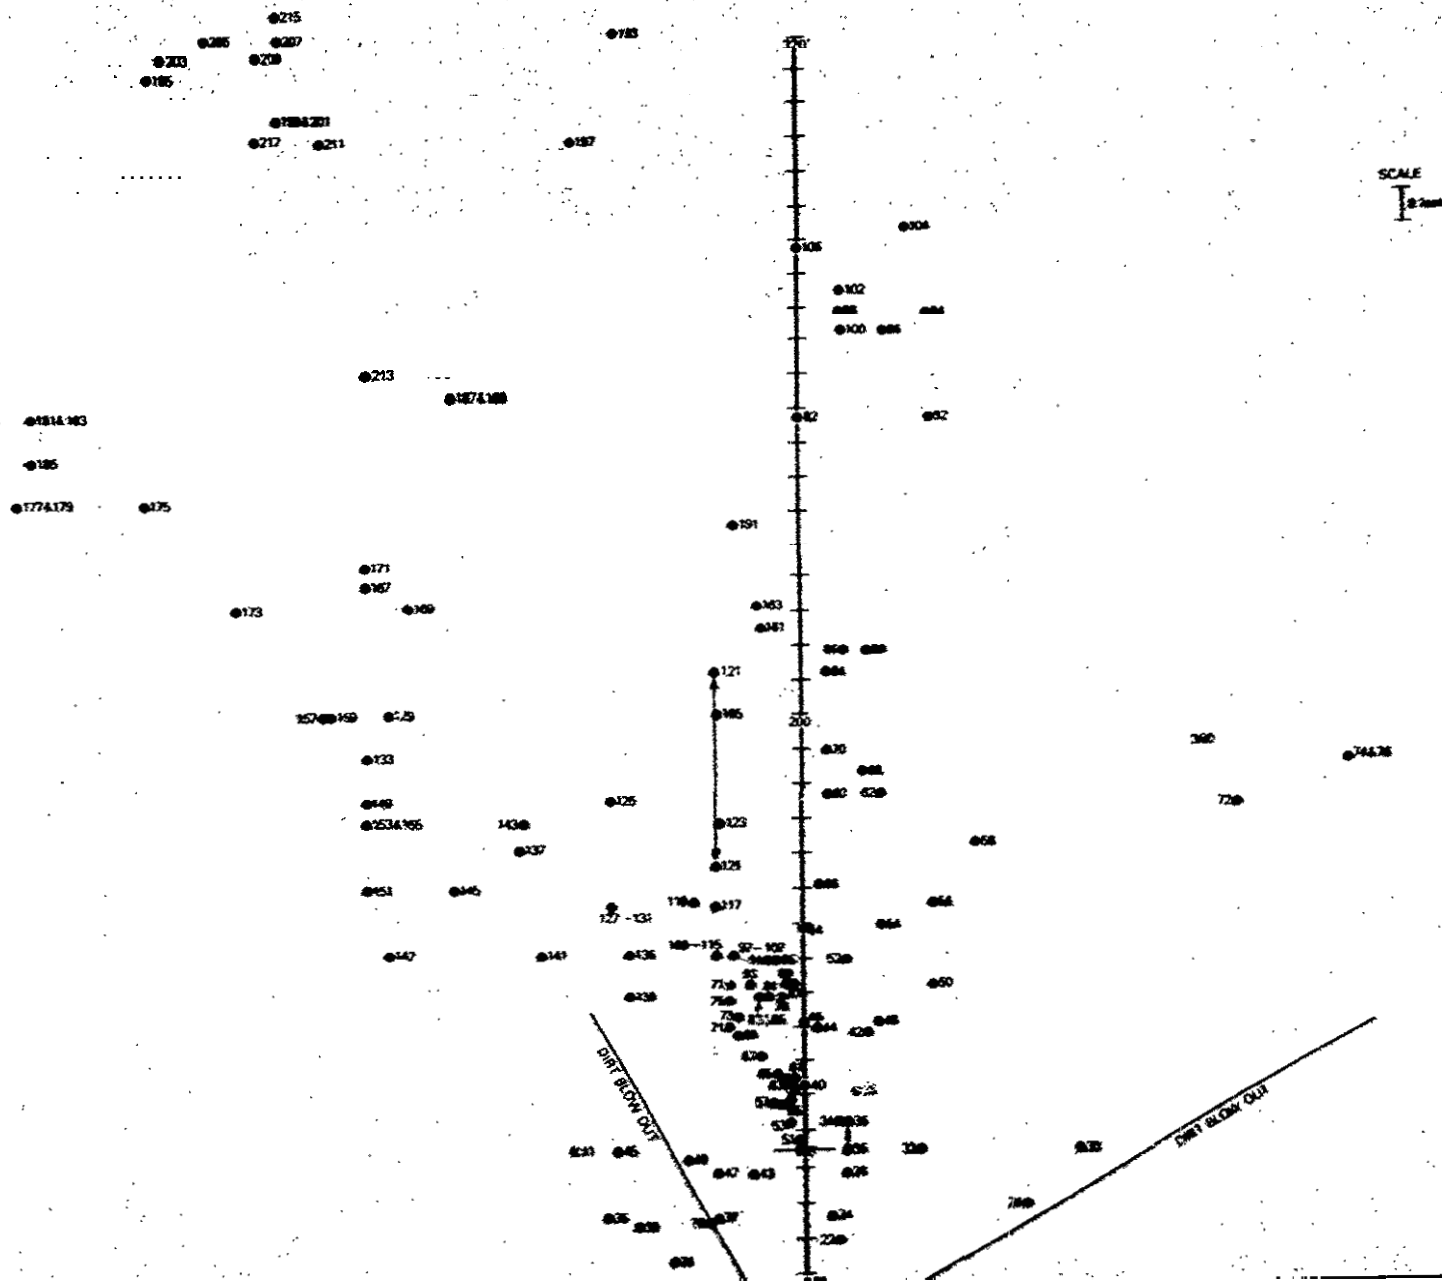
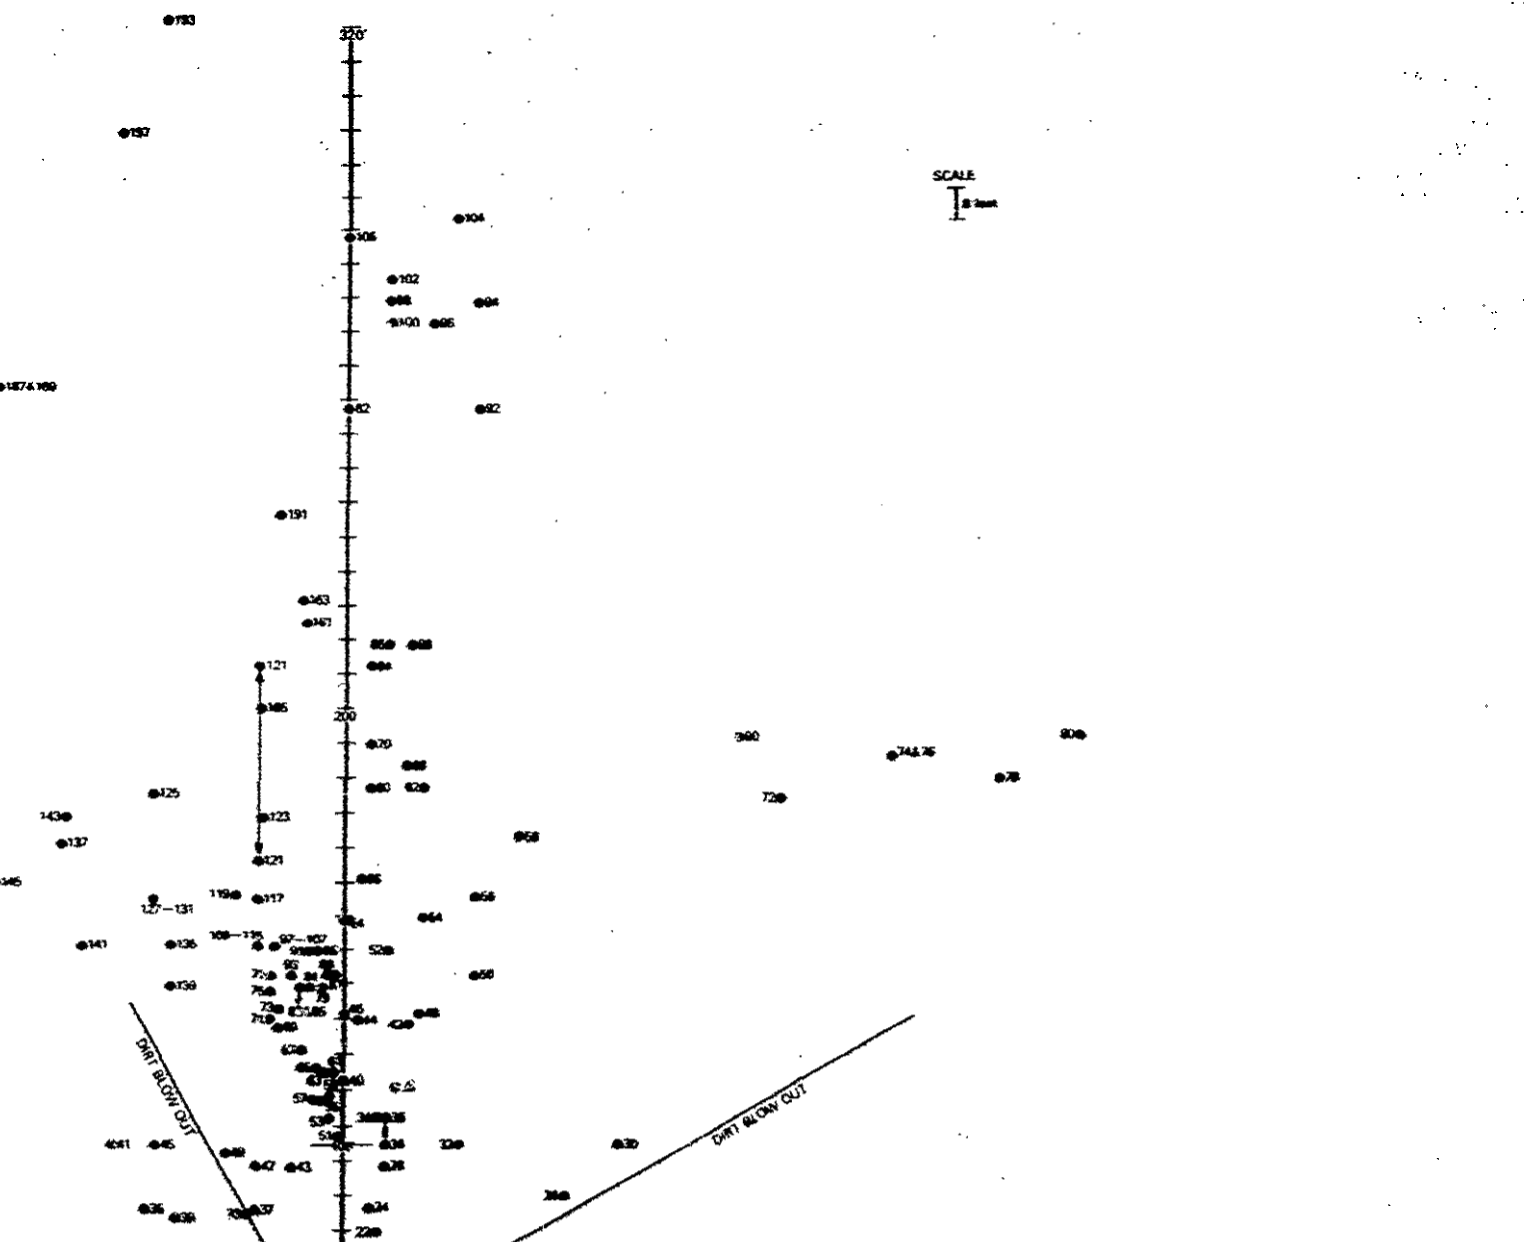
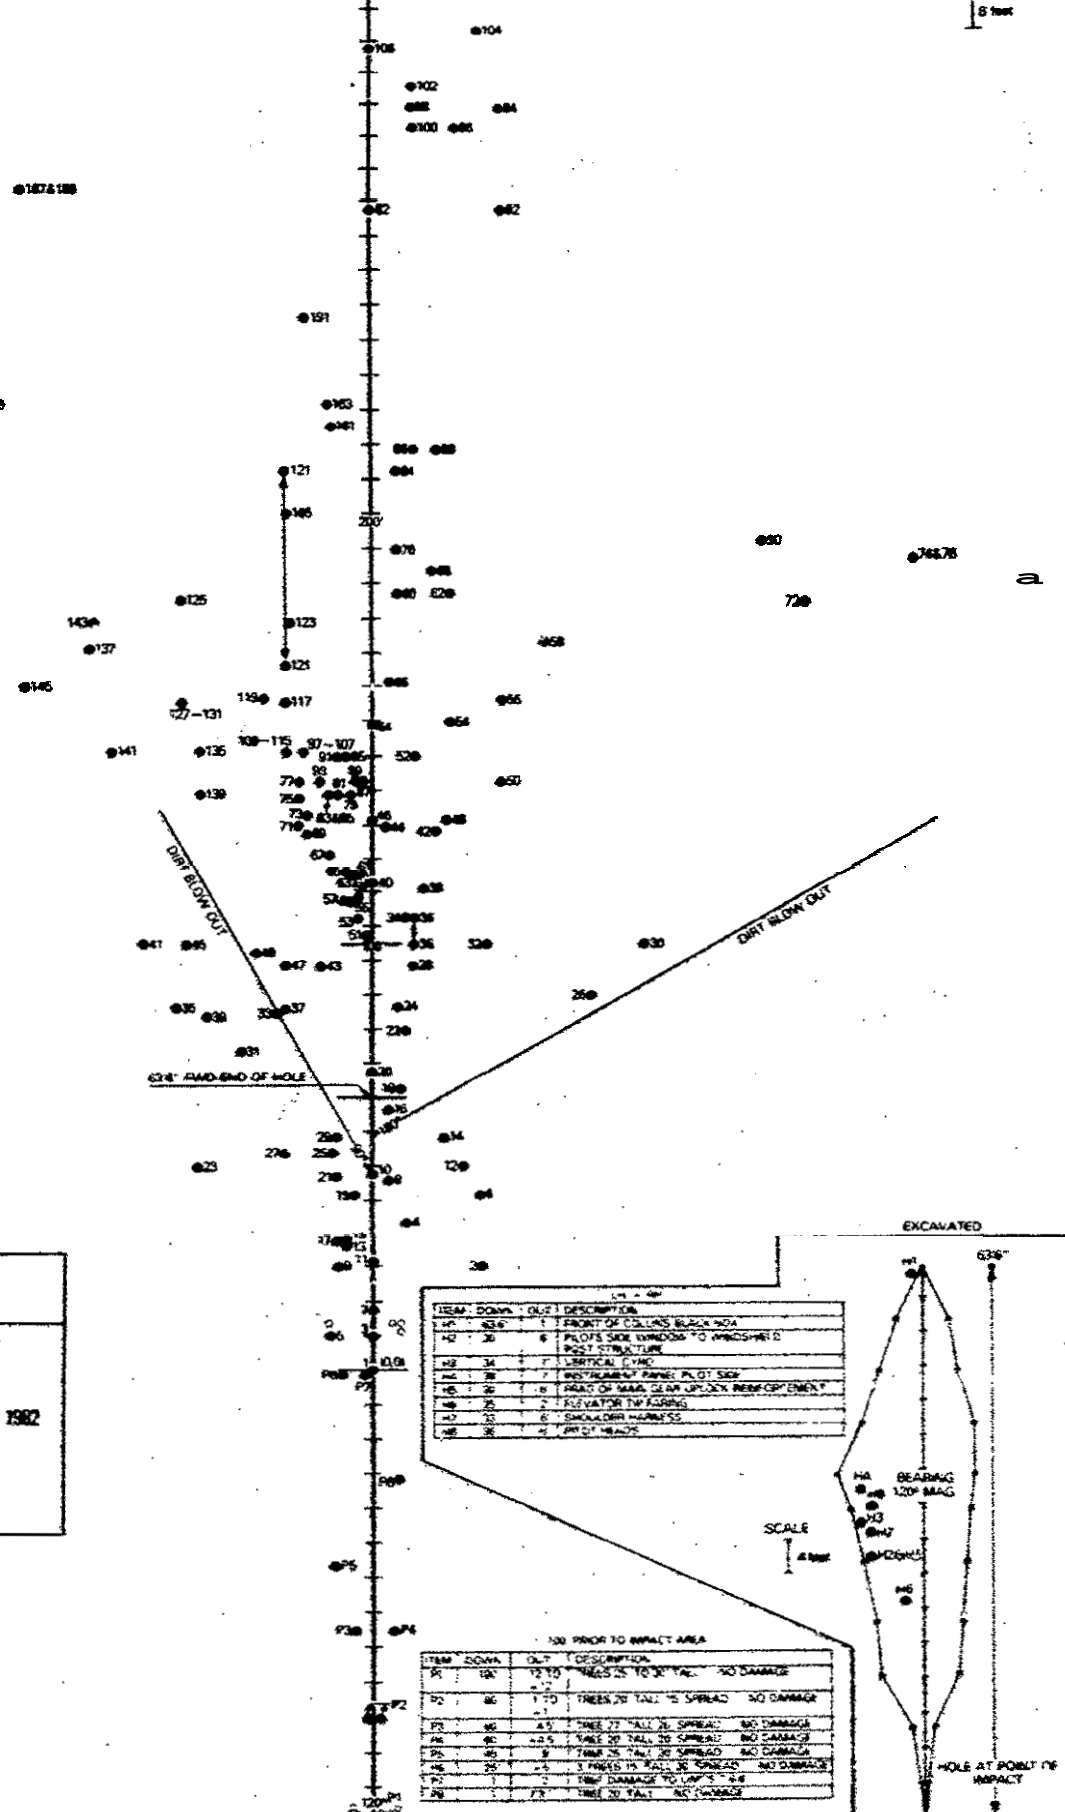
117	156	25	1 LH TR & BUCKET	
119	157	25	1 BATTERY BOX LID	
121	165 TO 210	20	1 BATTERY PIECES	
123	195	20	1 AOM HEAT EXCHANGER	
125	180	44	1 ENGINE OIL FILLER	
127	156	44	1 UPPER SPEED BRAKE PANEL SMOKE DISCONNECTED

ITEM	DOWN	OUT	DESCRIPTION
129	200	95	1 LOWER WING SHEL ACCESS DOORS
131	196	45	1 FUEL LINE & FITTING
133	196	100	1 HYD RESERVOIR
135	145	40	1 COMPLETE SIDE WINDOW FRAME & LOWER SKIN
137	169	65	1 RH WING TIP
139	136	40	1 SURGE TANK
141	145	80	1 ENGINE INLET
143	175	56	1 TOP TB OR AFT PRESSURE BULKHEAD
145	160	80	1 TR LOCK OUTS & TOOLS ESCAPE MATCH STREAMER STORAGE
147	145	95	1 THROTTLE QUADRANT
149	130	100	1 WEMAC & HYDROLYCAL 1/2 SHEET METAL PARTS
151	160	100	1 FUSELAGE SKIN PANEL 445287
153	175	100	1 1/2 S.U. WING
155	175	100	1 FS 190 DOOR FRAME INCLUDING 2 TOP FITTINGS
157	200	106	1 CROWN WINDSHIELD TOP
159	200	110	1 WINDSHIELD & SIDE WINDOW FRAME
161	220	5	1 ALERION LEADING EDGE END RH
163	225	10	1 COCKPIT AFT WINDOW FRAME & SIDE WINDOW
165	200	20	1 WHITTAKER CONTROL 222878 K
167	230	100	1 LH UPPER WING SKIN 16 LONG
169	225	90	1 2 SMALL FRAG OF PILOT INSTRUMENT PANEL
171	234	100	1 LH ENGINE LOW PRESSURE COMPRESSOR

ITEM	DOWN	OUT	DESCRIPTION
67	101	10	LH ELEVATOR COMPLETE BALANCE WEIGHT
69	126	16	FRAME TAIL CONE 9A12027 1
71	128	7	ENGINE COWL
73	130	19	R POSTAL LOCKOFF
74	134	17	WING TIP 252 2005
77	138	17	VERTICAL RN & TAIL CONE SKIN
79	135	6	SADDLE SKIN 6512027
81	136	8	RH GEAR ACTUATOR
83	135	10	ENGINE MOUNT BEAM LH
86	135	10	ENGINE PULON
87	136	2	RH CORE ENGINE
89	138	2	ACCESSARY DRIVE RH PC E-70342
91	144	5	LH CORE ENGINE
93	138	17	FIRE BOTTLE
95	144	6	FIRE BOTTLE
97	145	16	RH ELEVATOR WITH TAB CONNECTED
98	145	16	ENTIRE HORZ STAB TAB TO TAB
101	145	16	VERTICAL RN
103	145	16	RUDDER & TAB WITH TAB CONNECTED
105	145	16	AFT TAIL CONE UNDER RUDDER
107	145	16	SPERRY DRIVE SERVO PN 400819 304
109	145	13	AFT SPAR & LOWER SKIN
111	145	20	AFT PRESSURE BULKHEAD & AREA BELOW FLOORBOARD
FRONT END			
113	145	20	P G C U
115	145	20	BLEED AIR COOLER & CARRY THRU SPAR SPICE PLATE
117	150	20	LH TR & BUCKET
119	153	25	BATTERY BOX LID
121	105 TO 210	20	BATTERY PIECES

123	195	20	AIR HEAT EXCHANGER
125	180	44	ENGINE OIL FILLER
127	142	44	UPPER SPEED BRAKE PANEL SMOKE DISCLOSED

ITEM	DOWN	OUT	DESCRIPTION
173	225	130	4AN BLADE
175	200	150	TOP AFT CORN OF SIDE WINDOW FRAME
177	250	180	FORWARD DOOR FRAME & CABIN DOOR
179	230	220	ESCAPE HATCH & SEAT BURNIT ON GROUND FIRE
181	270	210	PILOT SEAT
183	270	200	RH CABIN SKIN & ESCAPE HATCH OPENING
185	290	200	CONTROL COLUMN
187	270	80	SPERRY BLACK BOX RT 220 54902702
189	280	80	CS PANEL & WING SKIN BURNIT
191	245	15	MAGNET GENERATOR
193	285	50	EMERGENCY ALTITUDE INDICATOR FACE
195	290	100	AUTO SWITCH PANEL TRANSPARENT AND REFLECTIVE
197	225	80	BLACK BOX'S ELECTRONICS
199	340	120	CONTROL COLUMN & CROSSOVER TUBE BURNIT
201	340	120	FORWARD PRESSURE BULKHEAD & WIRE BUNDLE & NOSE GEAR
203	355	142	PILOT ADR SPERRY AD 500
205	360	137	ANNUNCIATOR PANEL CRUSHED
207	360	120	RH WINDSHIELD CENTER POST
209	354	125	RADAR INDICATOR FRAME 400 SN 1639
211	335	130	ADR AG0231 581 SN 7809612
213	280	120	2 RAD SEAT BASES & 1 SEAT BACK BURNIT
215	425	120	OXYGEN BOTTLE & LEADING EDGE OF CONTROL SURFACE

217	340	125	COMPLETE SEAT BASE

ITEM	DOWN	OUT	DESCRIPTION
H1	30	1	FRONT OF COLLINS BLACK HOA
H2	30	6	FLOOR SIDE EXPOSED TO WINDSHIELD HOIST STRUCTURE
H3	34	7	VERTICAL CYLIND
H4	30	7	RESTRAINT PANEL PL. DT. SIDE
H5	30	8	HEAD OF MAIN GEAR UP/DN. REINFORCEMENT
H6	30	7	ELEVATOR TYP. FLOORING
H7	30	6	SHOULDER WELDING
H8	30	4	W. OF HEADS

ITEM	DOWN	OUT	DESCRIPTION	NO DAMAGE
H1	30	1	10' TO 15' TO 20' TALL	NO DAMAGE
H2	30	1	TREE 20' TALL, 12" SPREAD	NO DAMAGE
H3	30	4.5	TREE 12' TALL, 20" SPREAD	NO DAMAGE
H4	30	4.5	TREE 30' TALL, 20" SPREAD	NO DAMAGE
H5	30	9	TREE 20' TALL, 20" SPREAD	NO DAMAGE
H6	30	1	1' TALL TO 10' TALL, 20" SPREAD	NO DAMAGE
H7	30	1	TREE DAMAGE TO LAMP 2 - 4.6	
H8	30	7.2	TREE 20' TALL	NO DAMAGE
