NATIONAL TRANSPORTATION SAFETY BOARD

AIRCRAFT ACCIDENT REPORT

SIERRA PACIFIC AIRLINES
deHAVILLAND DHC-6-300, N361V
HAILEY, IDAHO
FEBRUARY 15, 1983

NTSB/AAR-84/03

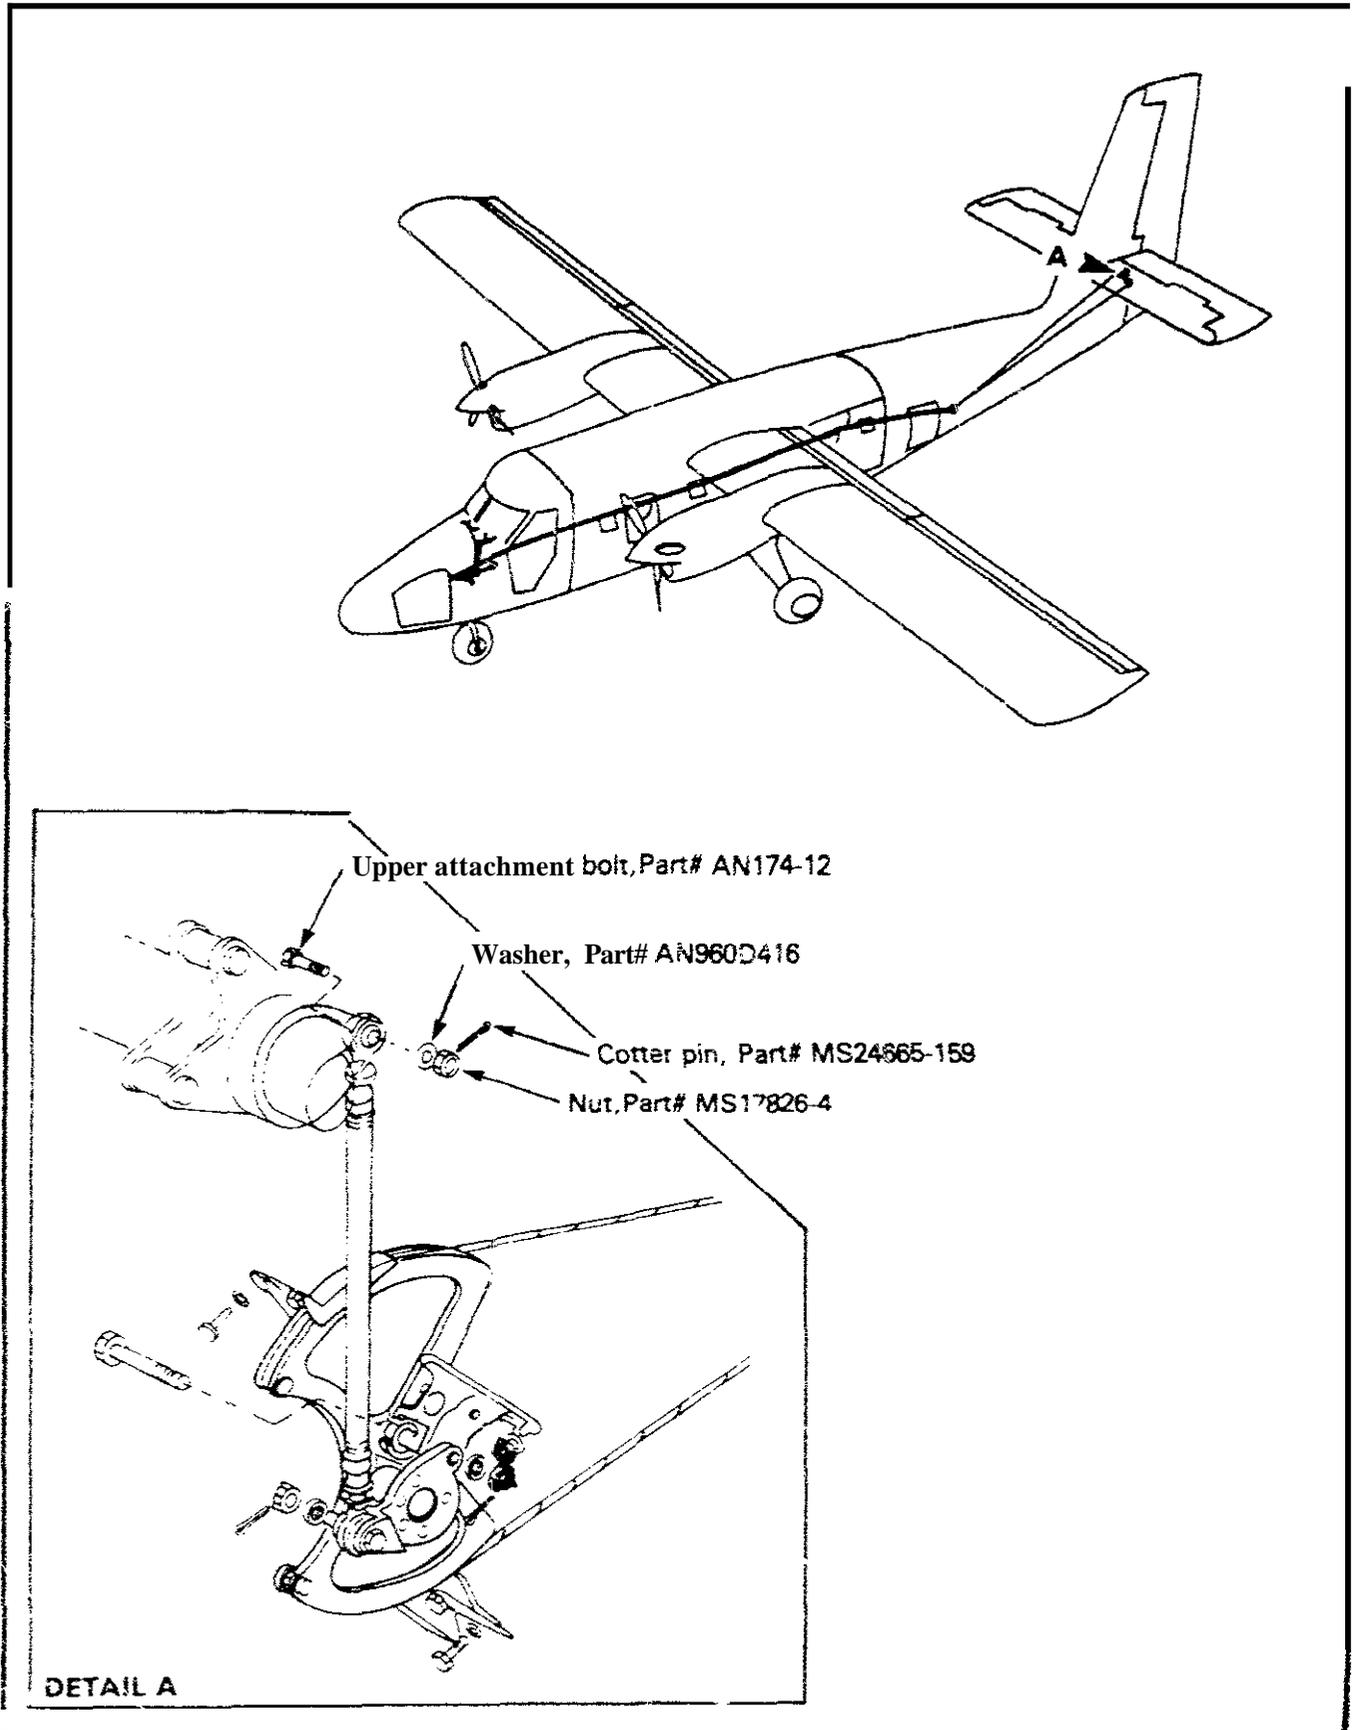
Figure 5.—Elevator control installation, from deHavilland DHC-6-300 PC, Chapter 27-30-00, page 0, figure 1 (descriptions added to the illustration for clarity).

with the bolt heads facing the right side of the airplane (opposite that shown in figure 5). Examination of the available maintenance records for the two airplanes disclosed no record of the reinstallation of the flight controls after the airplanes were painted. Sierra Pacific later found the records relating to these two airplanes and provided copies to the Safety Board on August 11, 1983.

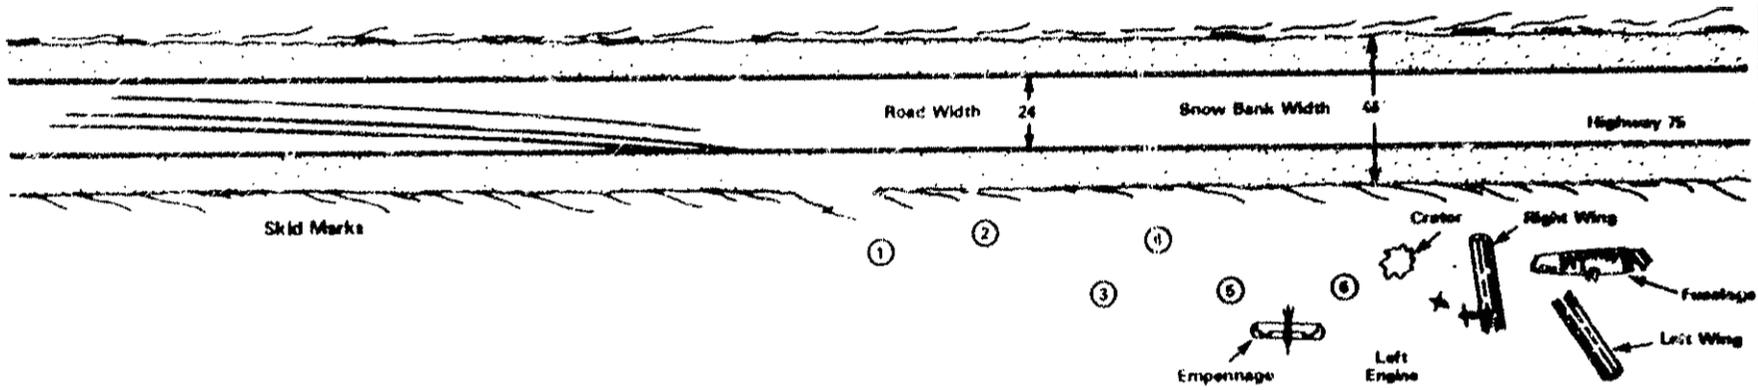
WRECKAGE DISTRIBUTION CHART

- 1. Piece of Radar Dome
- 2. Captain's Door
- 3. Piece of Nose Cone & Radar Hack
- 4. Nose Gear & Crew Step
- 5. Nose Baggage Door
- 6. Baggage Pod
