NATIONAL TRANSPORTATION **SAFETY** BOARD

AIRCRAFT ACCIDENT REPORT

ZANTOP INTERNATIONAL AIRLINES, INC., LOCKHEED L-I 88A ELECTRA CHALKHILL, PENNSYLVANIA MAY 30, 1984

NTSB/AAR-85/04

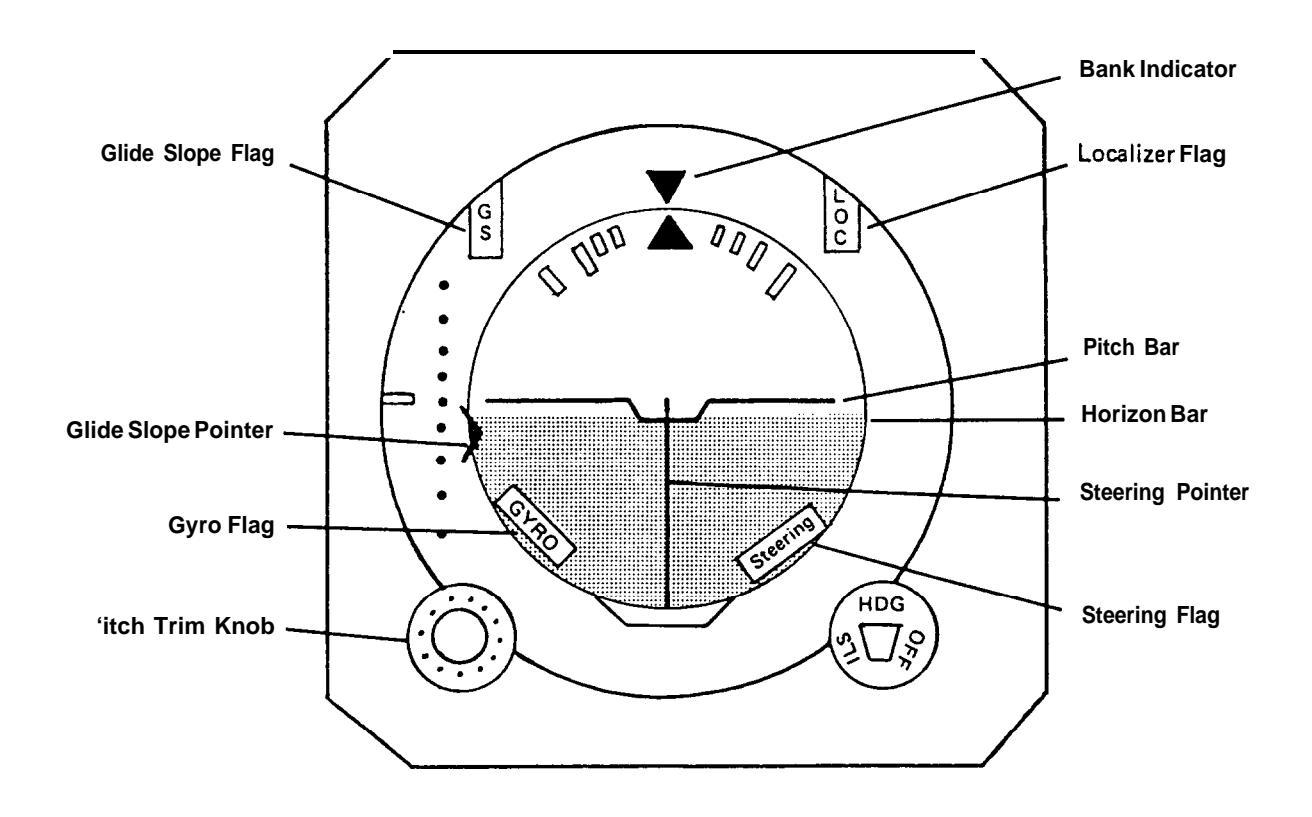
Figure 2.--Approach horizon.

The approach horizon is the primary attitude and steering instrument. (See figure 2.) It shows whether the wings are level or in a bank, and the position of the nose relative to the horizon. The vertical needle, or steering pointer, will point in the direction to which the airplane should be turned. The bank pointer and the horizon bar operate together. The bank pointer indicates the amount of bank in 10°, 20°, 30°, and 45° graduations at the top of the horizon disc. The horizon bar indicates the roll or bank attitude in a forward view presentation. The horizon bar is not sensitive to pitch and will always pivot about the center of the instrument. The pitch bar is the miniature airplane viewed from behind. It moves vertically above and below the centerline of the instrument to indicate changes in airplane pitch attitude. The steering pointer extends vertically from the center of the instrument. The pointer is an indication to a pilot of the turn that should be made. For example, a right deflection of the pointer is an indication to make a right turn.

The captain and first officer each had an approach horizon which was the primary display of the airplane's roll and pitch attitudes. The instrument panel-mounted indicators consisted of a pictorial display (a mask which moves in the roll axis and a pitch bar which moves vertically in the pitch axis), a series of mechanical synchros and servo motors to operate the **moveable** display, and instrument lights. The indicator did not contain the gyroscope used for attitude referencing. Two remotely mounted vertical gyroscopes supplied the attitude references for the indicators as well as for the weather radar and autopilot. A vertical gyro assembly consists basically of a precisely controlled electric motor operating as a stable gyroscope, a synchro transmitter which provided reference signals to the attitude indicator (the No. 2 vertical gyro additionally provided reference signals for the autopilot and weather radar system), and associated electronics. An instrument amplifier was used with each attitude indicator to process reference signals from the vertical gyro and the resultant display position signals from the indicator. Each amplifier also provided signals necessary to drive mechanically the attitude indicator display.

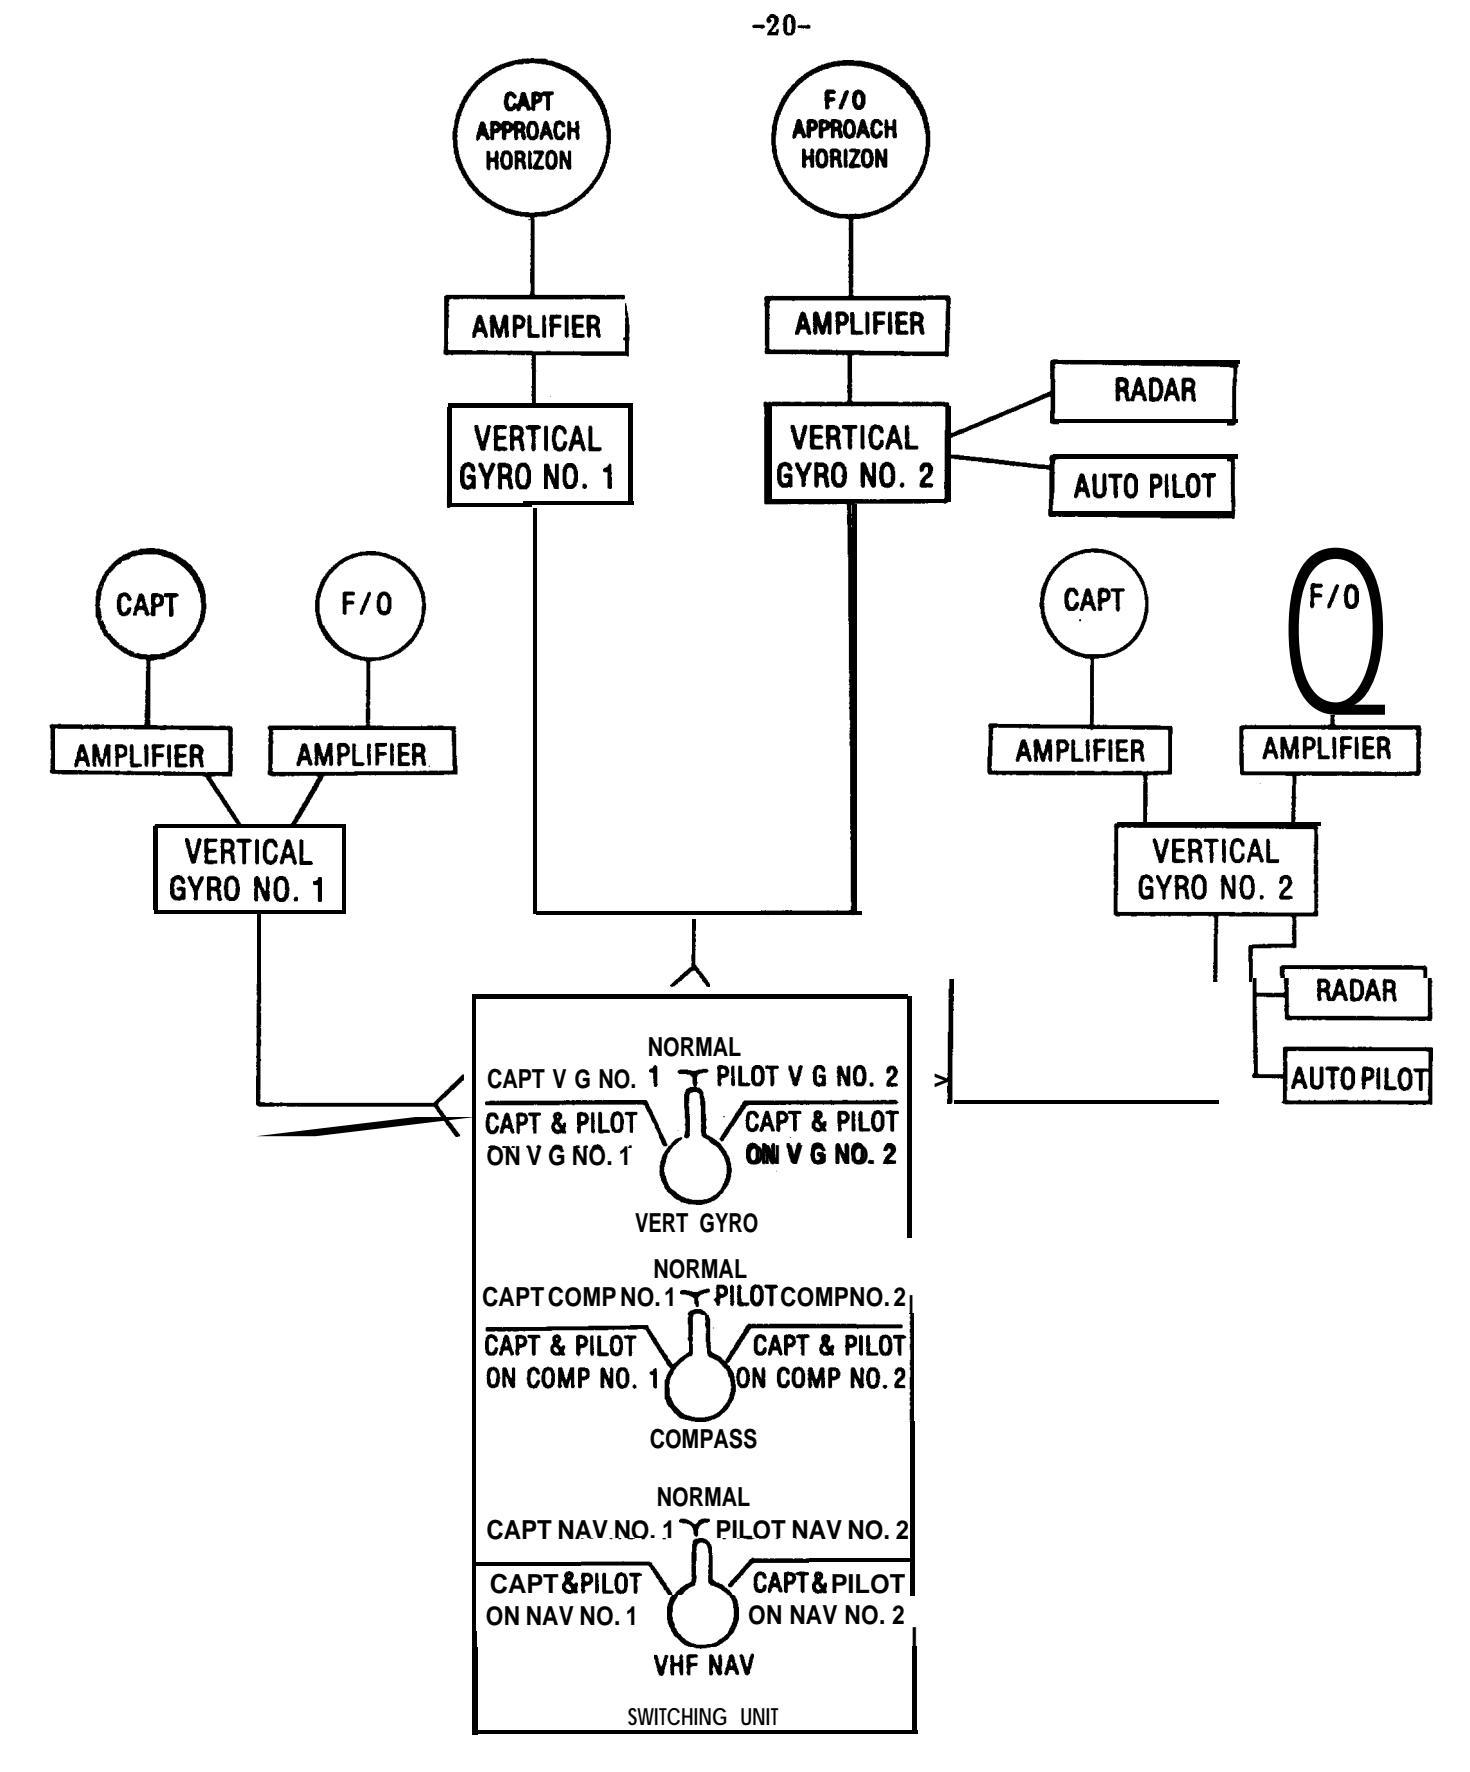
Figure 3. Wilcox Switching Unit

The Wilcox 732A switching unit allowed the flightcrew to select the source of vertical gyro information which drove the approach horizons for the captain and first officer. (See figure 3.) Under normal flight operations, the No. 1 vertical gyro drove the captain's approach horizon and the No. 2 vertical gyro drove the first officer's approach horizon. Additionally, the No. 2 vertical gyro provided stabilization for the airborne radar and the attitude reference signals for the autopilot.
