# **NATIONAL TRANSPORTATION SAFETY BOARD**

## **AIRCRAFT ACCIDENT REPORT**

**COLLISION OF  
AERONAVES DE MEXICO, S.A.  
McDONNELL DOUGLAS DC-9-32, XA-JED  
AND PIPER PA-28-181, N4891F  
CERRITOS, CALIFORNIA  
AUGUST 31, 1986**

**NTSB/AAR-87/07**

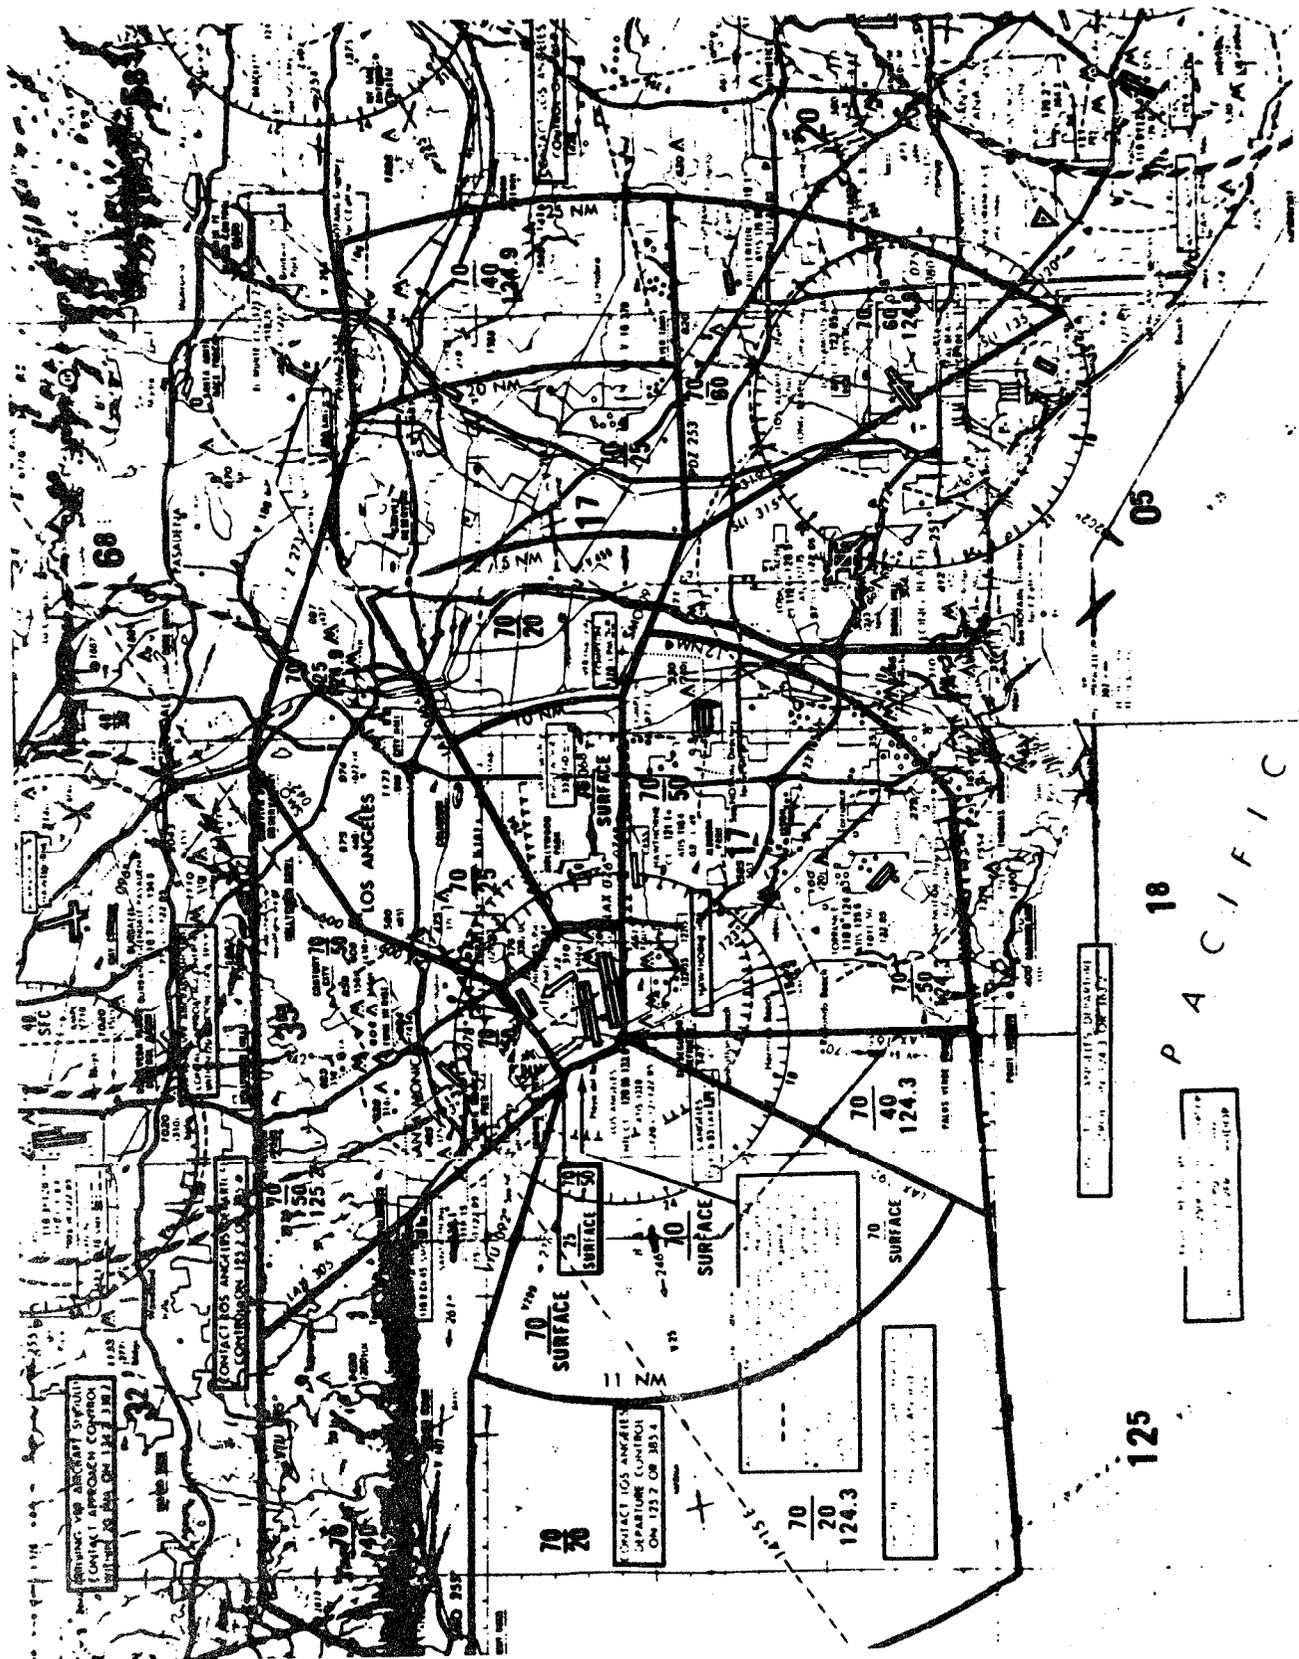
Figure-1.--Los Angeles Terminal Control Area (TCA).

**L.A.** International is located near the center of its TCA. Except for a triangular segment in the vicinity of Long Reach, California, the apex of which extends northward from its southern boundary, the TCA is essentially a parallelogram. Its western and eastern boundaries are about 20 nmi and 25 nmi, respectively, from the western edge of **L.A.** International. The **TCA's** northern and southern boundaries are **essentially parallel** to the extended centerlines of **L.A.** International's four runways and are each about 10 nmi from the center of the airport, respectively. (See figure 1.)

Vertically, the TCA resembles an "upside down" wedding cake, beginning at the surface at **L.A.** International and rising to a ceiling of **7,000** feet. Proceeding westward from the airport and aligned with the extended centerlines of the airport's runways, the floor of the TCA remains at the surface. Between 11 nmi and 20 nmi west of the airport, the floor rises to 2,000 feet. A similar gradient exists along the eastward extensions of the four runway centerlines. To the north and south of the airport and the extended centerlines of the four runways, the floor of the TCA rises sharply. (See figure 1.)

The lateral and vertical dimensions of the Los Angeles TCA are depicted on the Los Angeles VFR Terminal Area Chart. On one side of the chart, the TCA is superimposed on a **Lambert** Conformal Conic Projection map (figure 1); the **chart's overleaf** contains a Charted VFR Flyway Planning Chart of the TCA (figure 2). In addition to depicting the numerous airports in the **Los Angeles** area, the plan view also depicts prominent landmarks within and adjacent to the TCA. For example, the planning chart shows that Disneyland and the Anaheim Stadium are just east of the **TCA's** eastern boundary. It also depicts and names the freeways located within and around the TCA. Finally, the planning chart depicts the northsouth VFR flyway over **L.A.** International and the altitudes to be flown when using this flyway (figure 2).

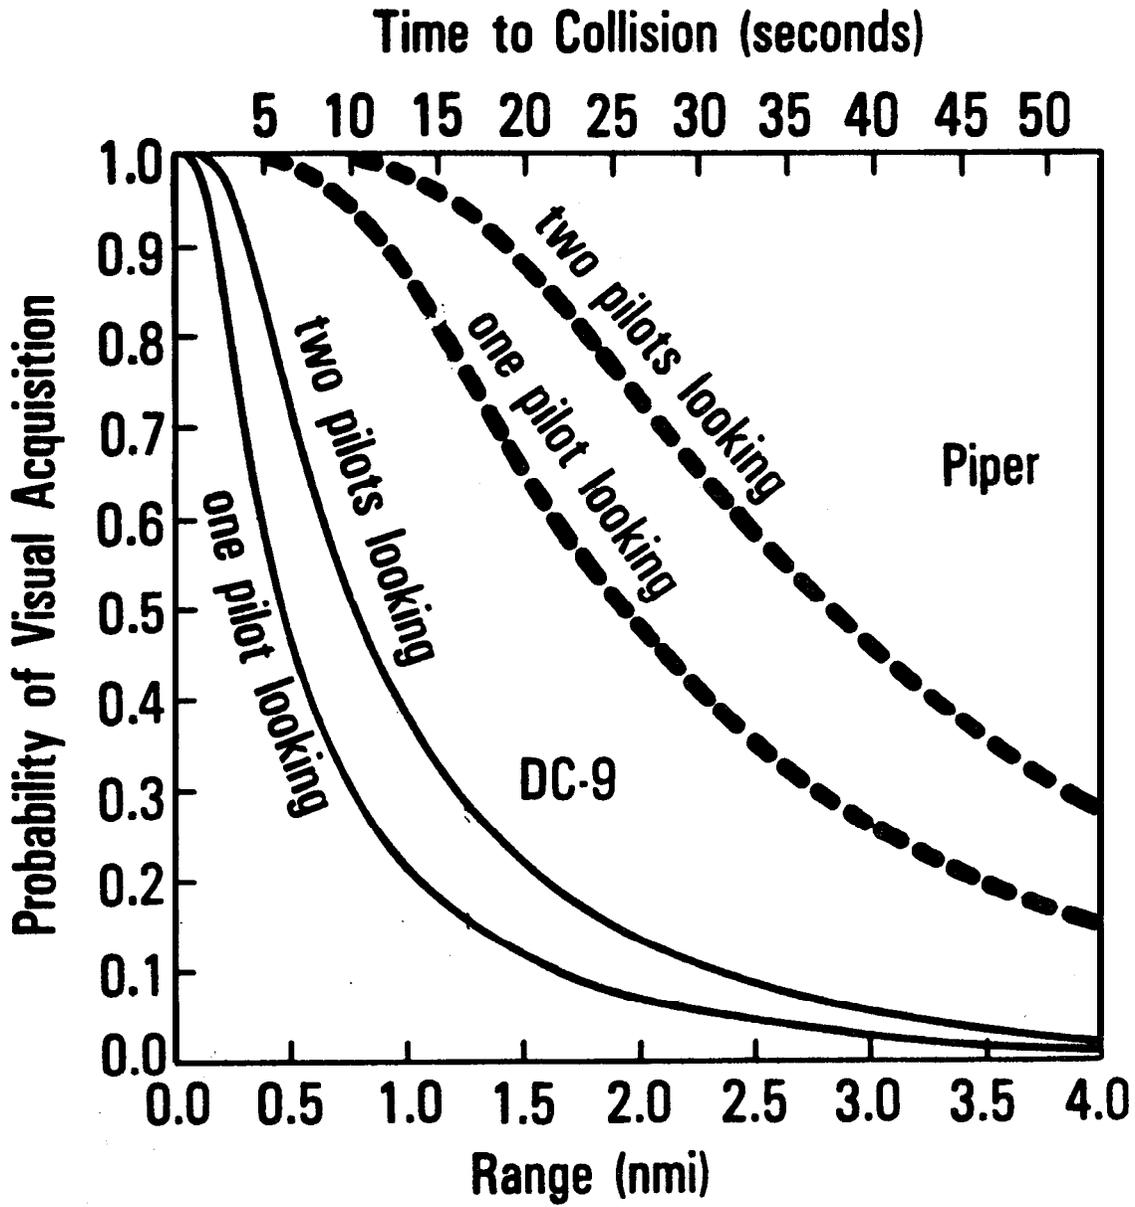
Figure 3.--Probability of seeing the other aircraft as a function of time until collision.

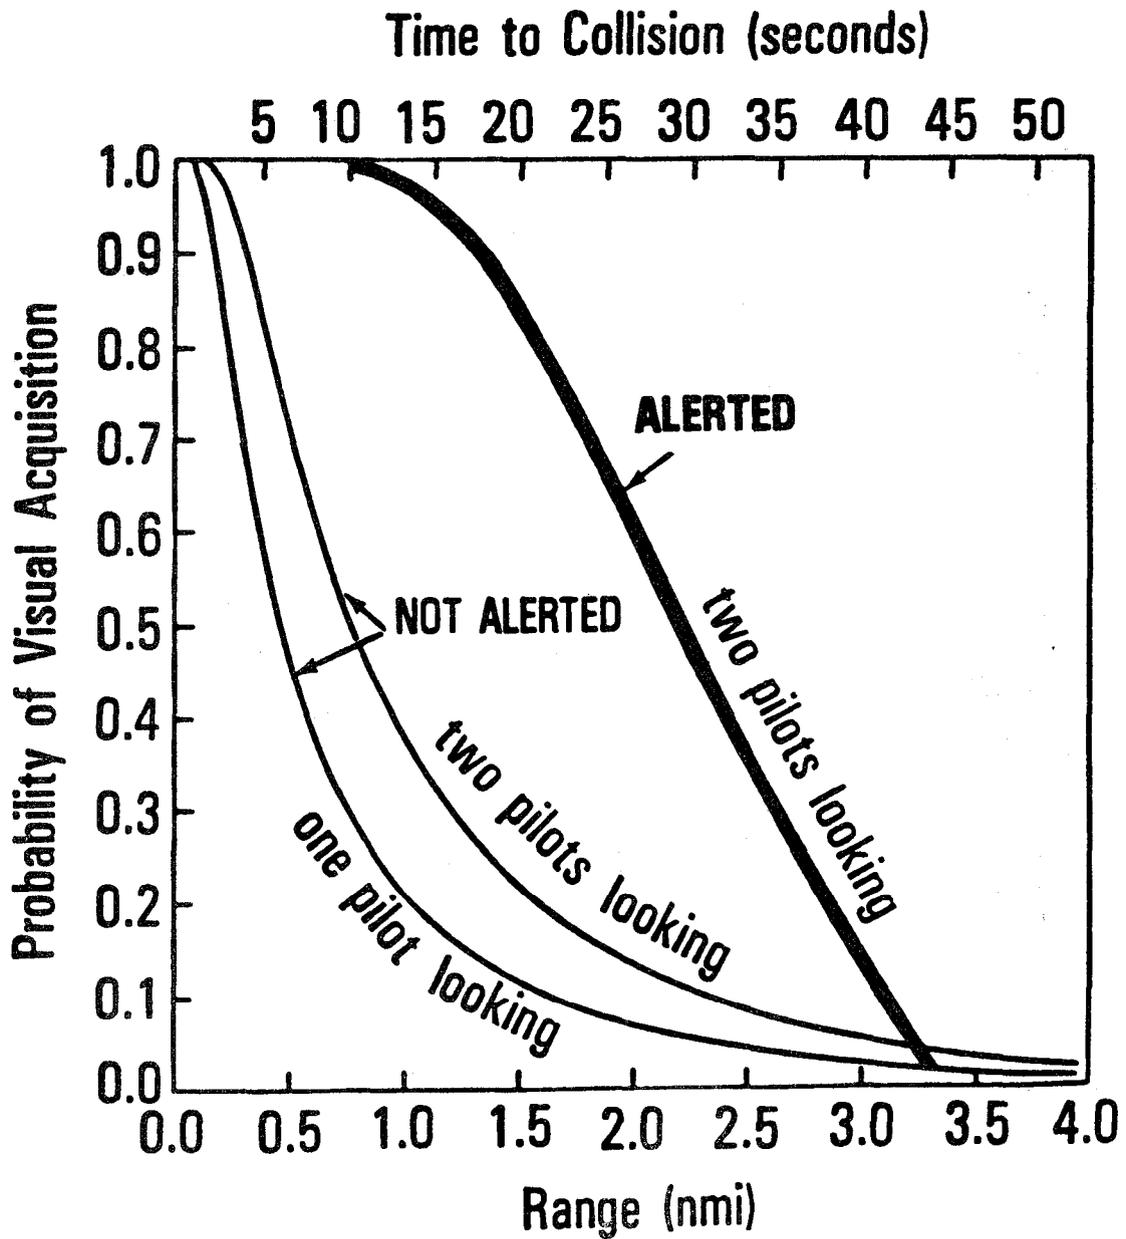
Figure 4.--The effect of TCAS-type alert on the probability that the DC-9 pilot would see the Piper Aircraft.

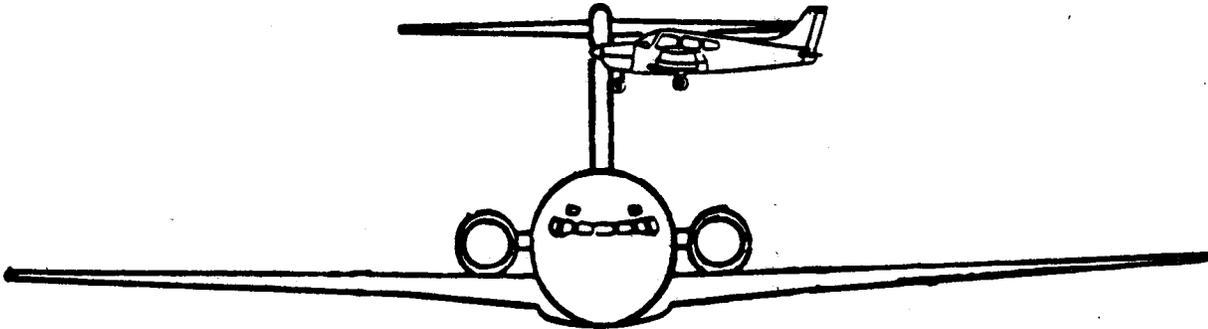
Figure 6.--Collision geometry as viewed from above the DC-9.

**The** damaged areas on the DC-9 vertical and horizontal stabilizers contained propeller slice marks, paint transfer marks Rom the nose wheel area and vertical stabilizer of the Piper, and embedded pieces from the cabin roof area of the Piper. **The** location and angles of these marks and damage on the **DC-9**, when matched to their respective locations on an intact Piper PA-28, showed that the front of the Piper had struck the left side of the DC-9 vertical stabilizer and that the impact angle was perpendicular to the longitudinal axis of each airplane. (See figure 6.) The impact angle was generally consistent with the flight tracks of the airplanes shown on the radar data plots.

Estimated positions of aircraft at impact, based on the propeller damage and scratch marks on the DC-9 Vertical and Horizontal Stabilizers.

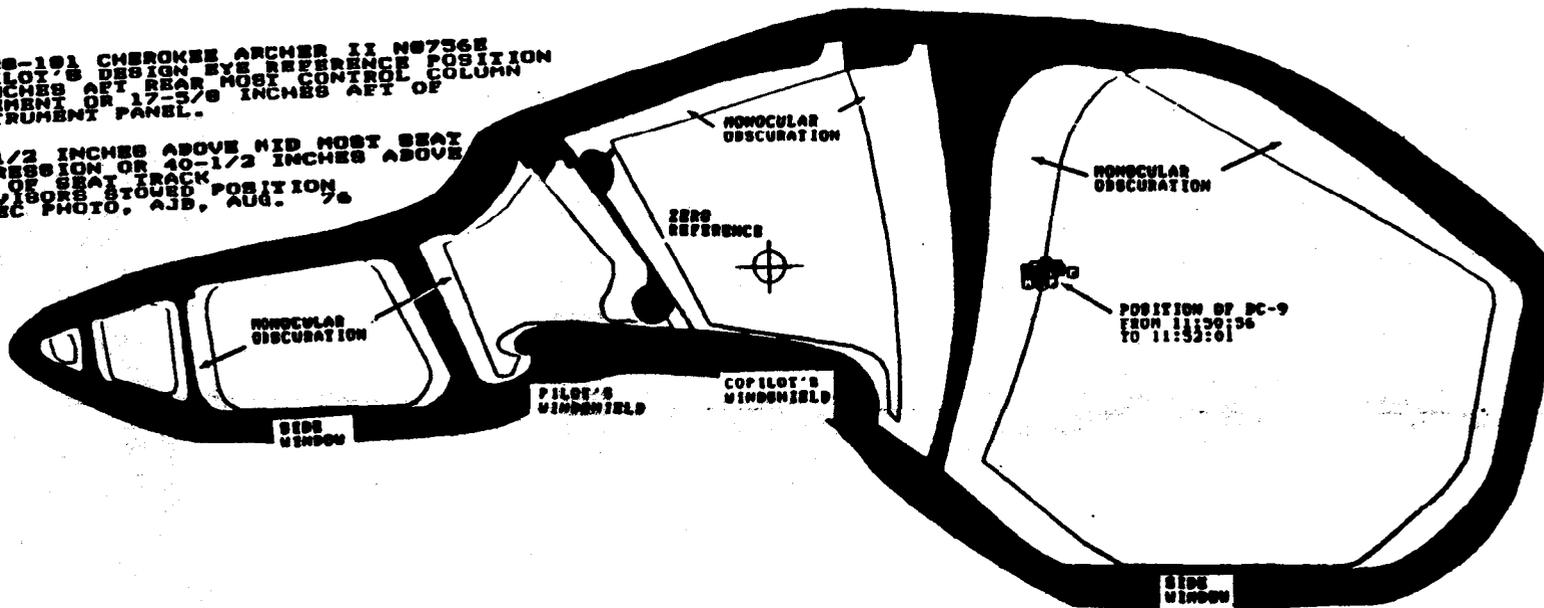
24-28-181 CHEROKEE ARCHES 11 METERS  
PILOT'S POSITION REFERENCE POSITION  
5 INCHES OR 17-5/8 INCHES ABOVE  
INSTRUMENT PANEL.

20-1/2 INCHES ABOVE MID MOST SEAT  
POSITION OR 40 1/2 INCHES ABOVE  
TOP OF SEAT TO BACK POSITION  
RANGE PHOTO. AFB. AUG. 1976
