NATIONAL TRANSPORTATION SAFETY BOARD

AIRCRAFT ACCIDENT REPORT

PIEDMONT AIRLINES FLIGHT 467

BOEING 737-222, N752N

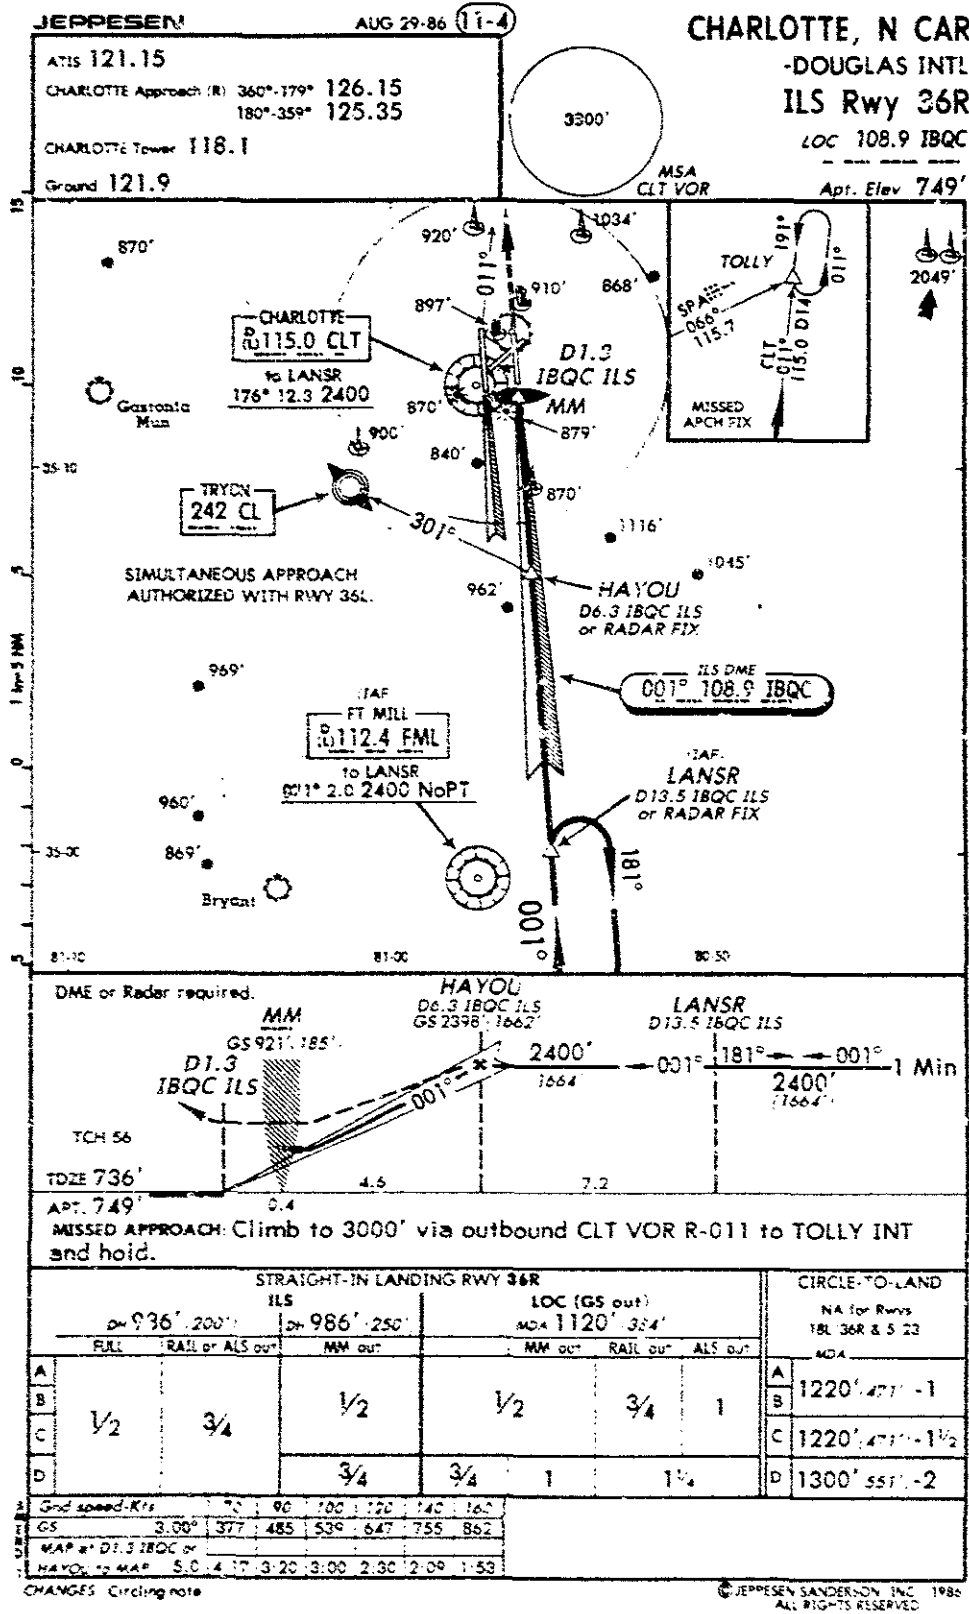
Figure 1.--ILS Approach to runway 36R--Charlotte Douglas International Airport.
 (Reprinted by permission of Jeppesen-Sanderson, Inc.
 Not to be used for navigation.)

Runway 36R at CLT is served by an ILS system. (See figure 1.) All navigation aids used in the ILS approach, except for the localizer, were found to be operational after the accident. An FAA flight check of the glide slope following the accident indicated that the glide slope was operating within prescribed tolerances. The localizer could not be flight checked since it was destroyed in the accident; however, no problems with the localizer were reported by the flightcrews who landed on the runway before PI 467.

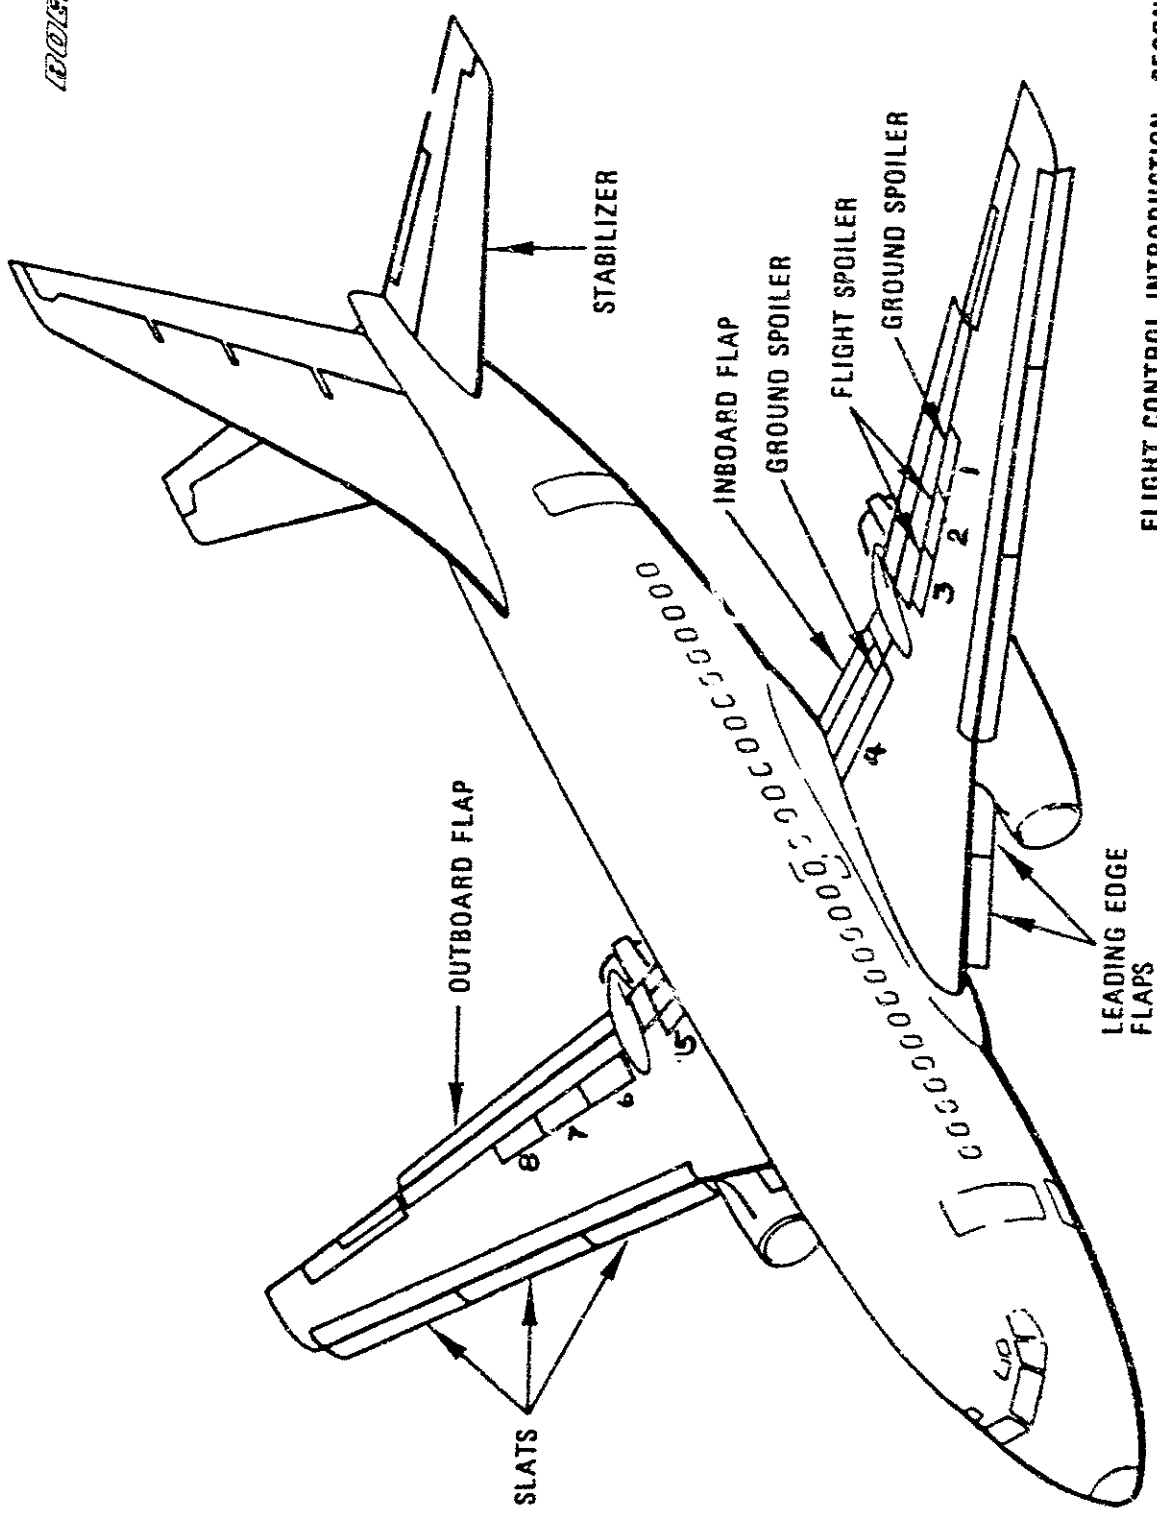
On the Boeing 737, the spoilers are composed of eight spoiler panels, four on each wing. (See figure 4.) The outboard and inboard panels on each wing can only be activated on the ground to a maximum deflection of 40° and 60° up, respectively. The

Figure 4.--Boeing 737-222.
