NTSB-AAR 90/03

NATIONAL TRANSPORTATION SAFETY BOARD

AIRCRAFT ACCIDENT REPORT

USAIR, INC., BOEING 737-400
LAGUARDIA AIRPORT
FLUSHING, NEW YORK
SEPTEMBER 20, 1989

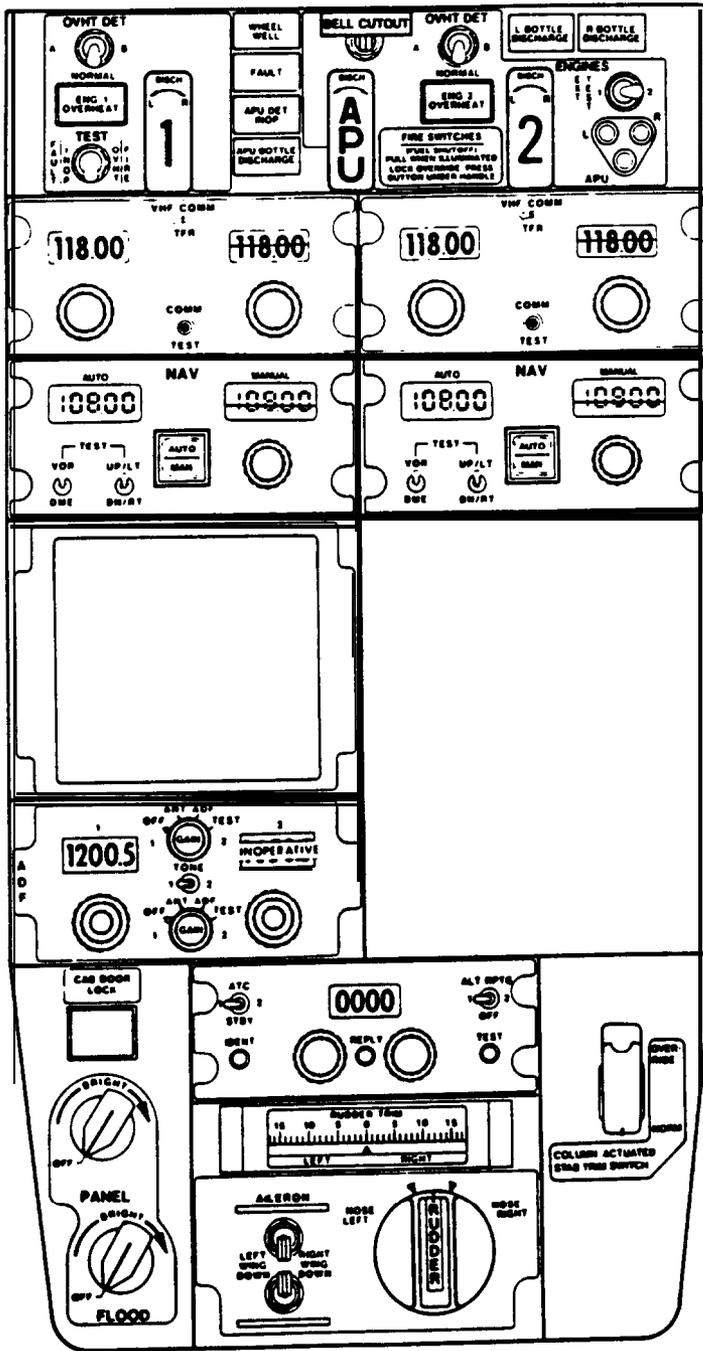
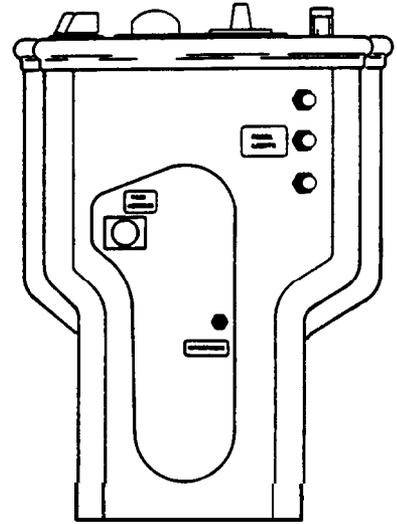
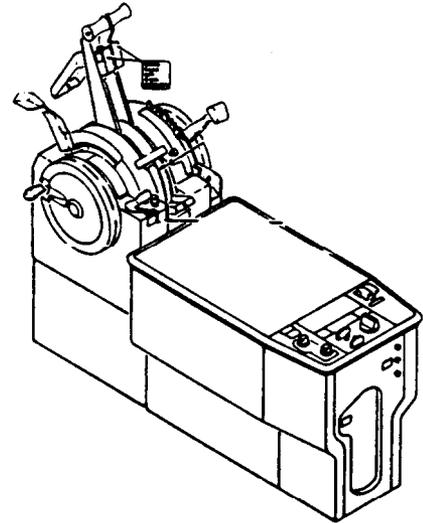
Figure 6. -- The B-737-400 cockpit aisle stand.

Figure 6 shows the B-737-400 rudder trim control knob at the rear of the cockpit center pedestal. The knob is spring-loaded to its center position and electrically activates the rudder trim actuator motor only when held away from center. The motor repositions the neutral point of a hydraulic servo actuator to position the rudder up to 16° either side of center. Regardless of the trim setting the pilots' force on the rudder pedals can still move the rudder to its full deflection of 26° either side of center. A horizontally scaled indicator forward of the control knob shows rudder trim settings to the crew.

Out-of-neutral rudder trim also changes the position of the rudder pedals and the steering angle of the nosewheel when on the ground. For example, full left rudder trim will move the nosewheel 4° left, producing an offset between the rudder pedals of 4 1/4 inches. That is, the left rudder pedal will be displaced about 2 inches forward and the right pedal 2 inches aft, which affects the position of the pilot's feet correspondingly. This trim condition will cause the airplane to turn to the left during taxi or takeoff, and right tiller or pedal force must be used to straighten the ground track.
