AAIS Case Reference: 13/2010

AIR ACCIDENT INVESTIGATION REPORT

**Uncontained Cargo Fire Leading to Loss of Control
Inflight and Uncontrolled Descent Into Terrain**

Boeing 747-44AF
N571UP
Dubai
United Arab Emirates
03 September 2010

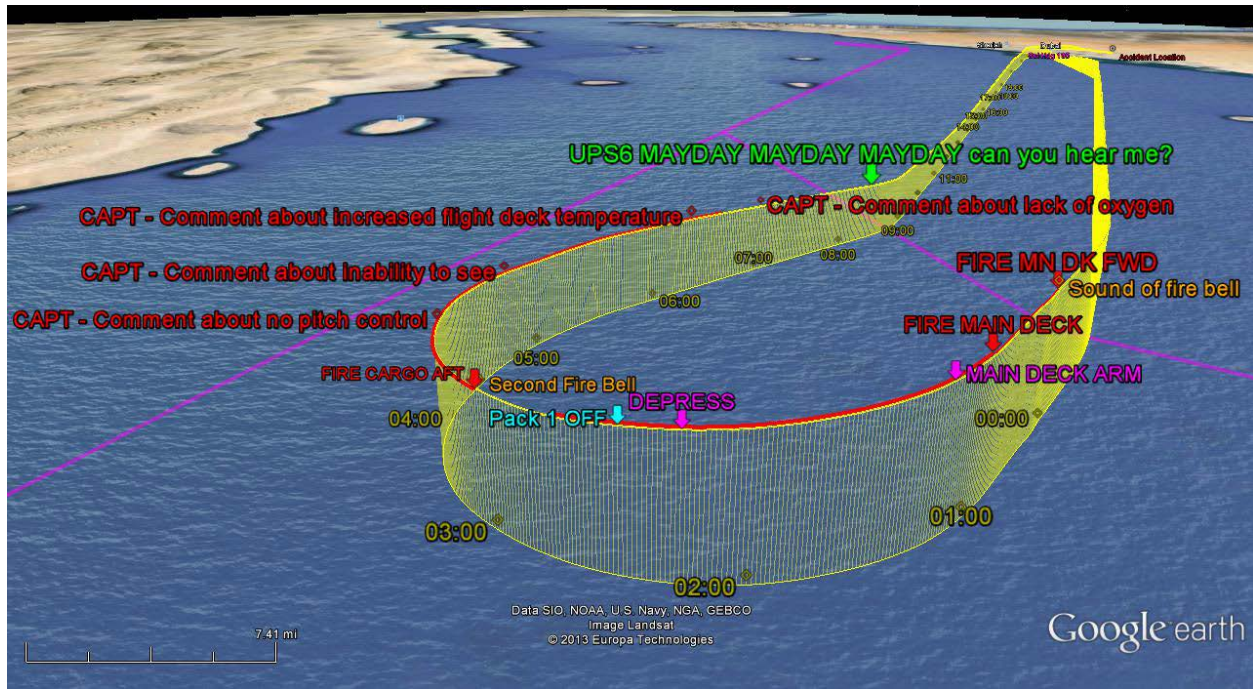
Figure 2 Inflight Turnback Fire Suppression Activation

- 15:14:57|CVR|F.O: Can you hear me?
- 15:14:58|CVR|CAPT: No, I can't hear you.
- 12:15:17|CVR|F.O: Why can't I hear you?

This communication problem appeared to be resolved as the flight progressed.

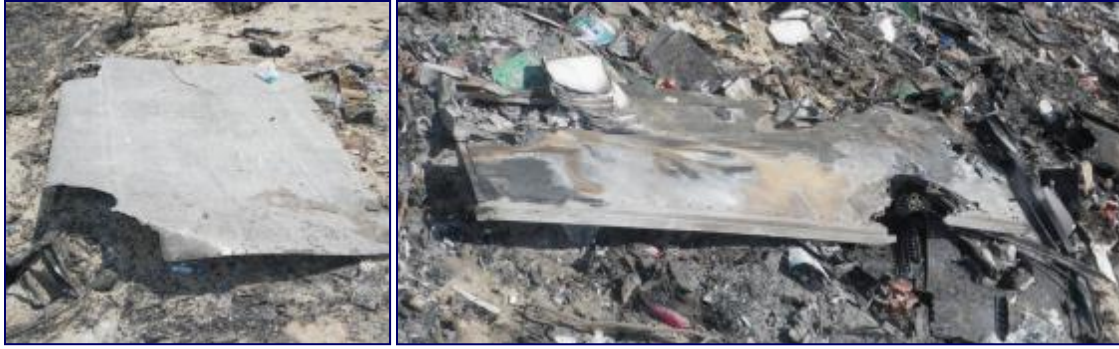
The cargo containers and pallets were all destroyed by the impact forces and post-crash fire. The few recognizable parts of the containers and pallets were base plates and a few doors. All of the pieces identified as being parts of containers and pallets were examined for recognizable in-flight fire damage. Due to the severe post-crash fire damage to these components, no particular in-flight fire characteristics were observed. The contents of the cargo containers were spread throughout the debris field, both inside and outside the post-crash fire zone. Details about the cargo contents, as declared by the shippers and contained within the cargo manifest, can be found in the cargo group's factual report.

Photo 3 Cargo container base plate [LH] and cargo door [RH]

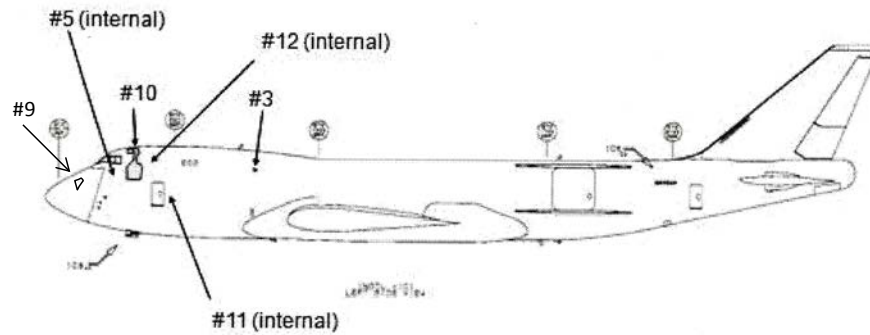
The on-scene wreckage examination focused on items found on the border and outside of the main post crash fire zone. These items were aircraft structure with thermal damage and soot patterns believed to be consistent with damage occurring prior to the aircraft's impact and not artefacts of the post-crash fire. The locations from where these items originated on the aircraft are shown in the following two diagrams of the aircraft's outline. Each of the identified items is numbered on the two diagrams including whether the item was internal aircraft component or external.

Left hand side outline of accident aircraft depicting locations of identified items

Right hand side of accident aircraft depicting locations of identified items

#1: Fuselage observation window	#7: Hinge casting
#2: Cover from power distribution center	#8: Part of nose door (lower)
#3: Fuselage skin	#9: Part of nose door (upper)
#4: Fuselage skin & structure	#10: Portion of structure and fuselage skin
#5: Structure with pulley attached	#11: Stair to flight deck

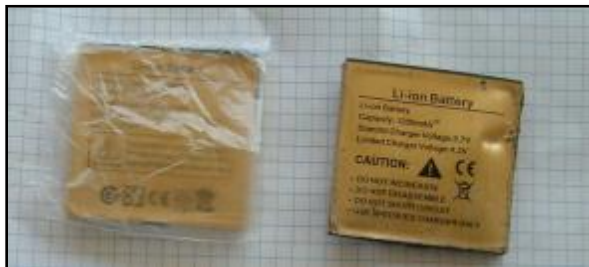
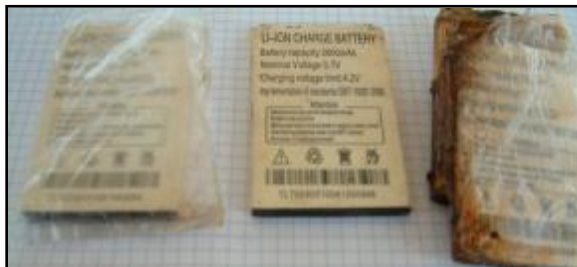
Lithium-ion, mobile phone type battery

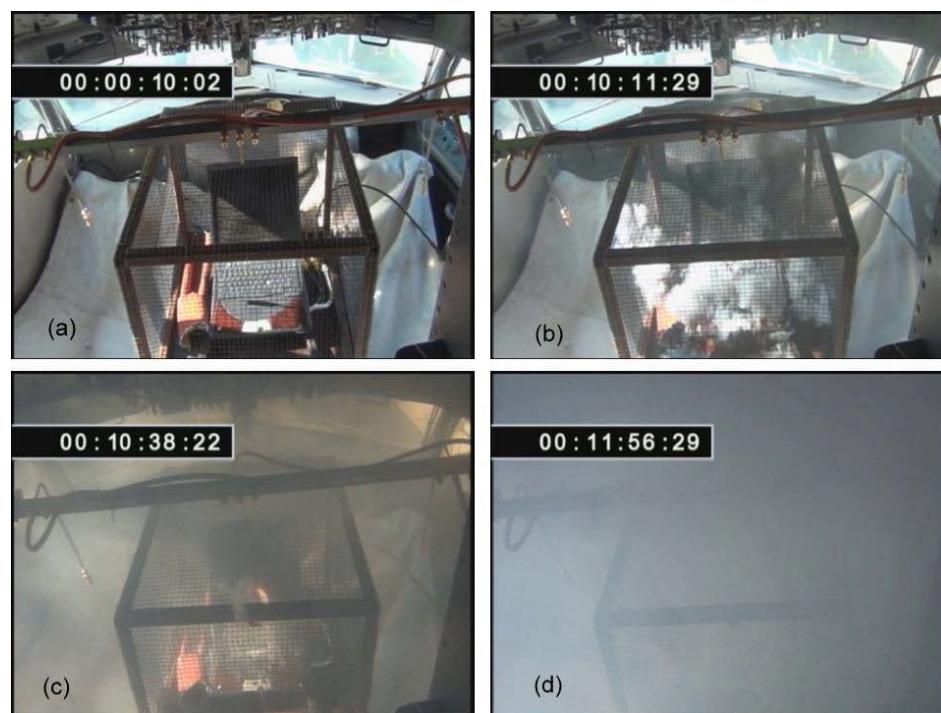
In this accident, the smoke was continuous and of sufficient density and rate of flow to prevent viewing the flight displays, radios panels and the view outside the cockpit.

As an indication of the smoke in the cockpit problem, the pictures below are of an FAA test of an EFB1/Laptop battery fire. The test is a good indication of the lack of visibility encountered when a cockpit is full or filling with smoke.⁵⁹

Picture 5 - Loss of pilot vision - ensuring pilot vision in the presences of continuous smoke.

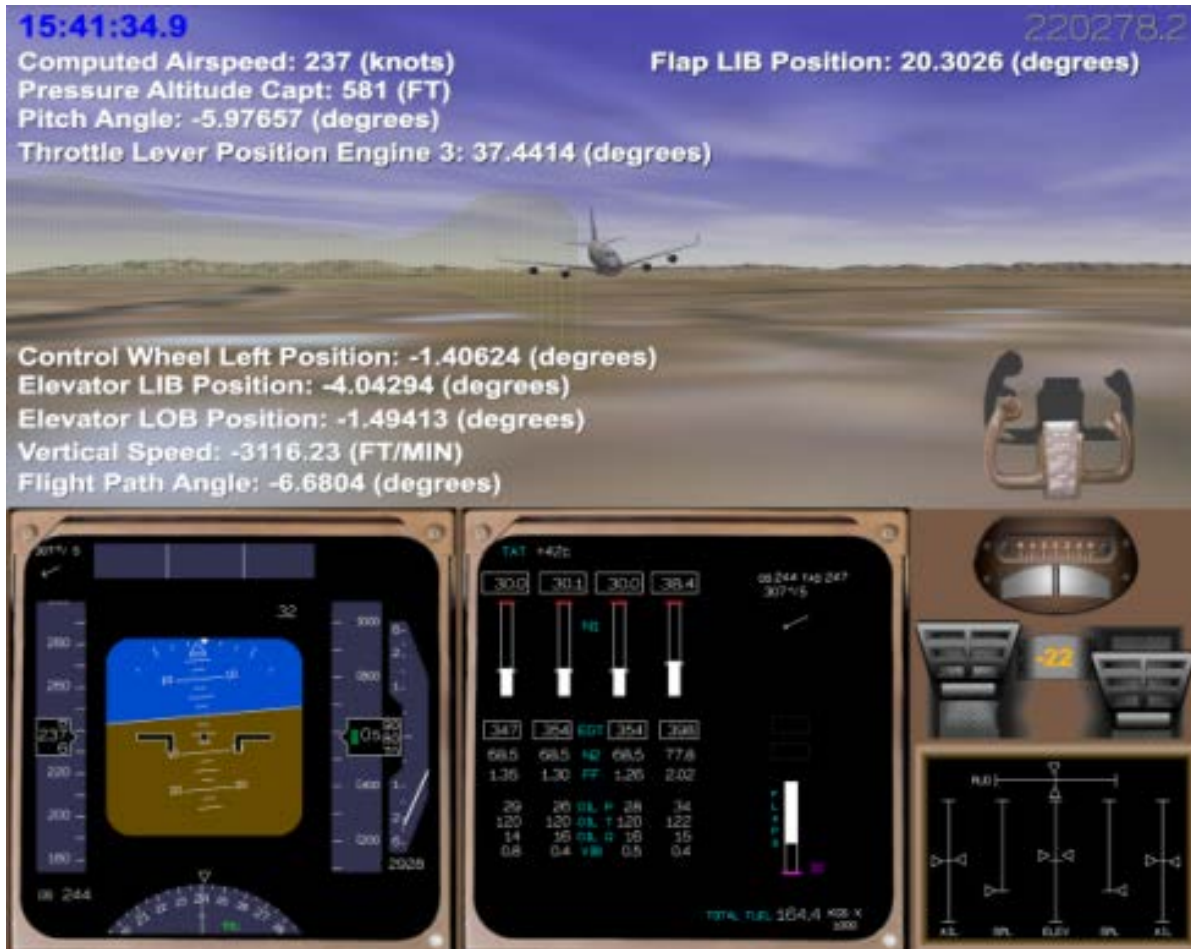
Figure 47 - 15:41:30 UTC - LOC-I/Loss Of Control In Flight/Data Ends

The collision with the terrain is now inevitable.

15:41:34 - LOC- I/UCFIT: Loss of Control In-flight/Uncontrolled Flight into Terrain/Data Ends.

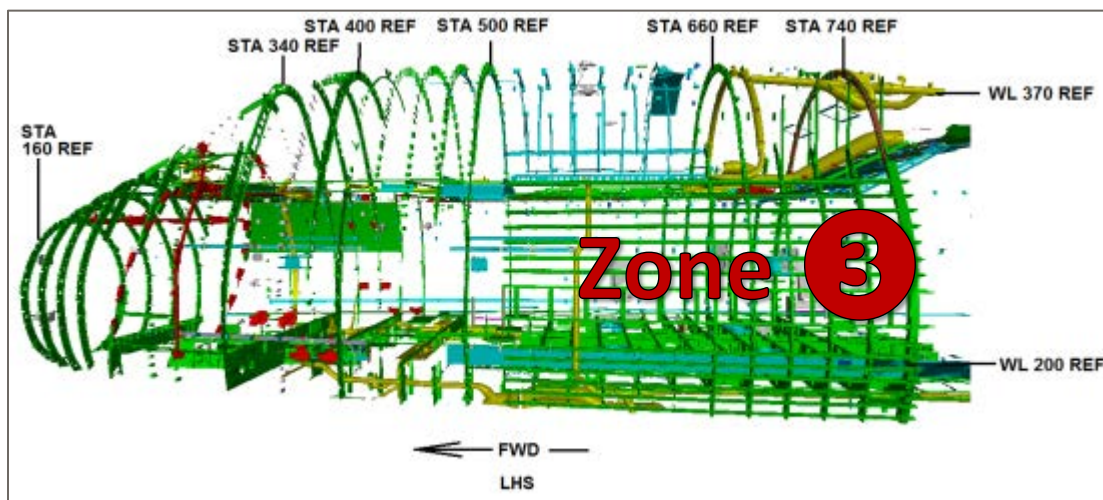
Figure 57- Cutaway Forward Fuselage and Main Deck Cargo Compartment

Conclusion: Based on the ACAR/AHM analysis the cargo fire occurred in Fire Zone 3 at 15:13 UTC

Zone 3 is approximately defined by the volume between STA 580 and STA 700, where the ceiling begins sloping up at the cargo liner transition point. This immediately below the LH and RH truss assemblies supporting the flight control cables

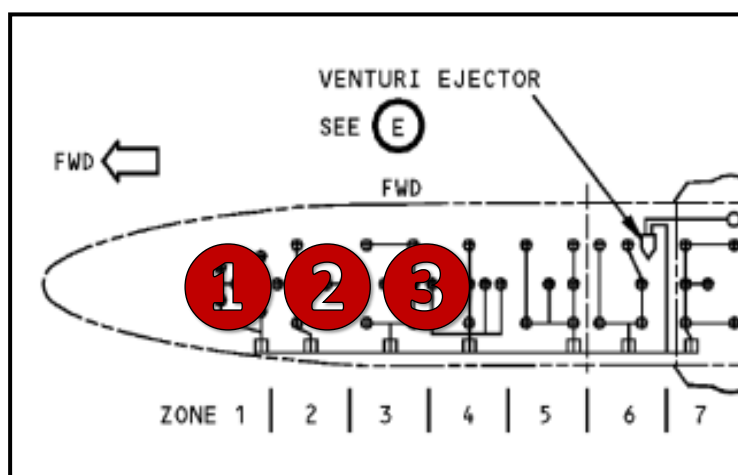
Figure 30 Fire Smoke Detection Zones

Smoke zone 2 encompasses the area occupied by forward portions of the ULDs in positions 4L and 4R, as well as position 3; smoke zone 1 encompasses the area occupied by the ULDs in positions 2 and 1.

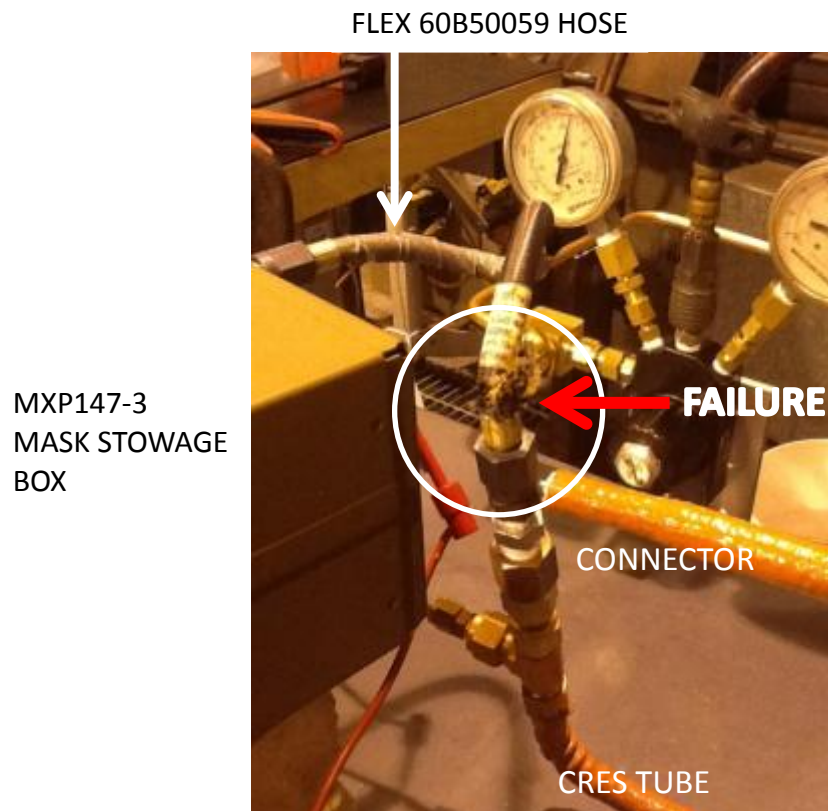
Mask Test #2 Flex Hose 60B50059 hose failure

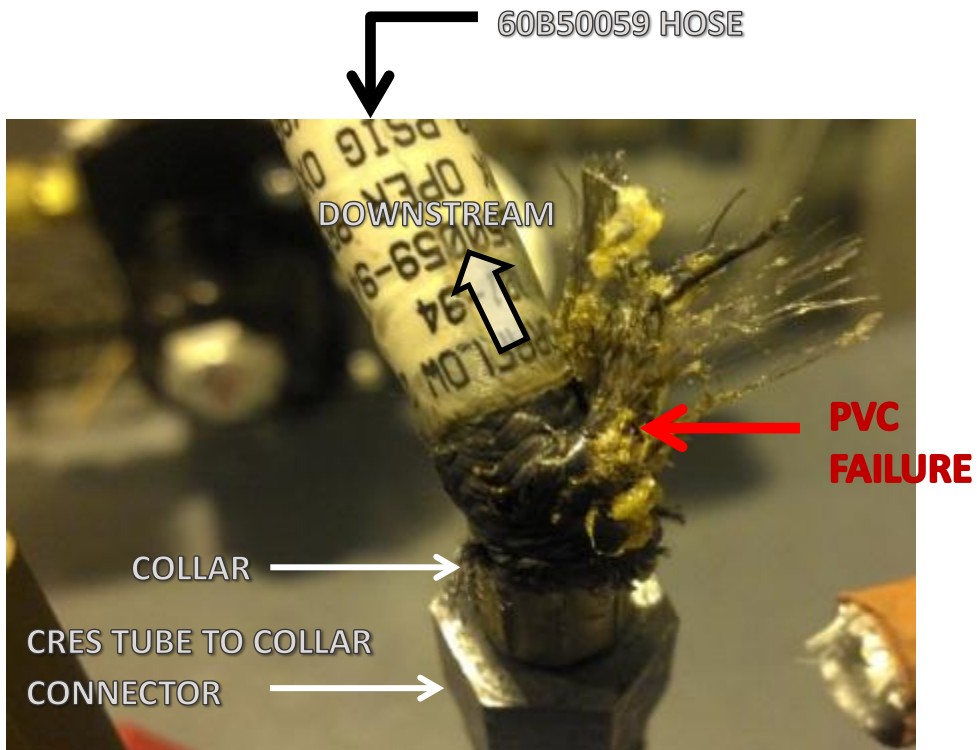
Mask Test #3 Flex Hose 60B50059 hose failure

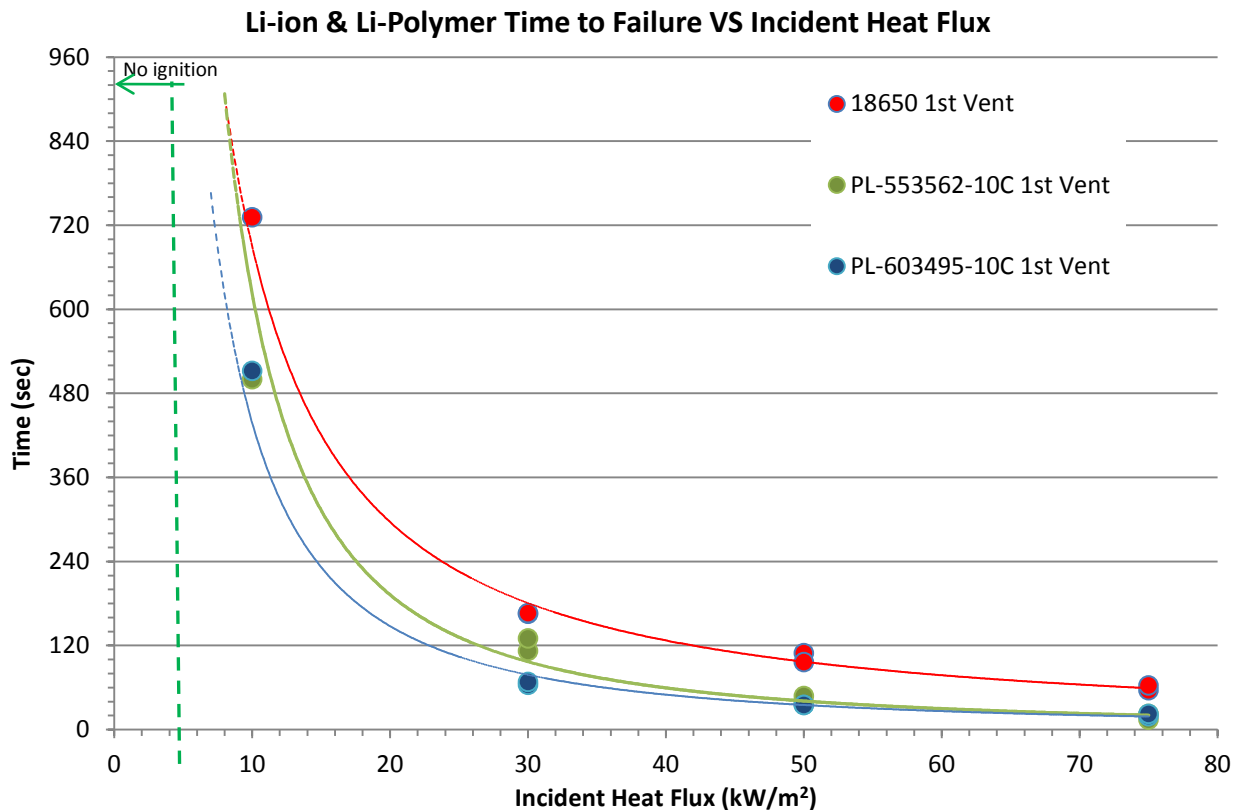
Figure 80: Battery failure time versus incident heat flux

Although the sensitivity to thermal abuse was not the focus of this study, plotting the results of the time to the first vent versus the incident heat flux (figure 6) of each test and fitting the data to exponential curves produces a graph suggesting a critical heat flux (CHF)¹⁸ for lithium-ion battery failure of approximately $5 \frac{kW}{m^2}$ for the types of batteries tested in this study. This number is based on limited data and the tests were terminated after 15 minutes without battery failure. With more tests at heat flux levels around the established CHF and longer test durations, this number could be further refined.

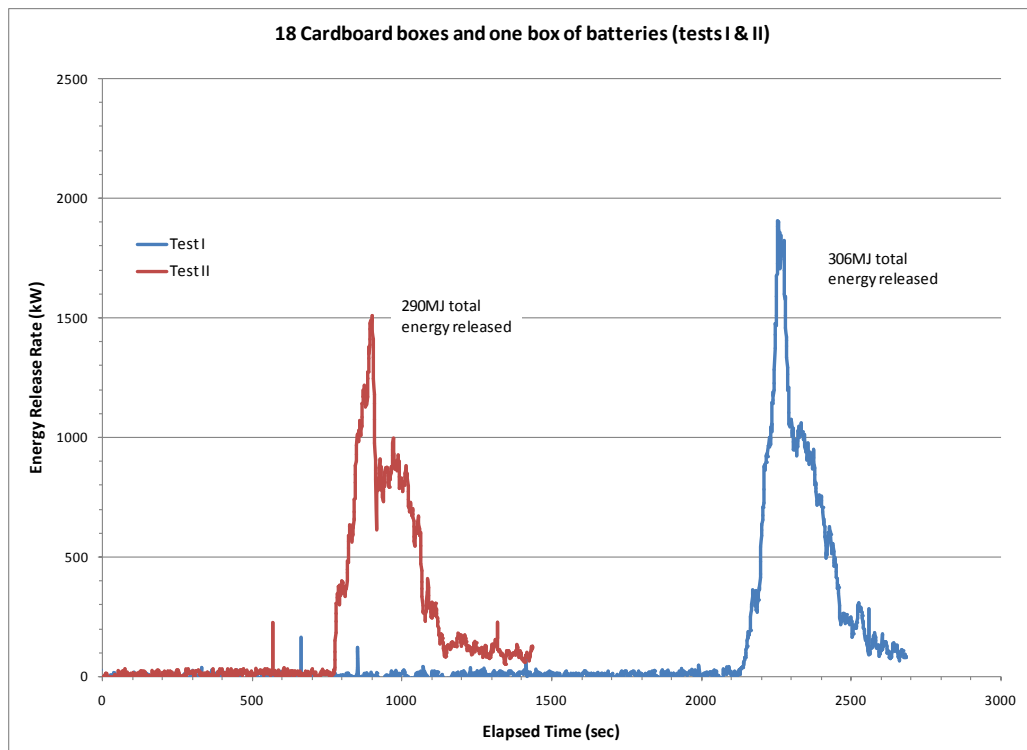
Figure 88: Energy release rate from tests involving cardboard boxes and batteries

The graph of the energy release rates of both of the two tests involving cardboard boxes and batteries is shown in figure 14. On average, the tests involving the cardboard boxes and batteries had a peak energy release rate of 1.7 MW and a total energy of 298 MJ. The tests to which these results are to be compared to involved only cardboard boxes and no batteries. The results of these tests are shown in figure 15. On average, the tests involving just the cardboard boxes had a peak energy release rate of 1.6 MW and a total energy of 288 MJ. The tests involving the batteries did not exhibit any perceptible differences in the overall characteristics of the fires. Peak energy release rates were very similar and well within the variable nature of fire tests. The overall burning time of all the tests was also similar and was approximately 400 seconds. The average total energy of the tests which included the box of batteries was 10 MJ greater than the average of those tests that did not include the box of batteries. That difference is very close to the energy contribution of the box of batteries calculated from the propane burner tests. Temperatures measured in the fire plume of all these tests were also consistent regardless of the presence of batteries and peaked at $1000^{\circ}\text{C} \pm 100^{\circ}\text{C}$. The measured radiant heat flux also did not exhibit any significantly different results for the tests that included the batteries. The test reports from the BATFE containing all the test results for the battery tests with the propane burner and the battery tests with the array of cardboard boxes can be found in appendixes B and C respectively.

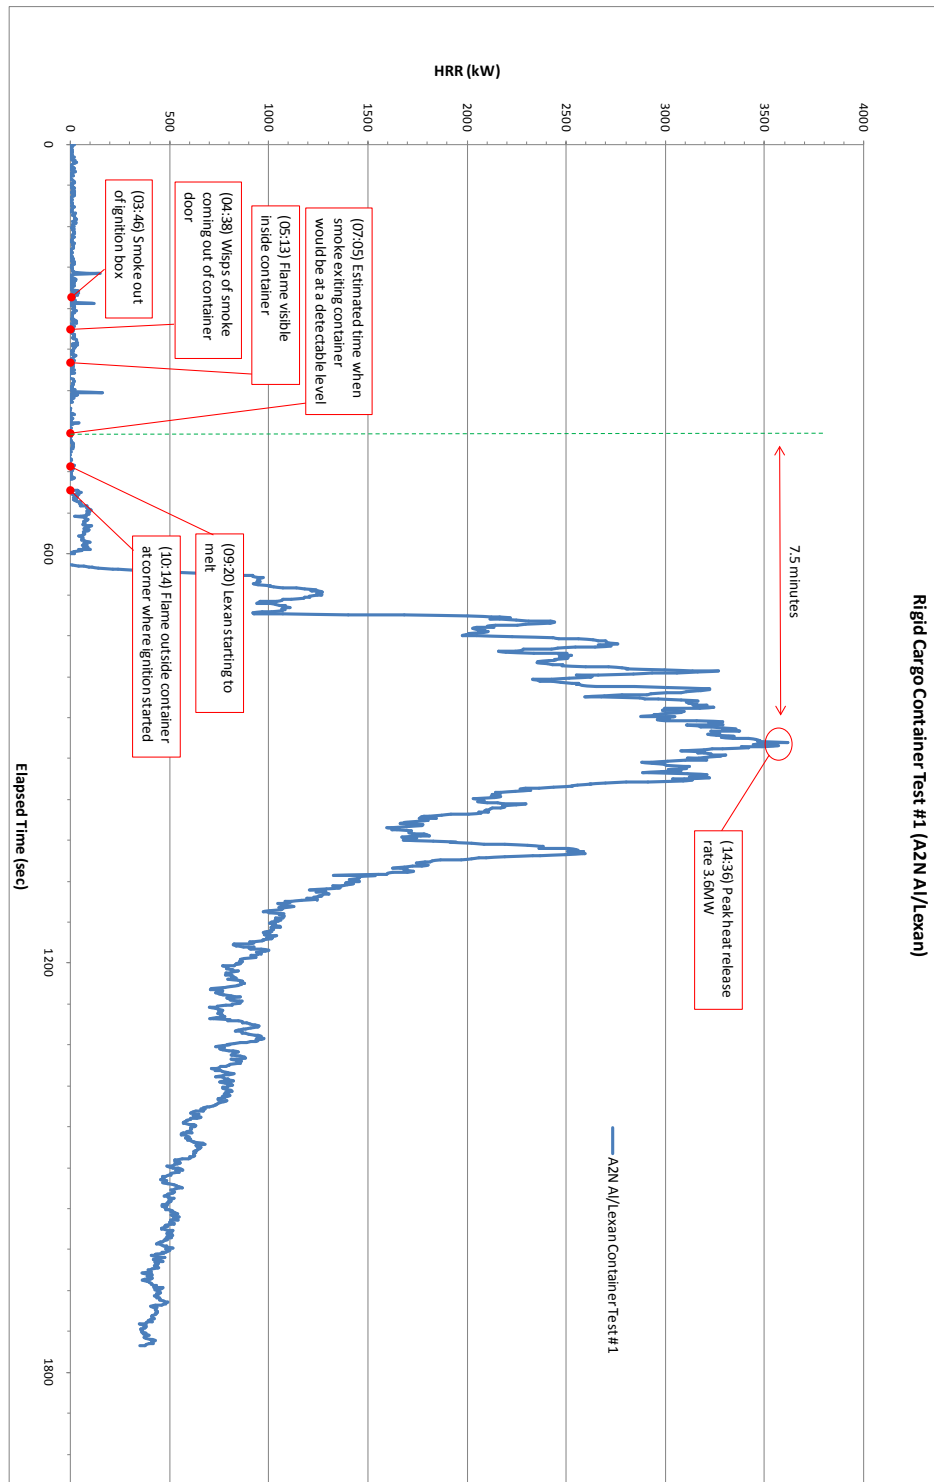
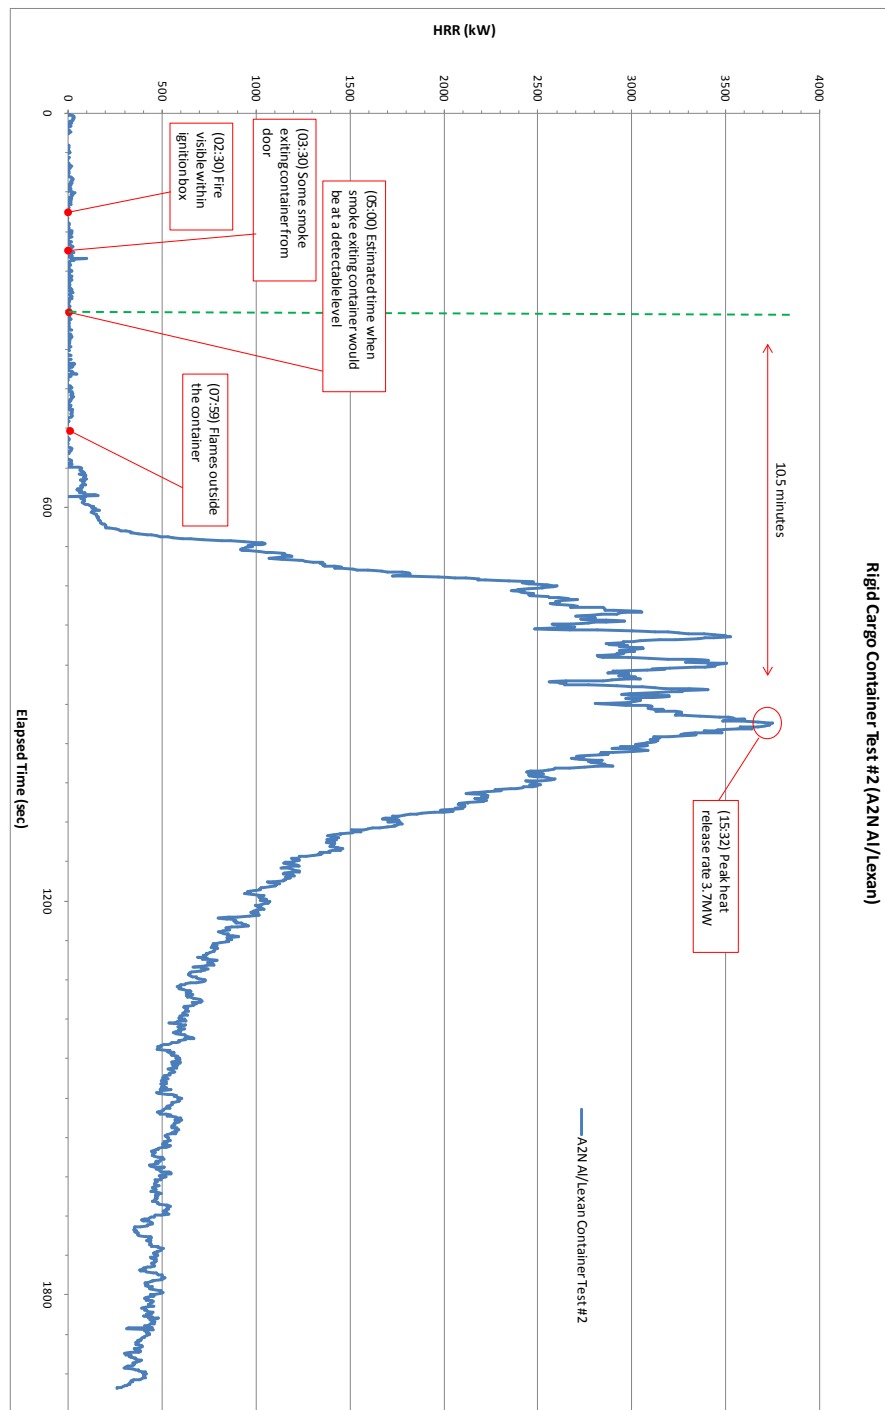
The results from both tests were in good agreement with each other. The peak energy release rates were 3.6 MW and 3.7 MW and the total energy released was 1530 MJ and 1690 MJ for tests 1 and 2, respectively. With regard to the smoke generation and its ability to exit the container, the observations made are noted on the graphs depicting the energy release rate of each test (figures 18 and 19). The first signs of smoke were observed to be exiting from the top portion of the roll-up door as expected. Two noteworthy time intervals are of particular importance. The first is the time between a fire being established inside the container and smoke beginning to exit the container in sufficient quantity to trigger an alarm, 199 seconds and 150 seconds for tests 1 and 2, respectively. The second is the time interval between the fire becoming detectable and the time to reach peak energy release rate, 450 seconds and 630 seconds for tests 1 and 2, respectively.

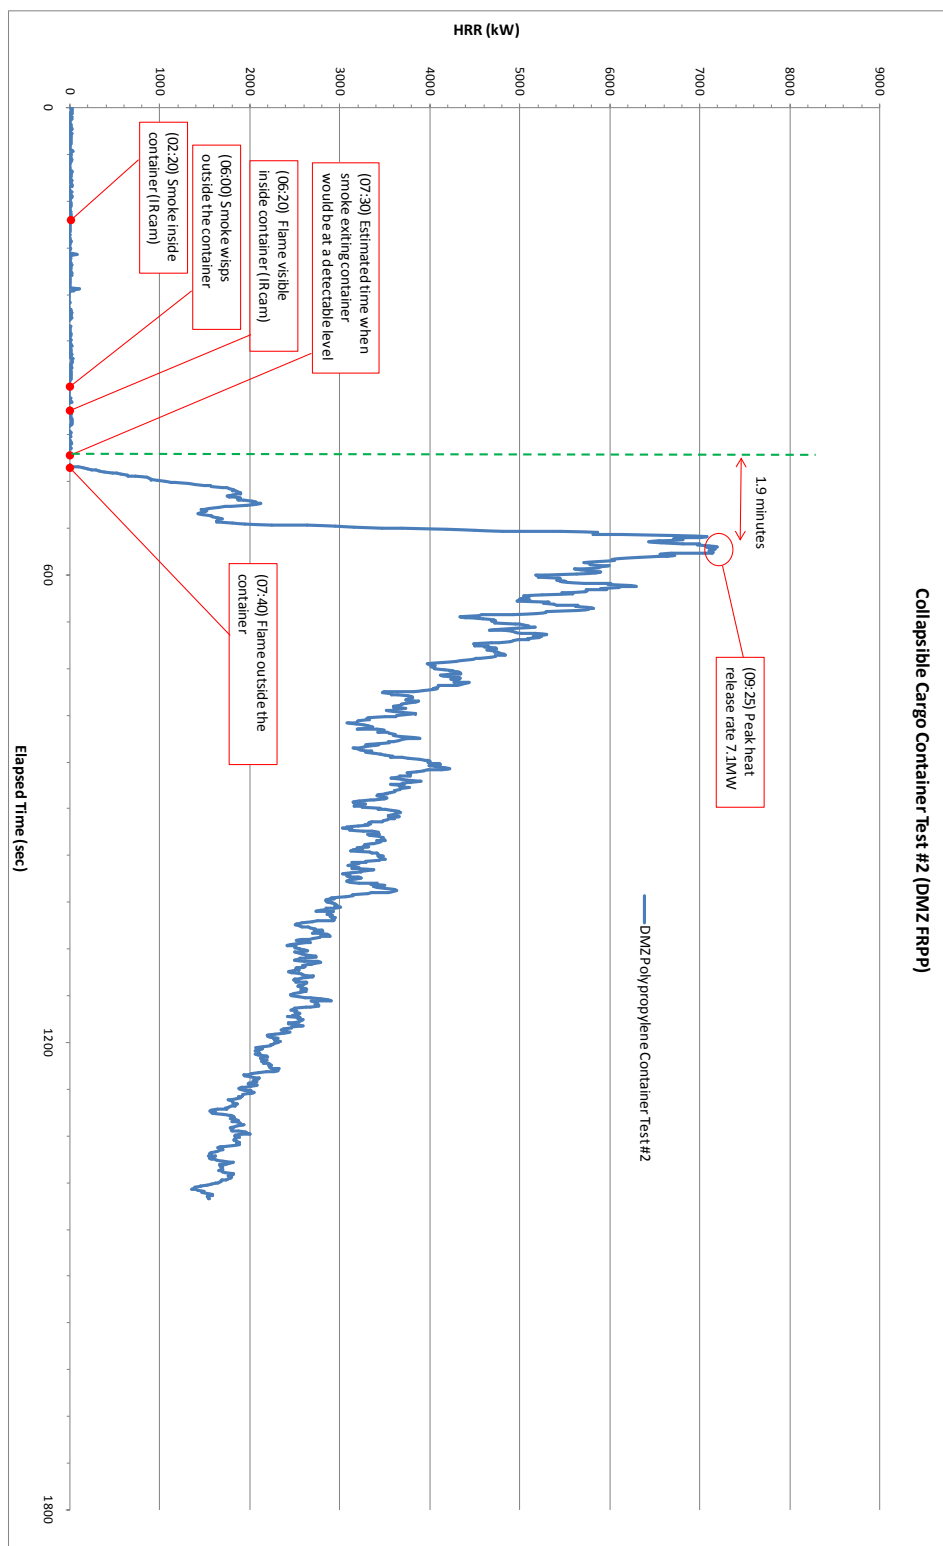
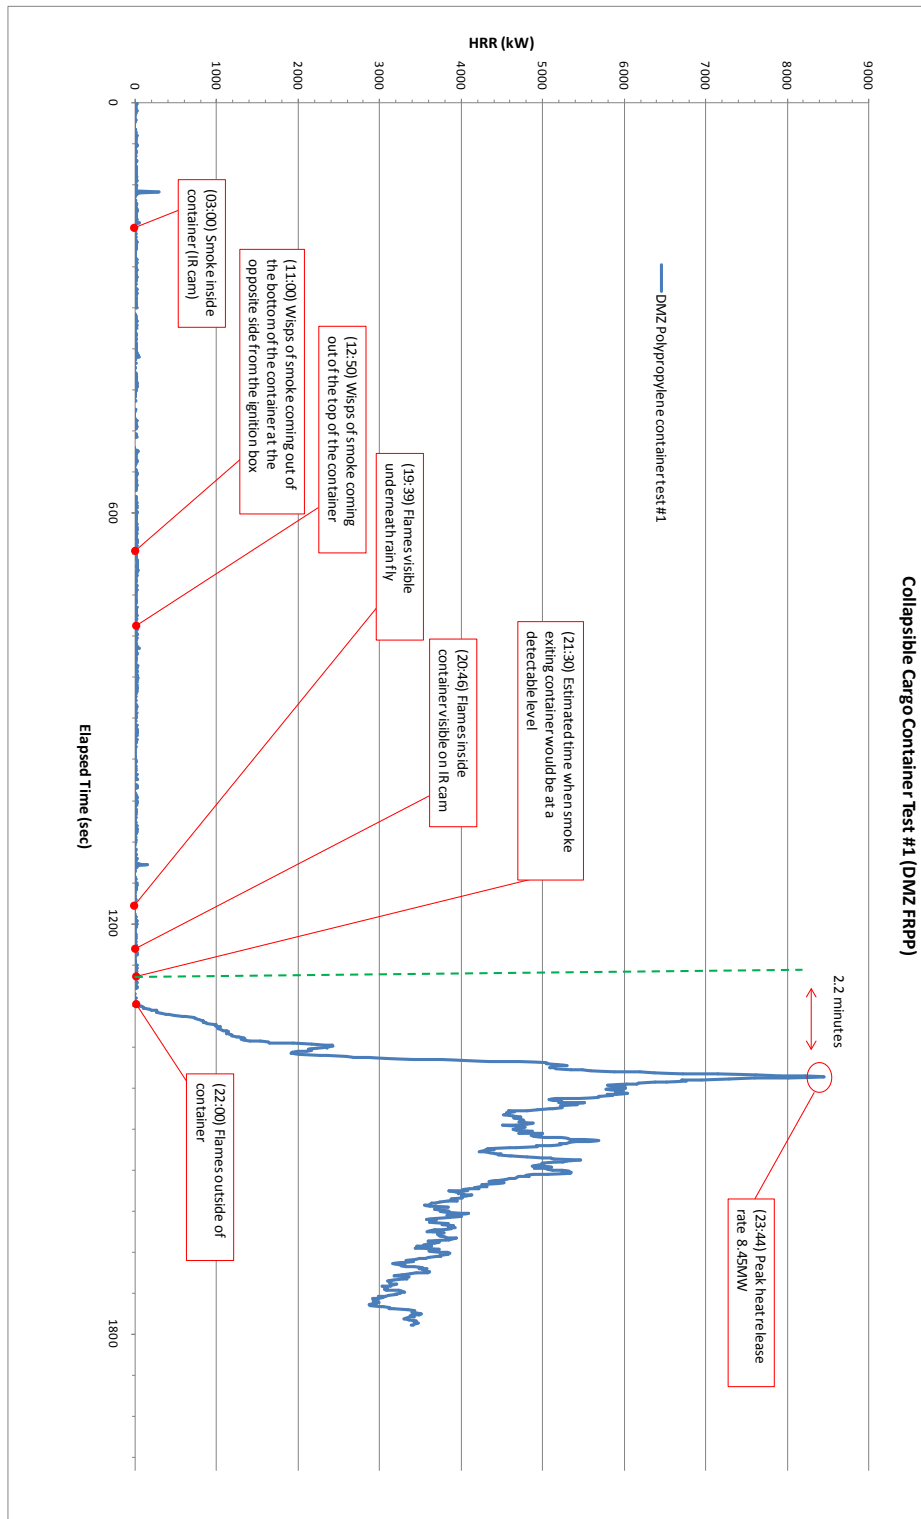
The results from both DMZ container tests were in good agreement with each other; however, in the first test, it took a longer time for the fire to begin to grow within the ignition box. The peak energy release rates were 8.5 MW and 7.2 MW and the total energy released was 1800 MJ and 3000 MJ for tests 1 and 2, respectively. Test 1 had a relatively smaller total energy release because the test was stopped early after the fire went into decline. For the second test, the fire was allowed to burn longer and thus the measured total energy was greater. With regard to the smoke generation and its ability to exit the container, the observations made are noted on the graphs depicting the energy release rate of each test (figures 21 and 22). An infrared camera was used inside the container to monitor the ignition and fire growth. The first signs of smoke were observed to exit the container and the plastic cover at floor level. The smoke exiting at floor level was no longer buoyant and remained at floor level. Two noteworthy time intervals are of particular importance. The first interval is the time between a fire being established inside the container and smoke beginning to exit the container in sufficient quantity to trigger an alarm, 18 min 30 sec and 5 min 10 sec for tests 1 and 2, respectively. The second interval is the time between the fire becoming detectable and the time to reach peak energy release rate, 132 seconds and 114 seconds for tests 1 and 2, respectively.

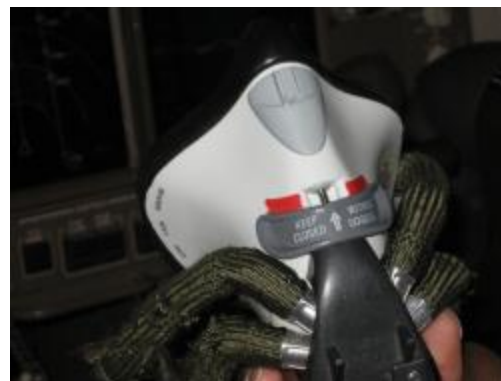
Figure 101: Smoke vent valve selector (closed) Figure 102: Smoke vent valve selector (open)

The pilots involved in the exercise indicated that with the smoke goggles donned, it was difficult to find the switch to clear the goggles of smoke (see figures 9 and 10) and one stated “it was “awkward”.
