*Accident  
on 25 July 2000  
at "La Patte d'Oie"  
in Gonesse (95),  
to the Concorde,  
registered F-BTSC,  
operated by Air France*

**Preliminary report  
translation  
f-sc000725pa**

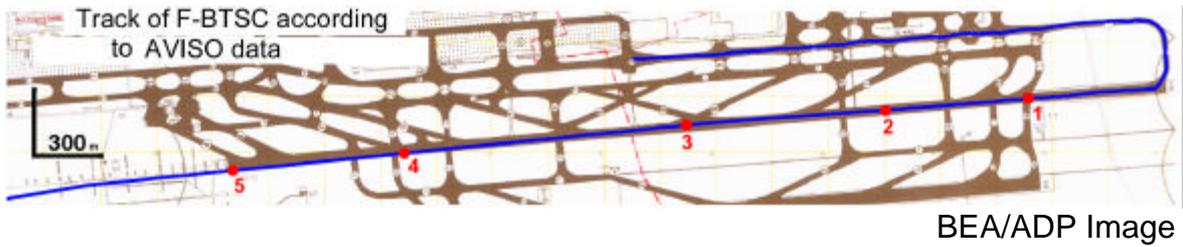
In order to obtain a precise position of the aircraft on the runway, the track was based on data from the AVISO system, the digitising system for the analogue

ground radar.

N.B: the numbers on the track refer to chapter 11.

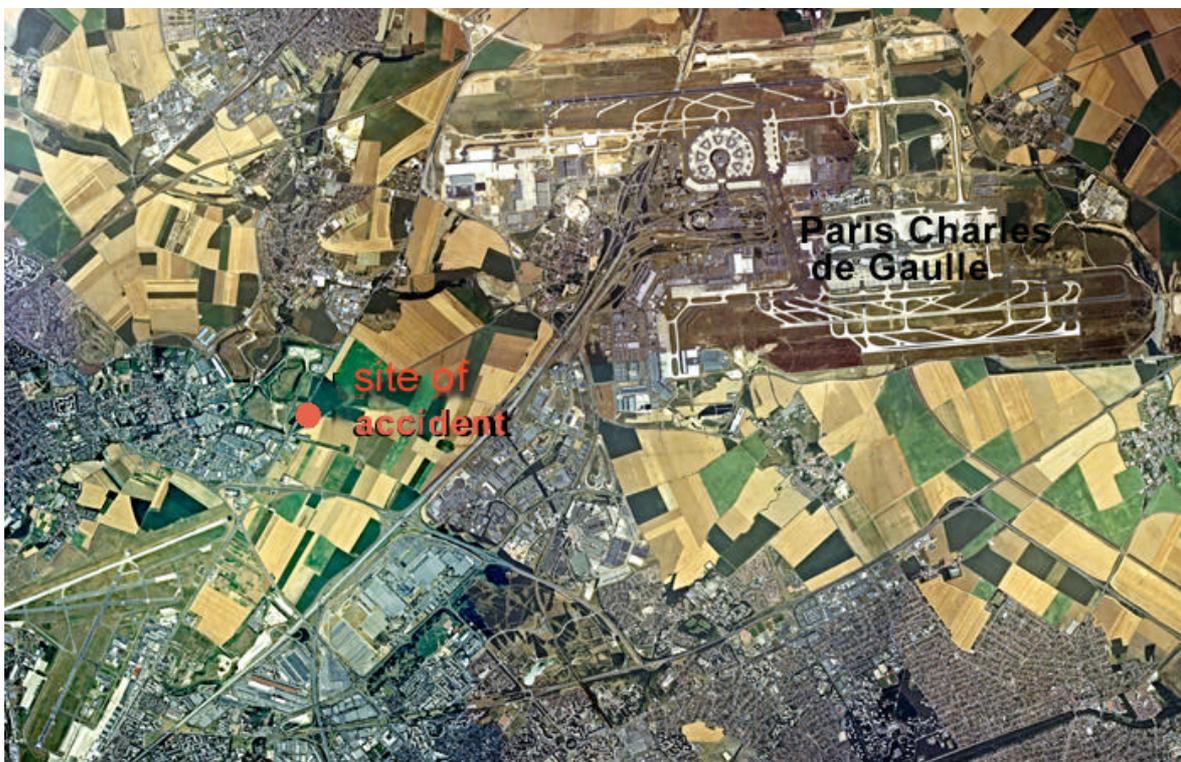
*Aerial photo of the accident area*

The crash occurred south-west of Paris Charles de Gaulle airport at about 9 500 m from the threshold of runway 26R in a level area. The altitude of the area is 400 feet. The wreckage was at the intersection of the N17 and the D902 roads.

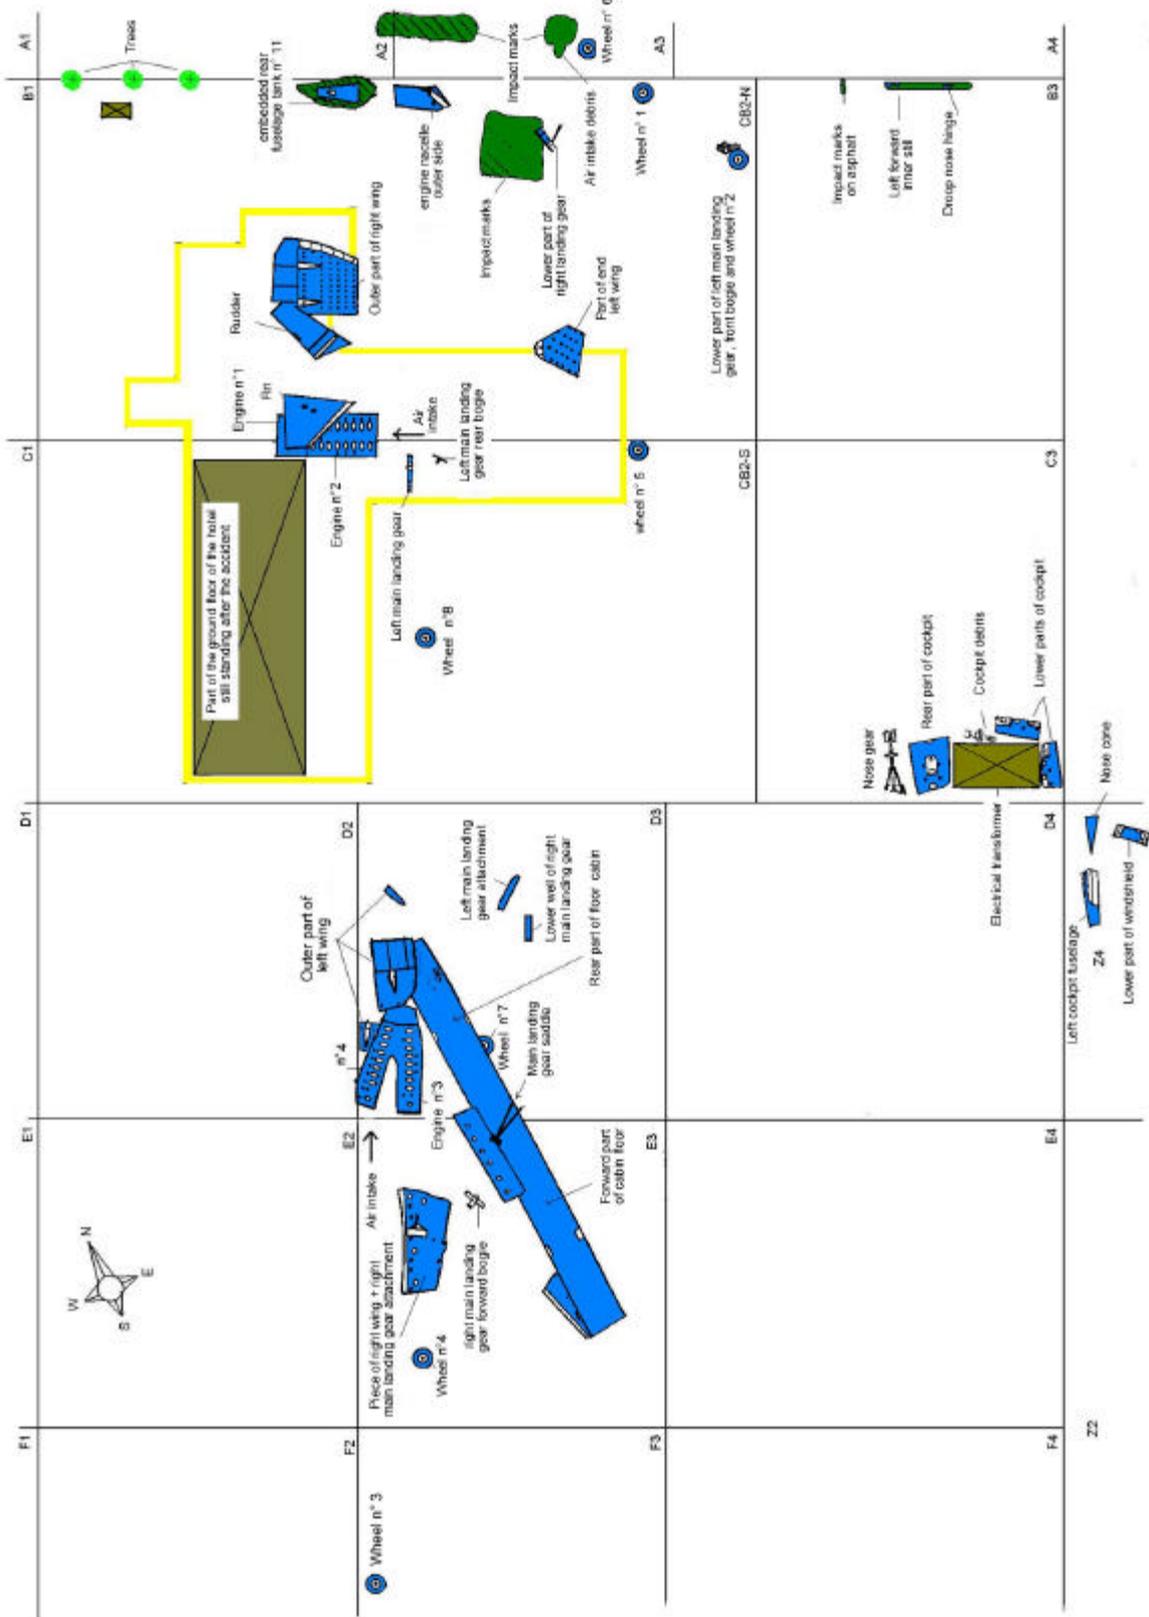
Map showing aircraft wreckage distribution at the crash site

The crash site was divided into a grid. The various areas were referenced to this grid.

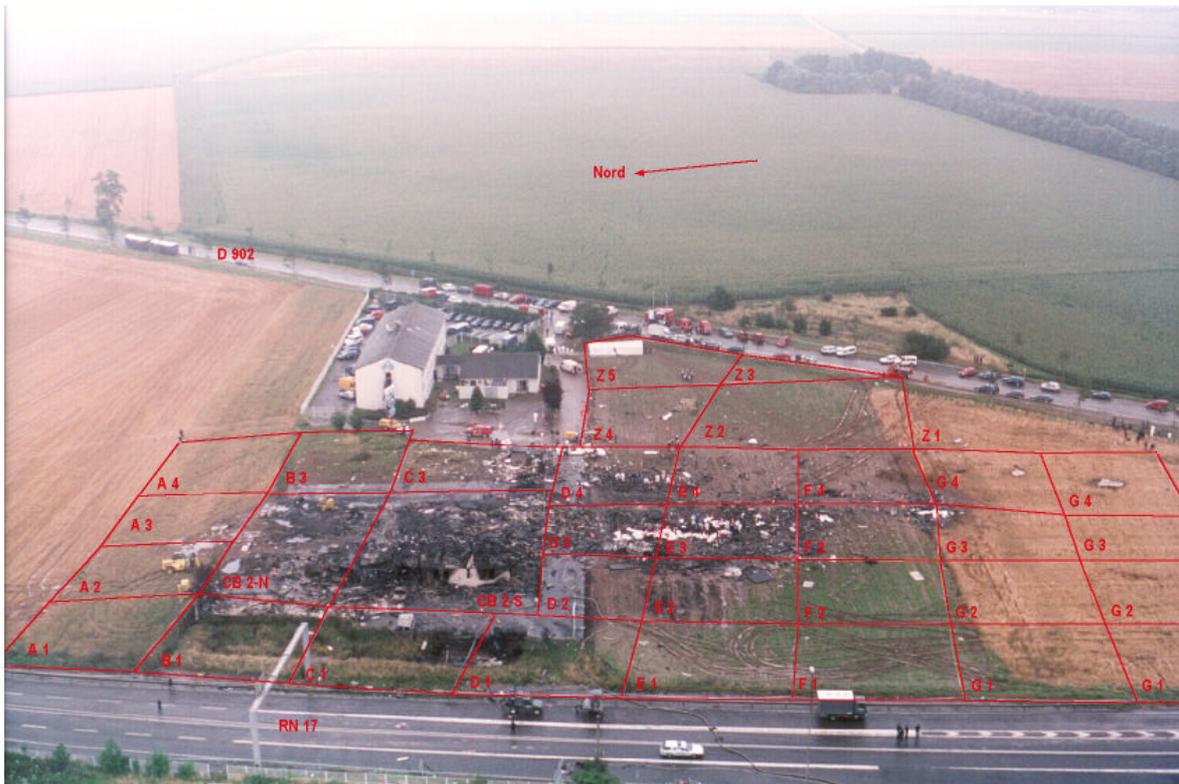
*Aerial view showing grid*

Examination of the site showed that the aircraft had struck the ground on heading 120° left, with little horizontal speed. After the impact, it broke and spread generally to the south, with the aircraft upright.

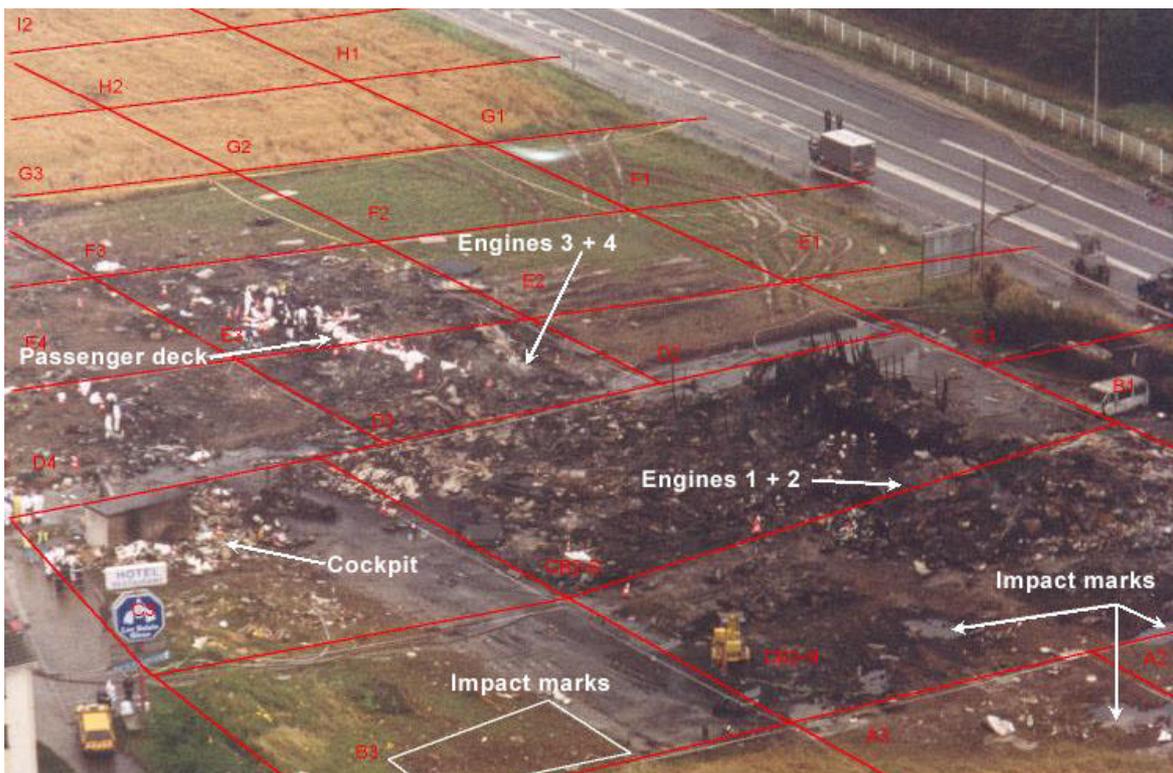
*Aerial view showing location of the main parts*

The hotel located at CB2-North was almost entirely flattened. The lower parts of the left and right main landing gears were close to the initial impact marks.
