Special Investigation Report--Search and
Rescue Procedures and Arming of Emergency
Locator Transmitter: Aircraft Accident near
Michigan City, Indiana, December 7, 1980

11 Aug 81

SPECIAL INVESTIGATION REPORT

NTSB-SIR-81-2

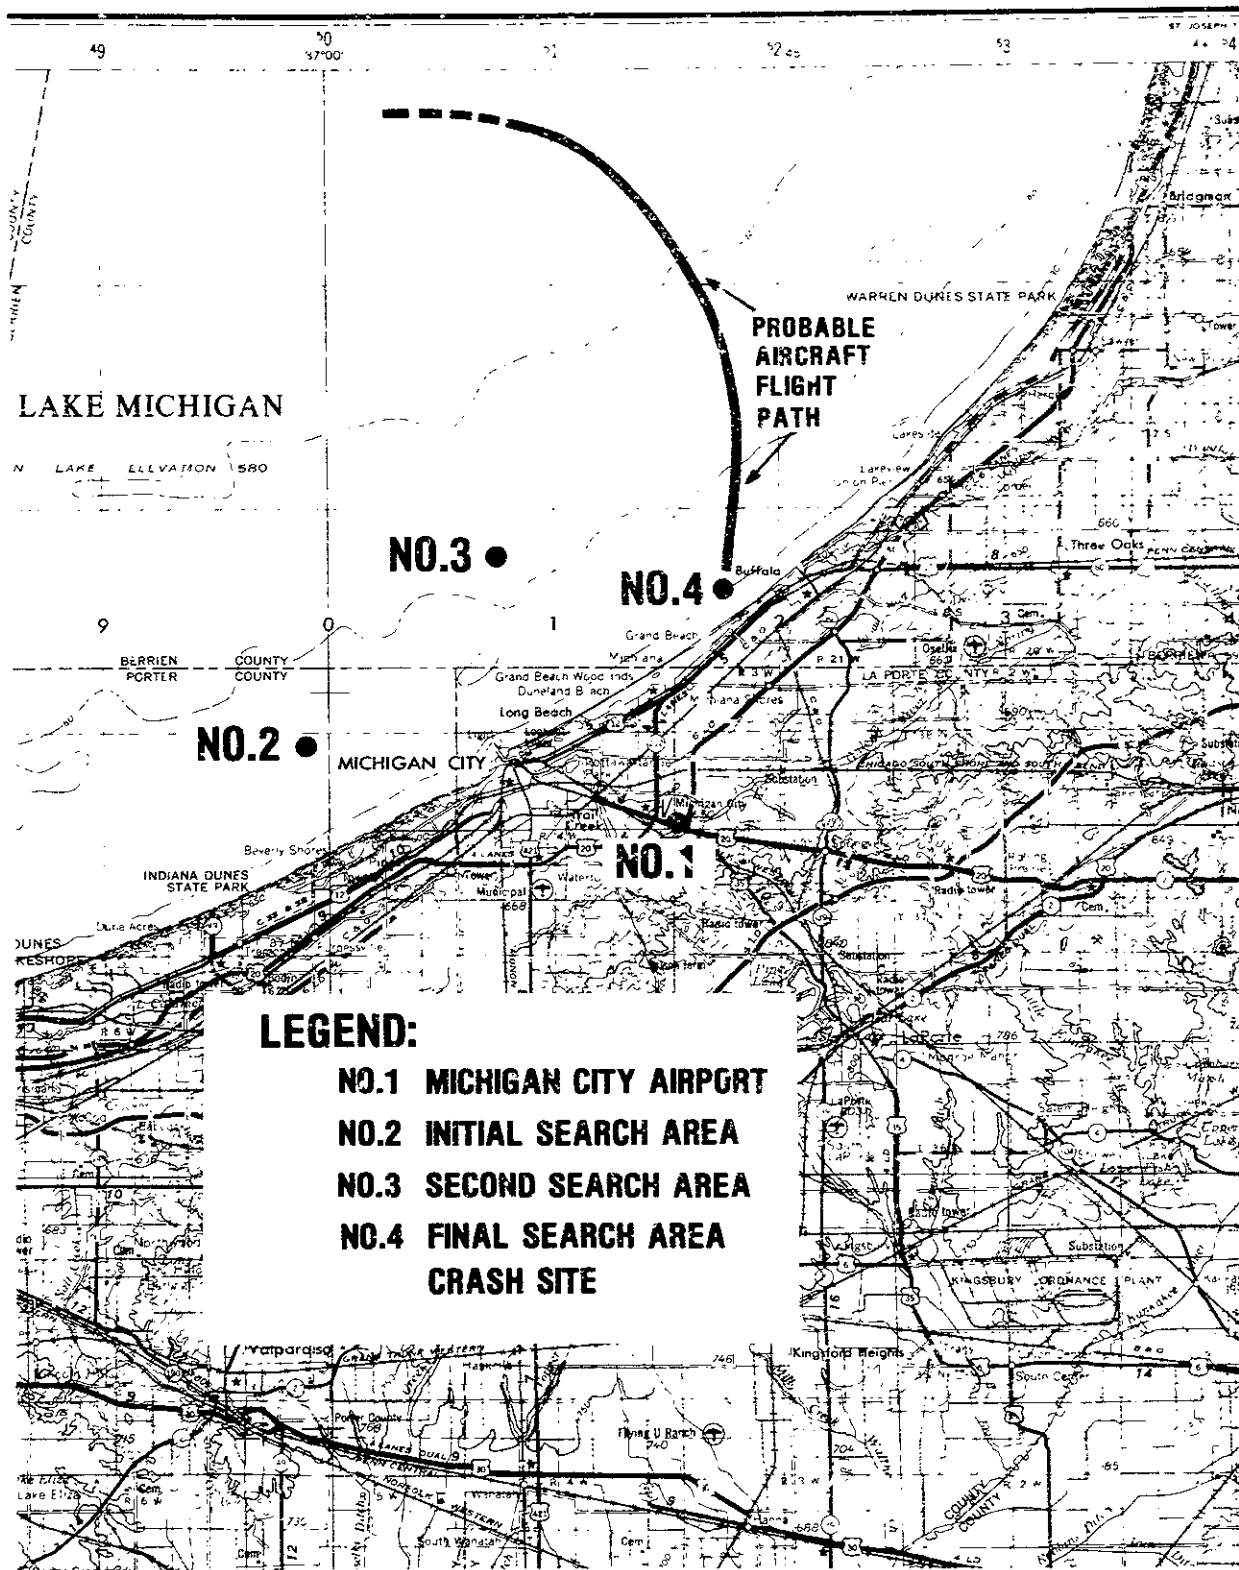
Before the aircraft was removed from Lake Michigan on December 18, 1980, divers made the following observations as the aircraft lay on the bottom of the lake.

The aircraft was inverted with the cabin and nose section buried in the soft sand. The fuselage was stuck in the sand at an angle of about 20° to 30° with the top of the vertical stabilizer resting on the bottom. The vertical stabilizer, rudder, and horizontal stabilizer were not damaged. Both engines were attached. The right engine appeared to be bent to the right; the left engine did not appear damaged. Both propellers were attached to the engines. All propeller blades were visible, except two blades on the right propeller; these two blades were buried in the sand. Both wing sections and ailerons were not damaged; the main cabin door on the left side of the fuselage was closed; the cockpit windows were closed; the emergency escape hatch above the right wing, which can only be opened from within, was not twisted or bent and was found unlatched and open; the main cabin door was opened without difficulty. The main cabin door was closed and latched when the divers first examined the aircraft.
