1. Report No. FAA-AM-72-15	2. Government Accession No.	3. Recipient's Catalog No.	
4. Title and Subtitle CRASH SURVIVAL ANALYSIS OF 16 AGRICULTURAL AIRCRAFT ACCIDENTS		5. Report Date April 1972

CRASH SURVIVAL ANALYSIS OF 16 AGRICULTURAL AIRCRAFT ACCIDENTS

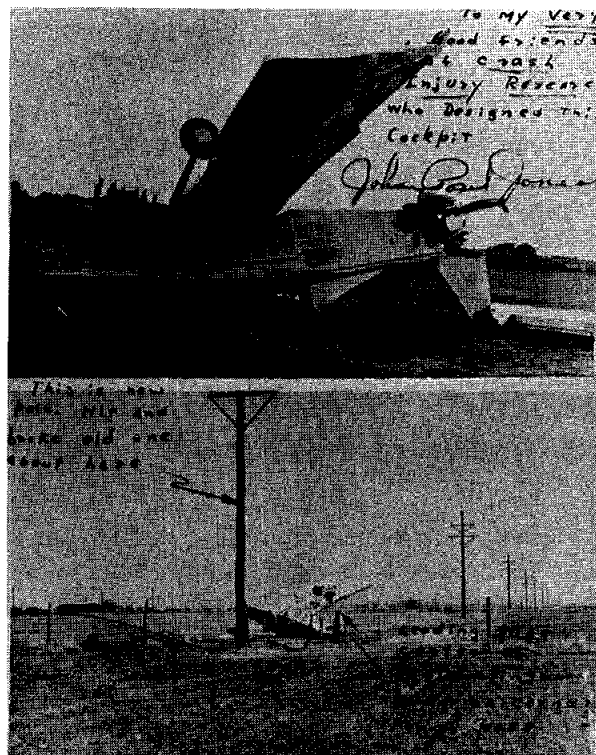
Although only one AG-1 was built (it crashed without injuring the pilot—Figure 2), it served as a prototype for the present fleet of aerial applicator aircraft. The Piper Pawnee, Cessna

FIGURE 2. Scenes at the crash site on the AG-1.

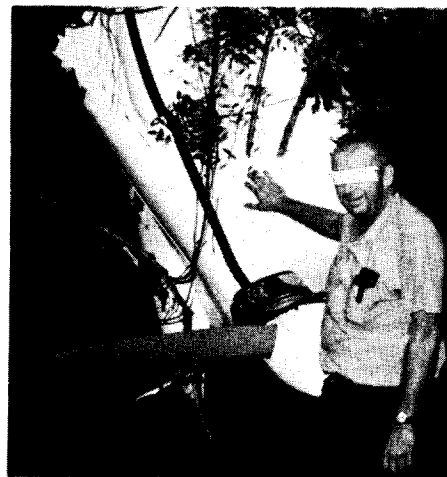
d. Pilot uninjured.

This Callair probably experienced some rather high G forces as it broke off some trees 6 to 8 inches in diameter. The pilot stated that he avoided head injury by bracing his feet up on the instrument panel when he saw he was going to crash.

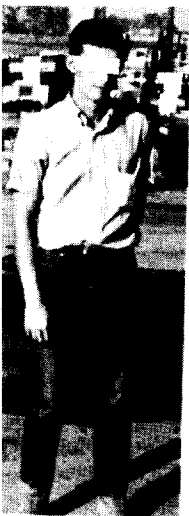
Case 5: This 1963 Piper Pawnee was in a minor crash landing and was flipped over onto its back. The pilot (Case 5-c) was wearing his shoulder harness, a lap belt, and a crash helmet and was uninjured. A significant hazard noted in this accident relates to incipient failure of the roll bar structure in this minor flip-over; slightly more force would probably have resulted in total failure and crushing of the pilot.

c. Photograph of the pilot--no injuries.

A 1963 Piper Pawnee (PA-25-235) was involved in a minor crash and rolled over into an inverted position. Pilot was wearing both lap belt and shoulder harness and there was no failure of this restraint equipment. Use of proper restraint and the integrity of the roll bar cage prevented any injuries in this accident.

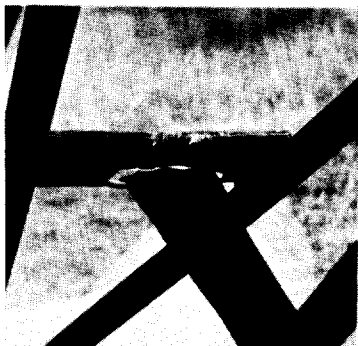
Strong shoulder harness attachment.

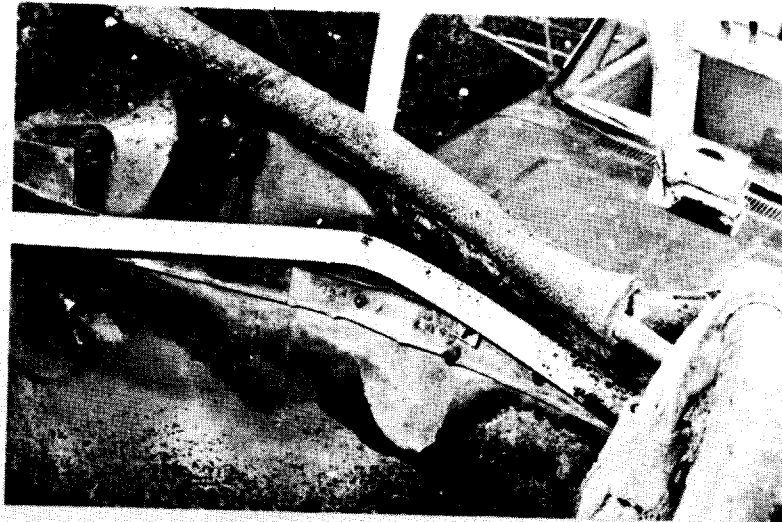
b. Right side of open cockpit.

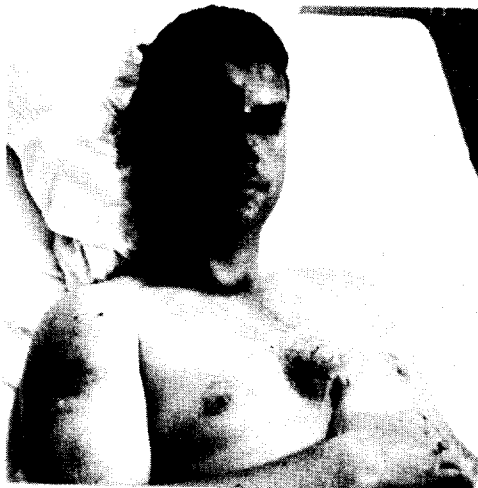
d. Photograph of pilot four days after the crash.

Considering the severity of the crash impact of this 1960 Piper Pawnee (PA-25), it is worth note that the pilot escaped with relatively minor injuries; namely, a fracture of the right frontal sinus, moderate concussion, fracture of left ankle, and minor cuts.
