## Appendix E

### Accident Airplane Maintenance Records

## **Appendix F**

### **Sooting and Fracture Diagrams**

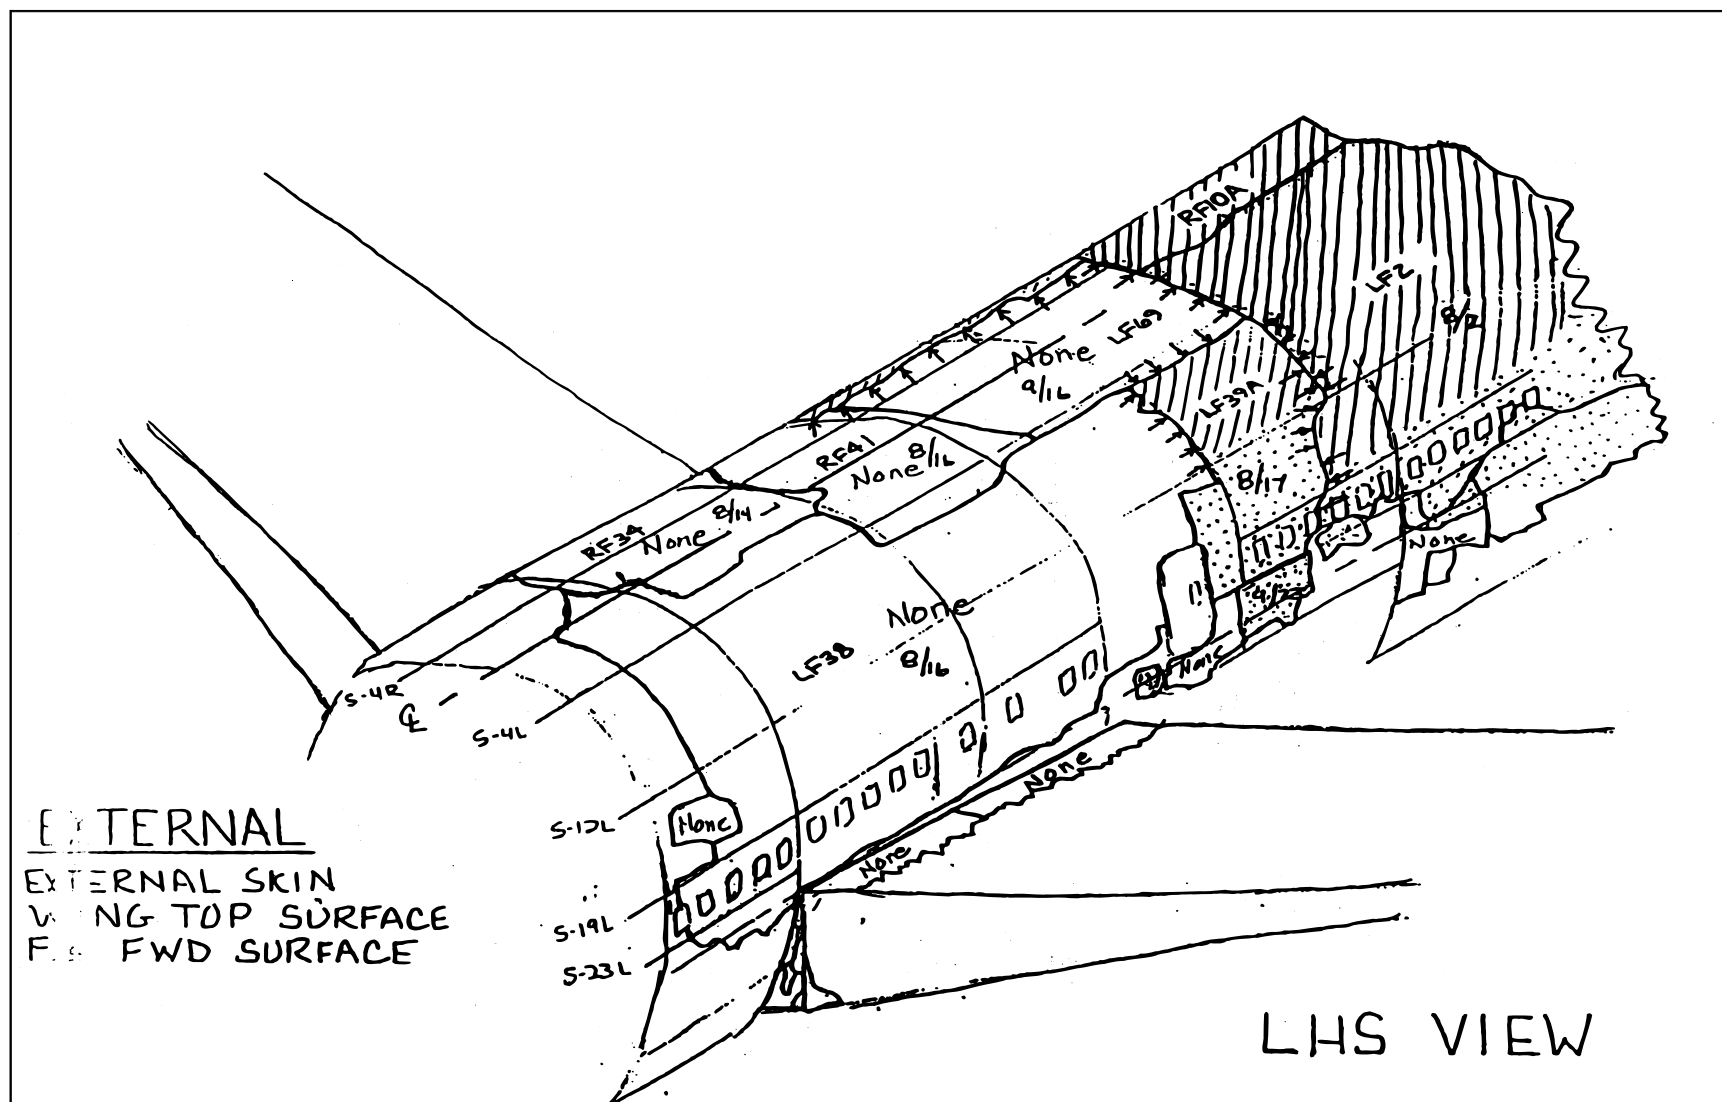
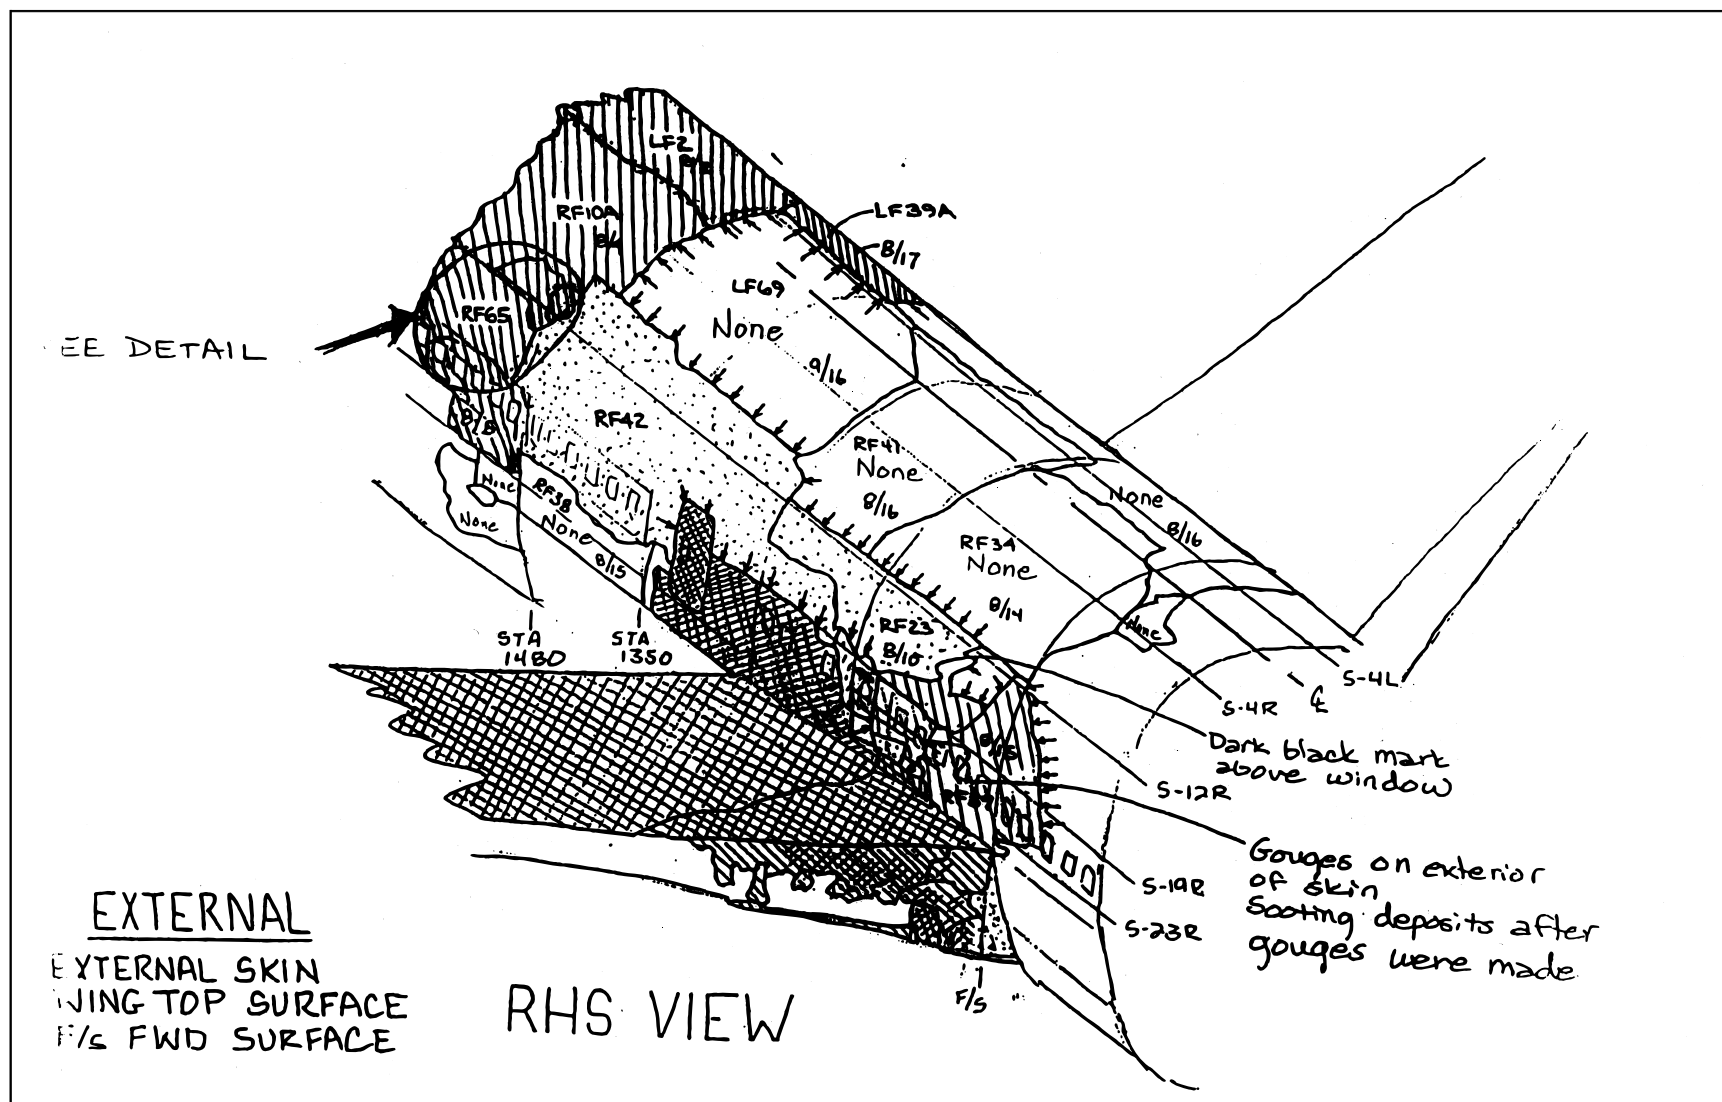
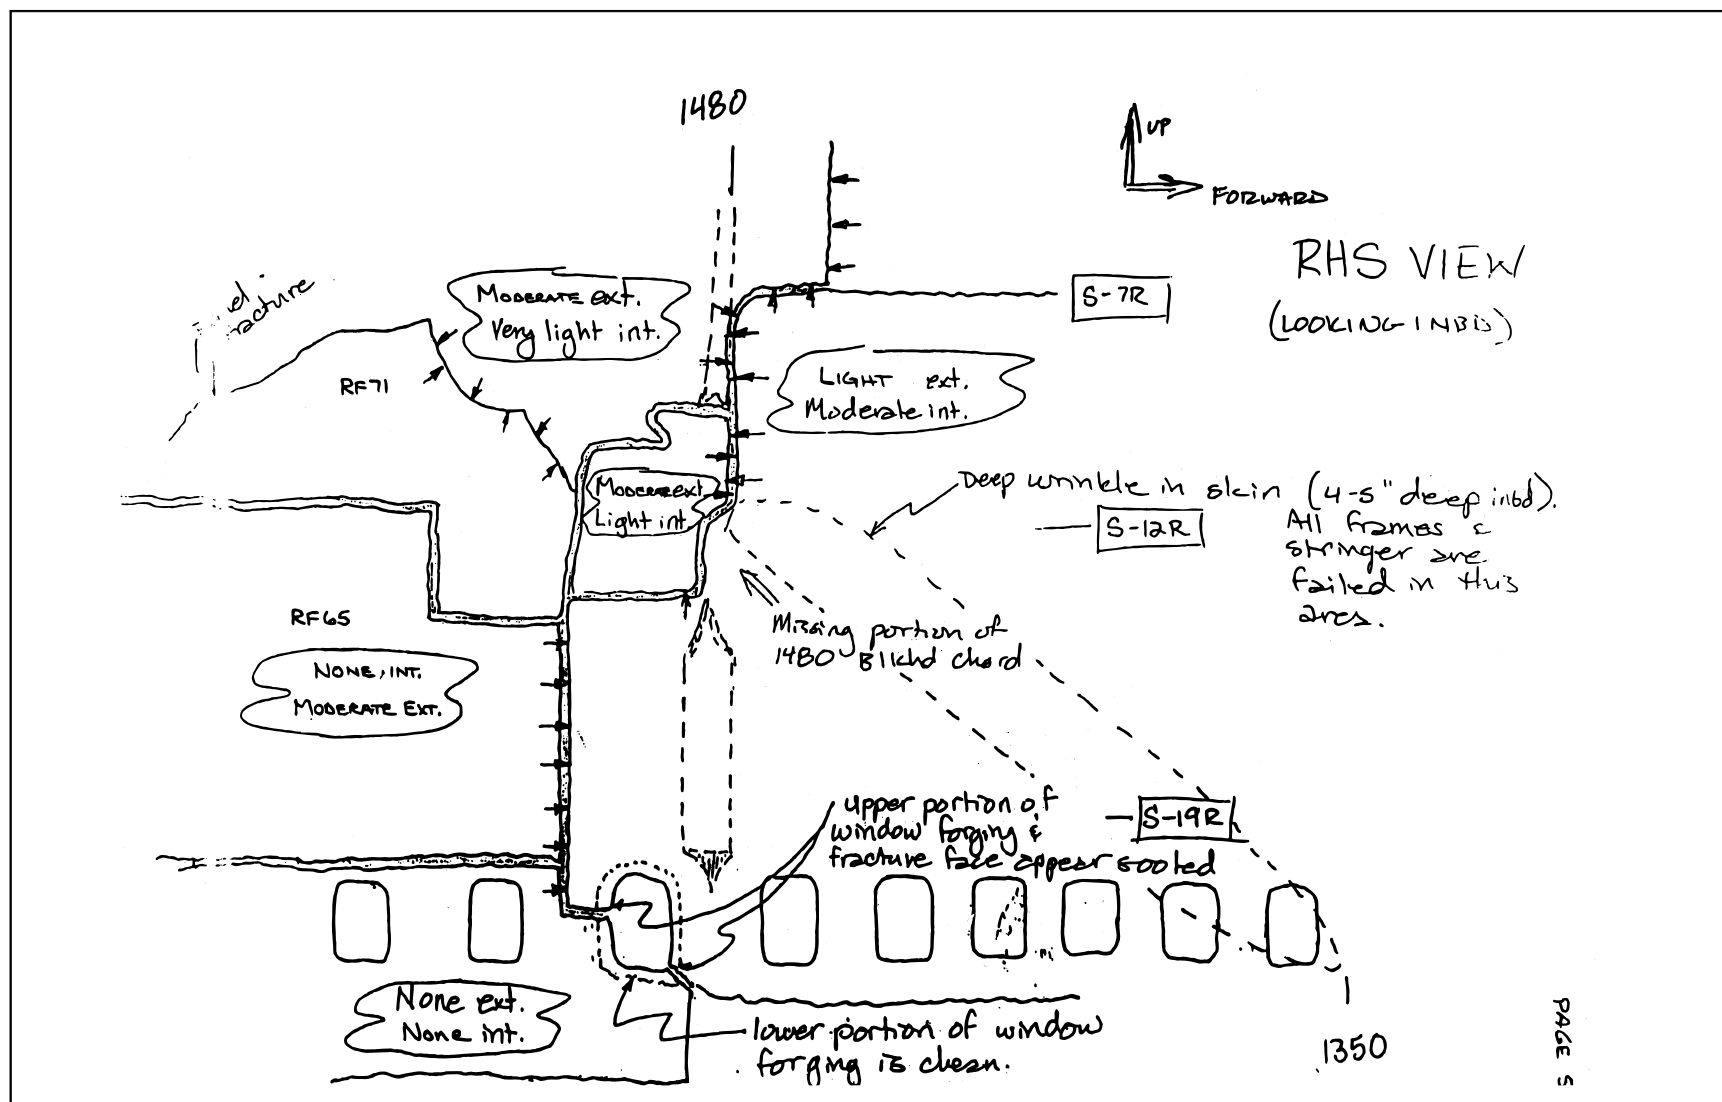
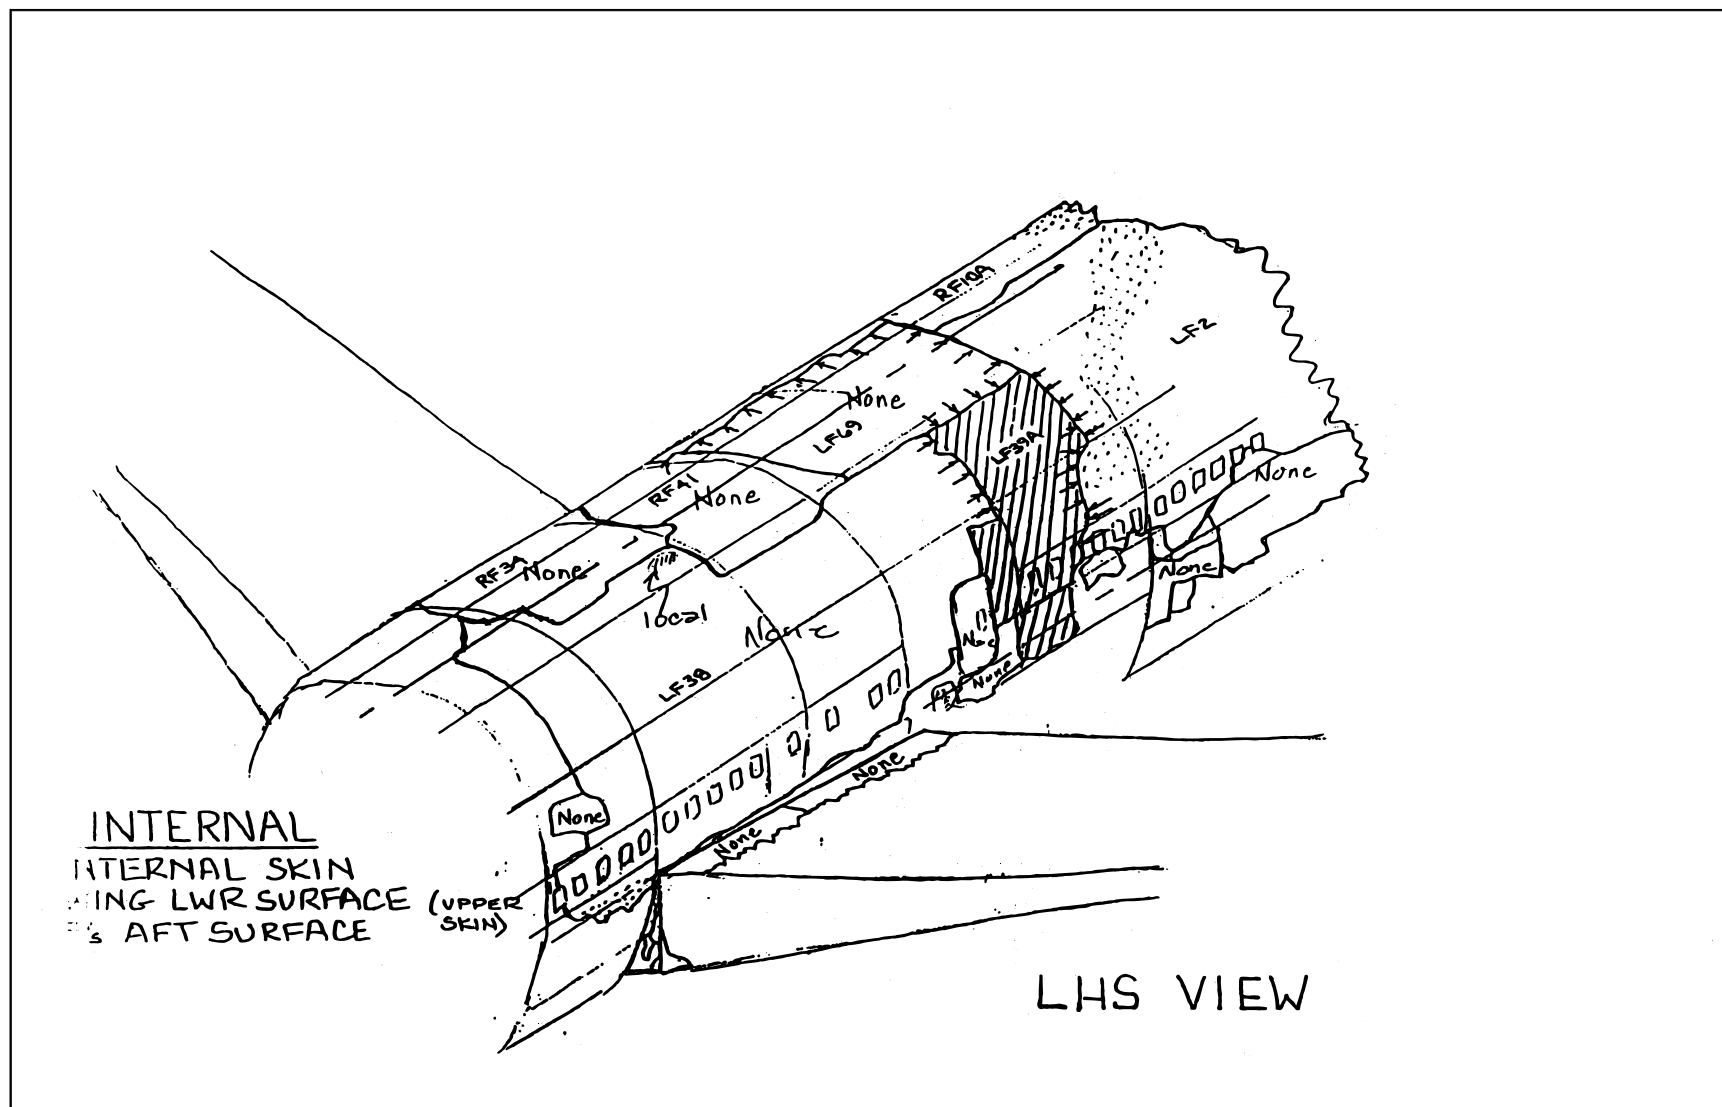
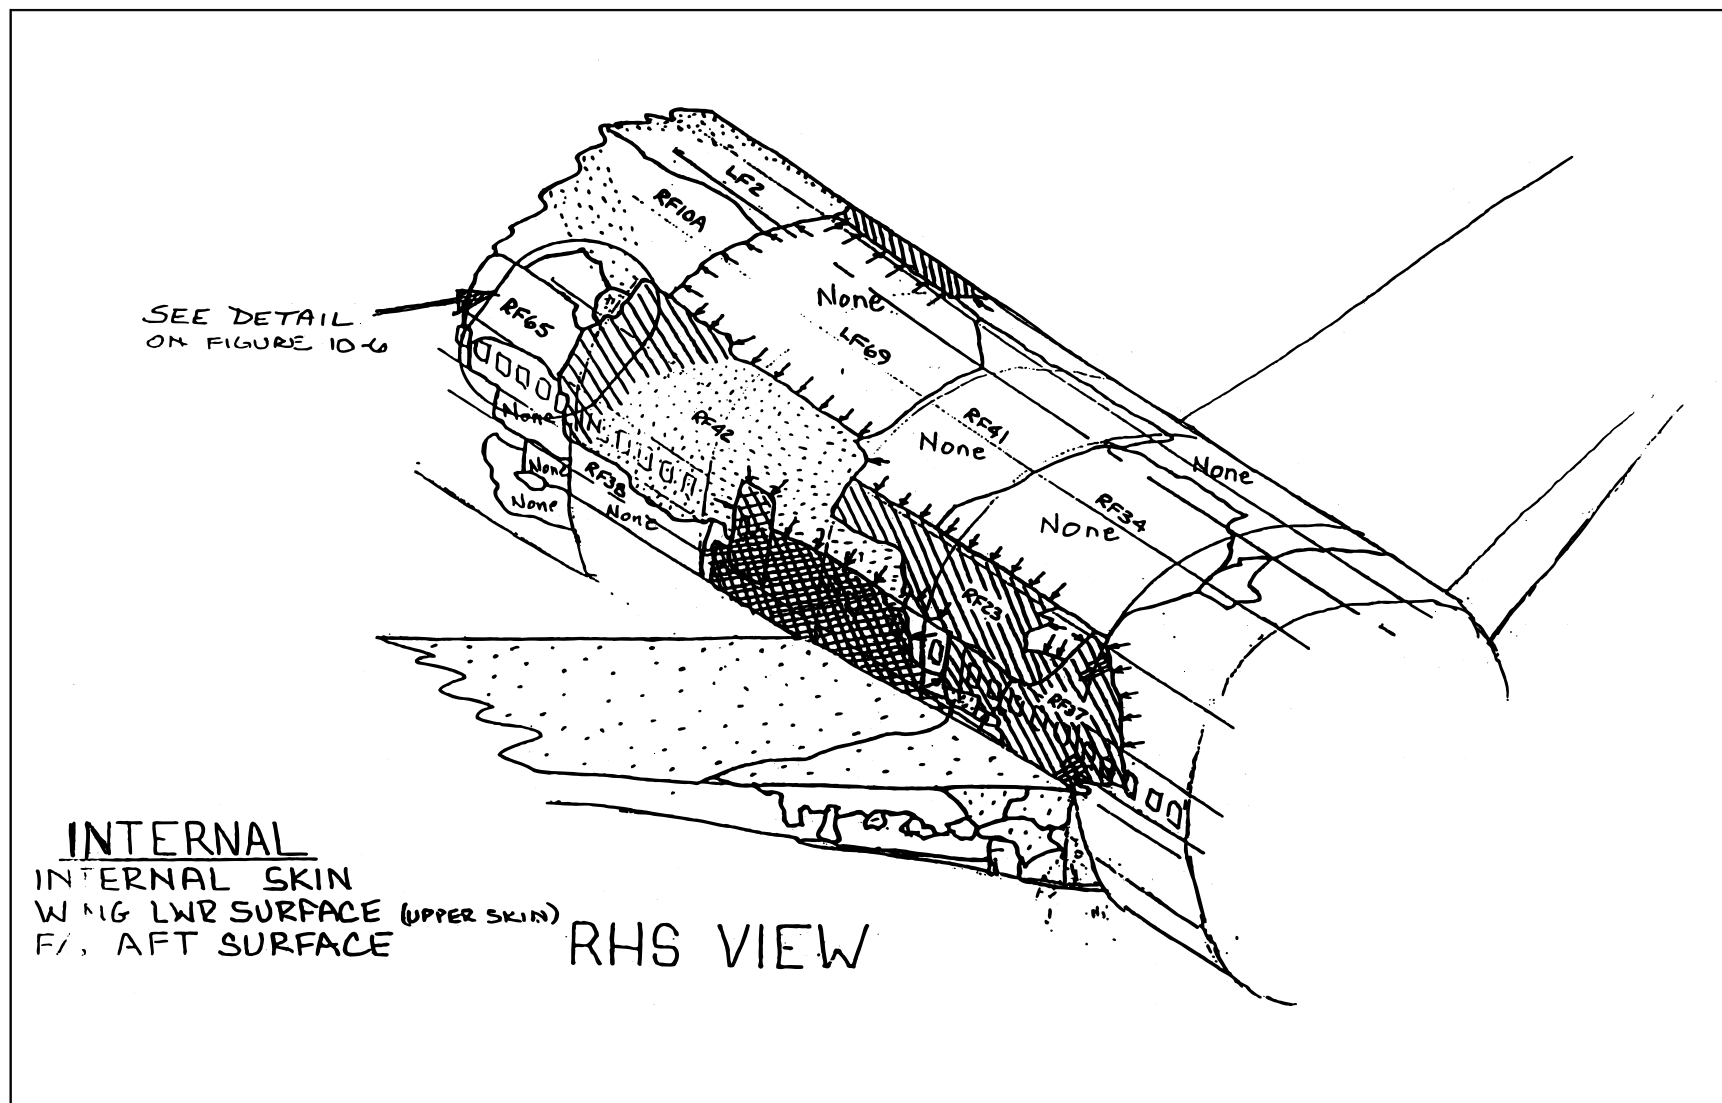
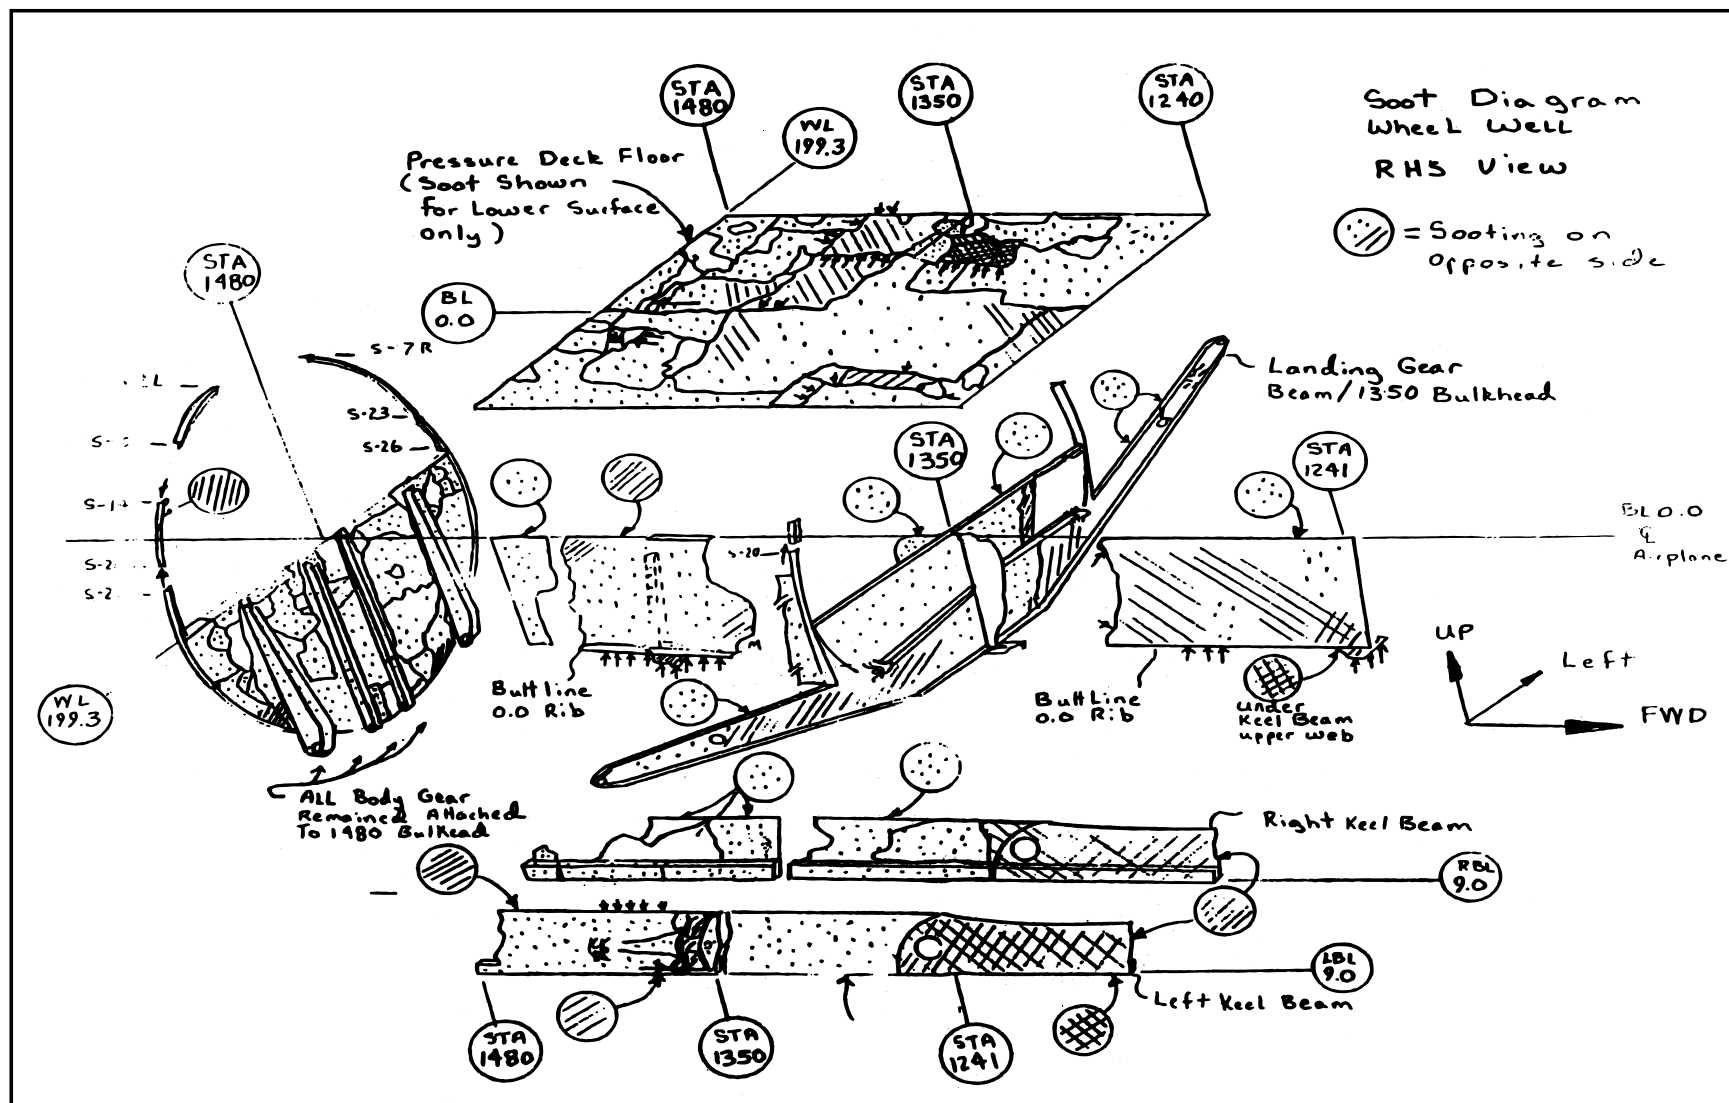
### Fuselage sooting diagrams

Determination primarily made by examining external paint failures near the fracture edge. Soot deposits remain on underlying paint when the top layer peels near fracture.
