**Crash During Landing
Executive Airlines (doing business as
American Eagle) Flight 5401
Avions de Transport Regional 72-212, N438AT
San Juan, Puerto Rico
May 9, 2004**

NTSB/AAR-05/02

**NTSB/AAR-05/02
PB2005-910402
Notation 7650A
Adopted September 7, 2005**

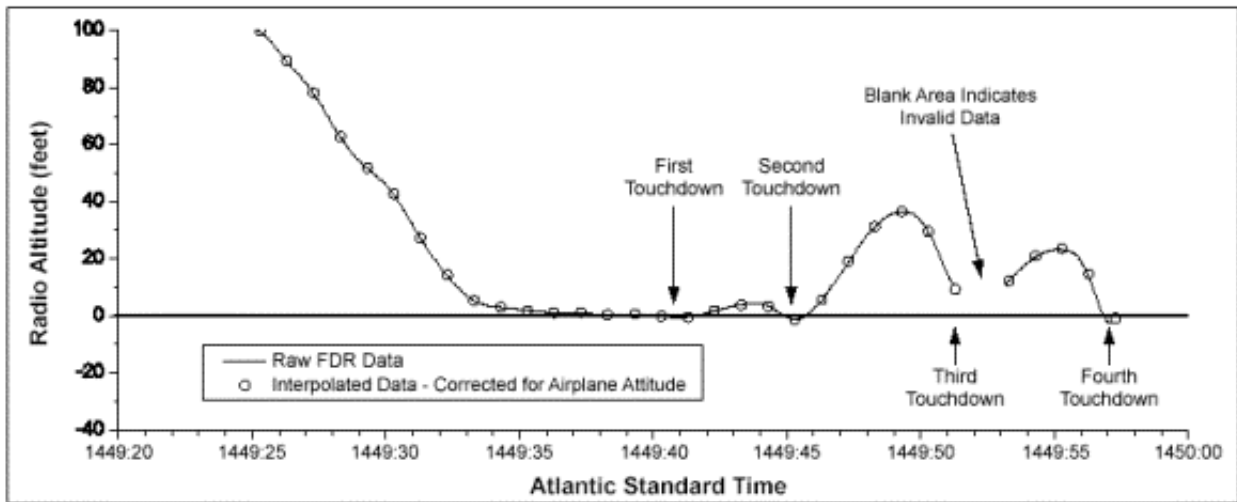
CVR and FDR information indicated that the airplane touched down a fourth time about 1449:56 (about 15 seconds after the initial touchdown) and about 4,000 feet beyond the runway 8 threshold. FDR data indicated that the airplane pitched down to -7° and that it was banked 29° left wing down. The airplane came to a complete stop about 4,317 feet from the runway threshold. Figure 1 shows the ground track of the accident flight, and figure 1a shows the altitude profile of the accident flight.

Figure 1a. Altitude profile of the accident flight.
