Runway Overrun During Rejected Takeoff
Gulfstream Aerospace Corporation G-IV, N121JM
Bedford, Massachusetts
May 31, 2014

NTSB/AAR-15/03
PB2015-105492

Aircraft Accident Report

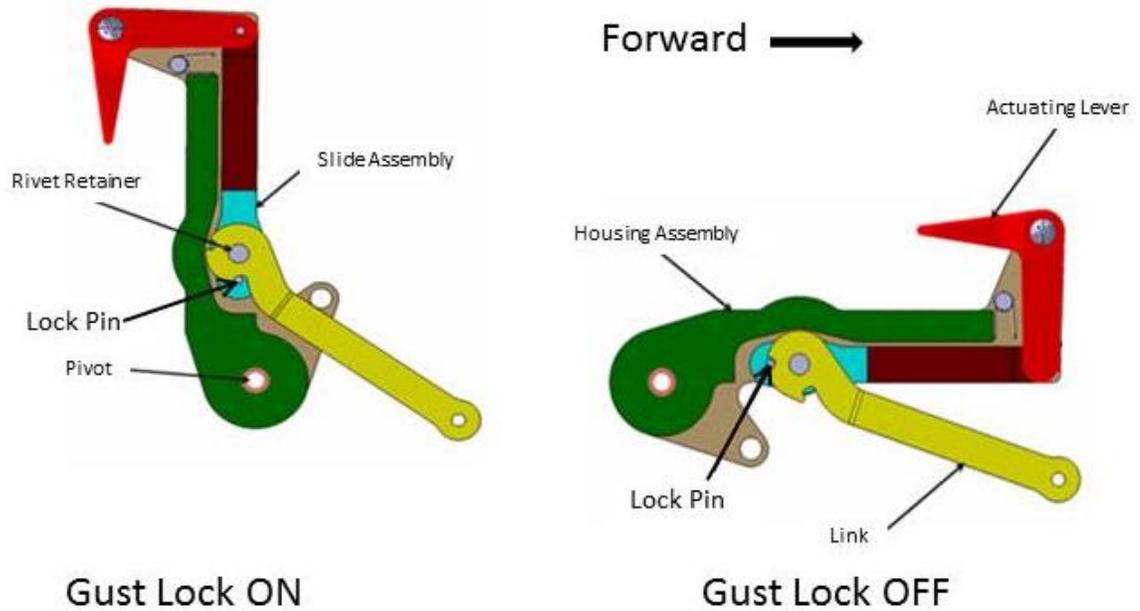
Figure 3. Diagram of a gust lock handle in the ON and OFF positions.

As shown in figure 3, the gust lock handle can be placed in either an up/aft position (gust lock on) or a down/forward position (gust lock off). Moving the handle forward and down to the OFF position releases the gust lock hooks and unlocks the flight control surfaces. Moving the handle aft and up to the ON position engages the gust lock hooks and locks the control surfaces. The gust lock handle latches internally in both the ON and OFF positions. A spring latch operated by the actuating lever must be unlocked before the handle can be moved out of

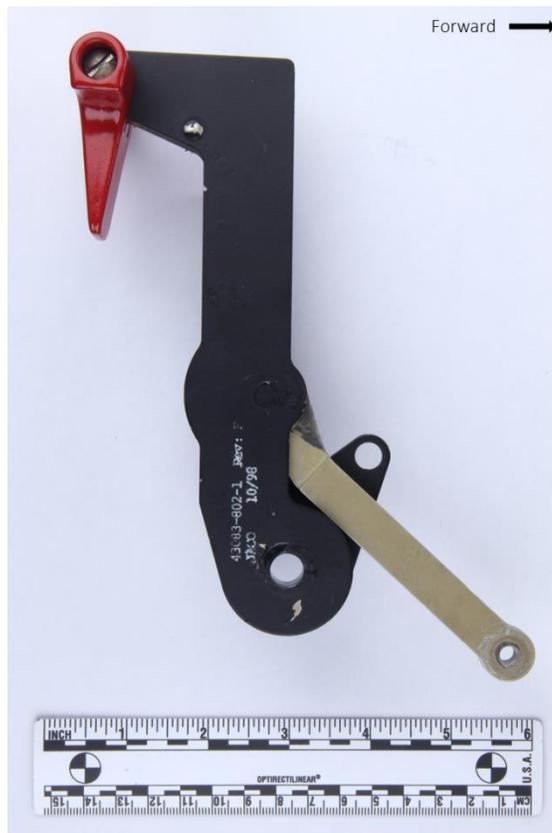
Figure 4a. Photograph of an exemplar gust lock handle in the ON position.

either latched position. The gust lock handle has 87° of rotation from the OFF position to the ON position. Figures 4a and 4b show an exemplar gust lock handle in the ON and OFF positions, respectively.

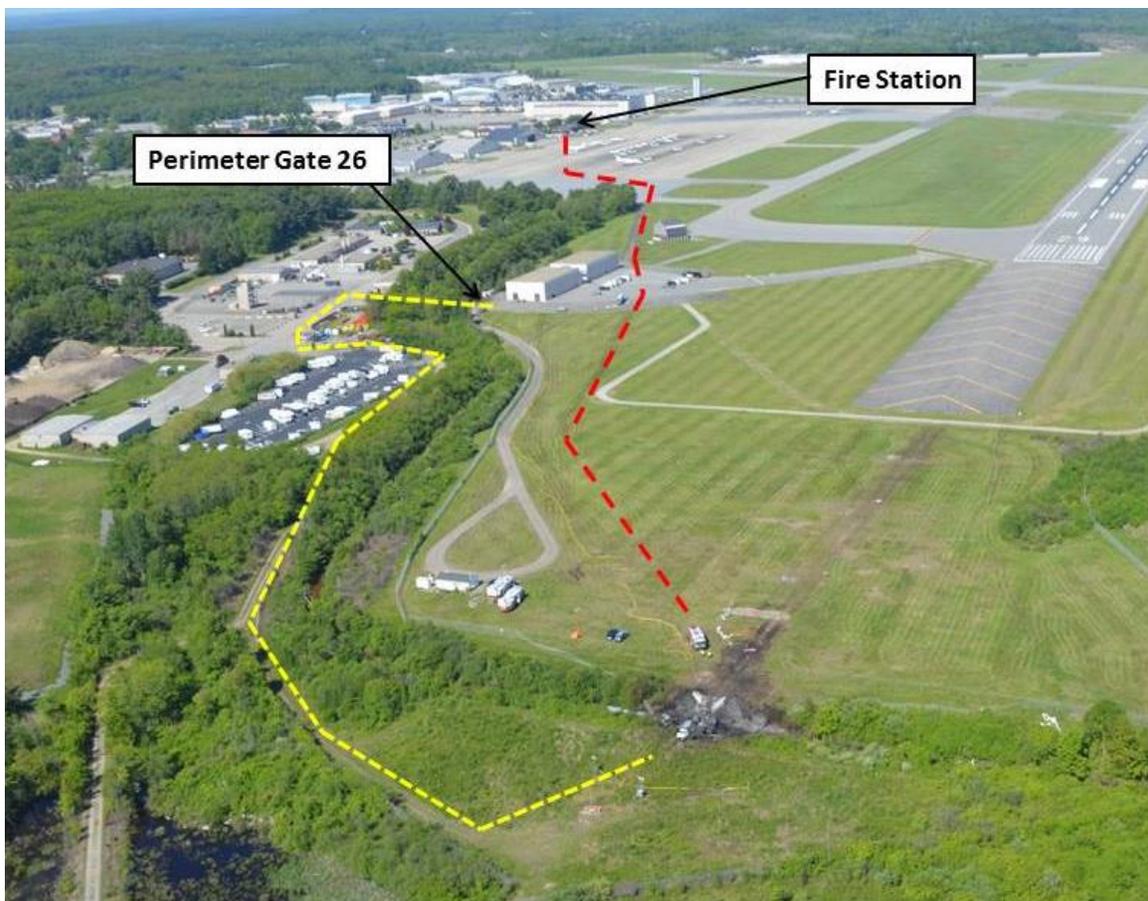
Figure 8. Aerial photograph of BED showing routes to the accident site.

According to the Hanscom AFB-FD chief, seven Hanscom AFB-FD vehicles responded to the accident.²¹ Each vehicle traveled about 4,750 ft from the Hanscom AFB-FD station to the airport side of the ravine. Some of these vehicles subsequently traveled to the nonairport side of the ravine. Figure 8 shows the routes to the accident site. Additional firefighting support was provided by mutual aid from the surrounding towns of Bedford, Lexington, and Lincoln, Massachusetts.

The Hanscom AFB, Lexington, and Lincoln fire departments made numerous attempts to put personnel and equipment on the nonairport or east side of the ravine. About 2229, Engine 6 personnel indicated that they would be “going on the outside thru Hartwell [gate] to see if they can get on the backside of this aircraft,” but Engine 6 personnel did not reach the other side of the ravine. (The Hartwell gate is the main gate to Hanscom AFB; it is not an airport perimeter gate and does not provide access to the east side of the ravine. Airport perimeter gate 26, which is shown in figure 8, does provide access to the east side of the ravine.) About 2244, Engine 4’s fire officer informed the incident commander that there was no way to gain entry to the cockpit from the airport side of the ravine because it was “too steep [and there was] debris in the way.”

Confusion ensued about how to put personnel and equipment on the nonairport (east) side of the ravine to reach the nose of the airplane. About 48 minutes after the initial notification, a Hanscom AFB-FD firefighting vehicle reported that it would attempt to reach the nose of the airplane using the Hartwell gate; however, this gate does not provide access to the east side of the ravine. Perimeter gate 26 located between the fire station and the accident site (shown on figure 8) provides access to the east side of the ravine; however, the location of this gate was not shown on the airport grid map in the BED AEP. According to Massport, the location of the perimeter gate was shown on an airport gate map, but this map was not included in the AEP.

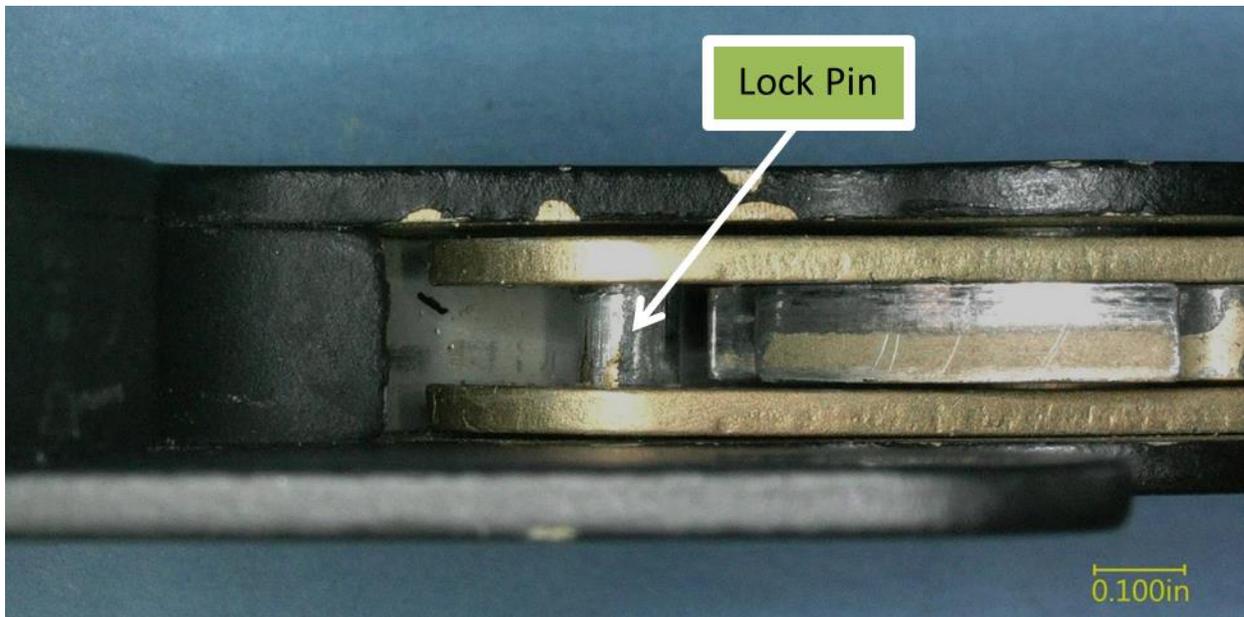
Figure 9b. Photograph of an exemplar gust lock pin.

As previously mentioned, the lock pin in the gust lock handle's slider assembly was broken. The NTSB's laboratory examination revealed that the pin had fractured into at least three pieces with the middle section missing and only small stubs remaining on both sides of the slider assembly. As shown in figure 9a, the left stub piece was recessed into the pin hole in the left side of the slider assembly bracket, and the right stub piece protruded from the pin hole in the right side of the slider assembly bracket into the path of the lock link's travel. Figure 9b shows an exemplar gust lock handle pin.
