Collision with Terrain  
Promech Air, Inc.  
de Havilland DHC-3, N270PA  
Ketchikan, Alaska  
June 25, 2015

NTSB/AAR-17/02  
PB2017-102178

# Aircraft Accident Report

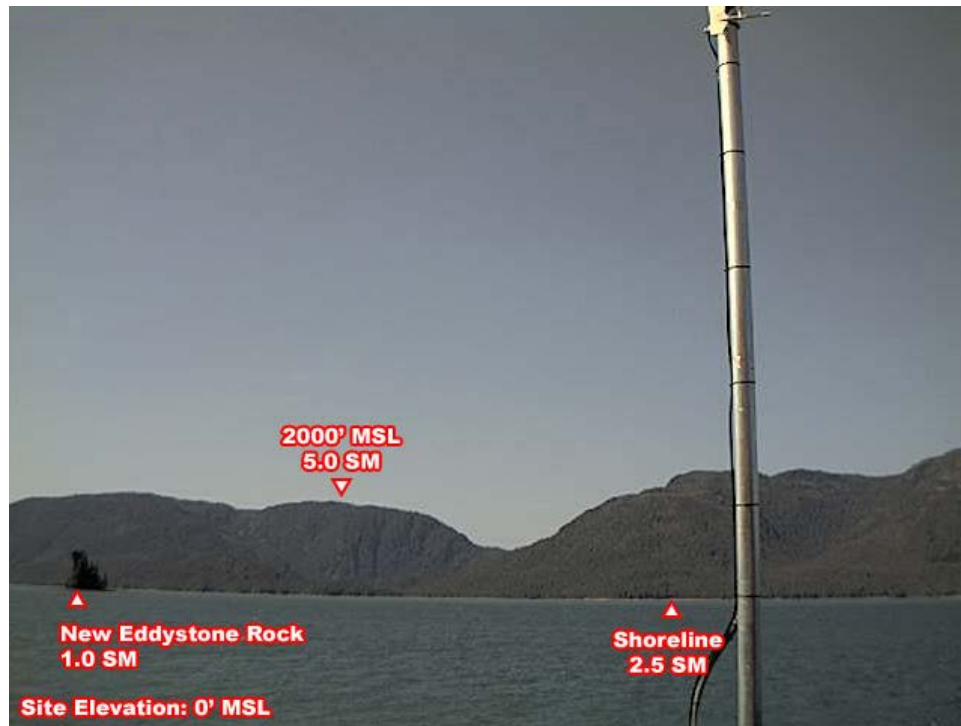
**Figure 9.** Image from west-facing (259°) Misty Fjords camera on a clear day.

Note: Distances to select landmarks are provided for reference, and the accident site is about 5 miles beyond the labeled 2,000-ft ridge. This image, as labeled, appears on the FAA web page for this camera, available from <http://avcams.faa.gov/sitelist.php>.

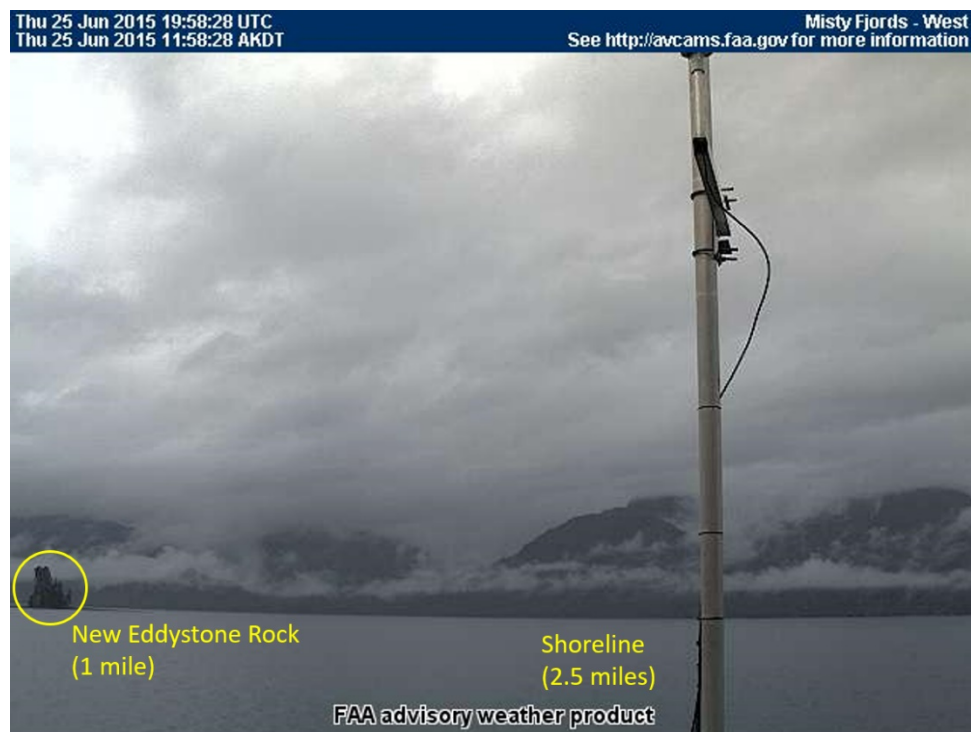
**Figure 10.** Image from west-facing (259°) Misty Fjords camera at 1158, a few minutes before the airplane's departure from Rudyerd Bay.

The following three figures show annotated images from the west-facing Misty Fjords camera. Figure 9 is an exemplar image from a clear day with measured distances to identifiable landmarks labeled for reference. The other two images were captured on the day of the accident; figure 10 was captured at 1158 (a few minutes before the airplane departed), and figure 11 was captured about 3 minutes before the accident. The images show that the higher ridge elevations were obscured by clouds with a layer of stratiform clouds below the peaks. Visibility also decreased during the period with rain.

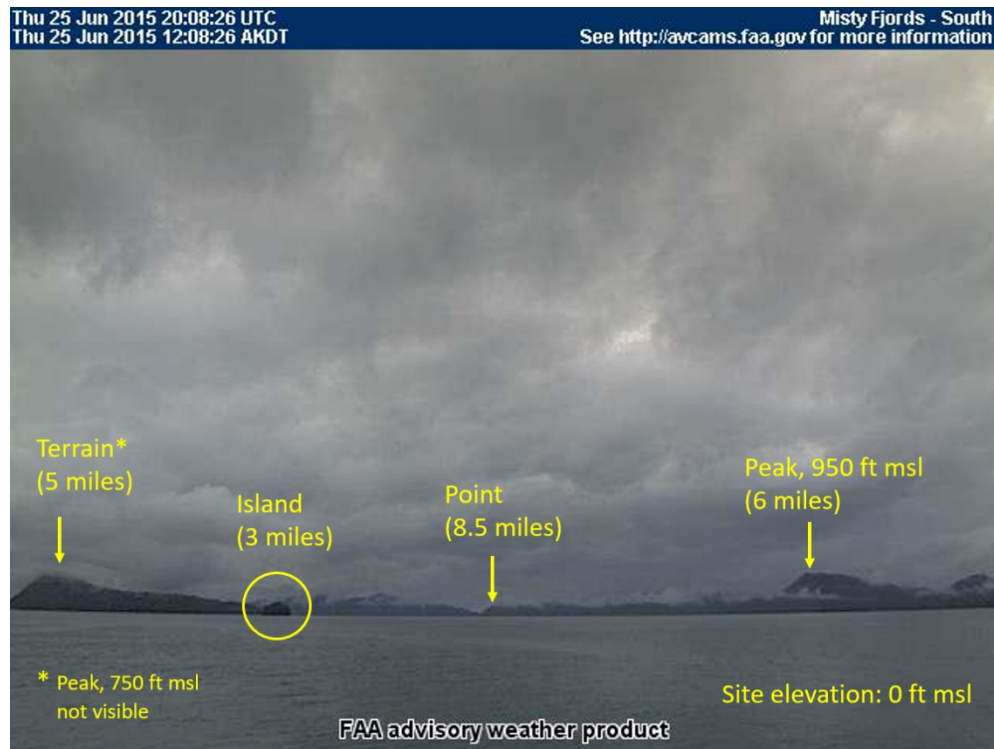
An FAA weather camera in Ketchikan facing toward the accident location also depicted the higher terrain obscured by clouds with visibility restricted less than 1 mile during the period. Figure 12 is an image captured by the south-facing Misty Fjords camera at 1208. This camera view showed that conditions in Behm Canal, which is part of the long route over the water, included good visibility.

**Figure 12.** Image from south-facing (196°) Misty Fjords camera at 1208, showing conditions on the long route over the water.

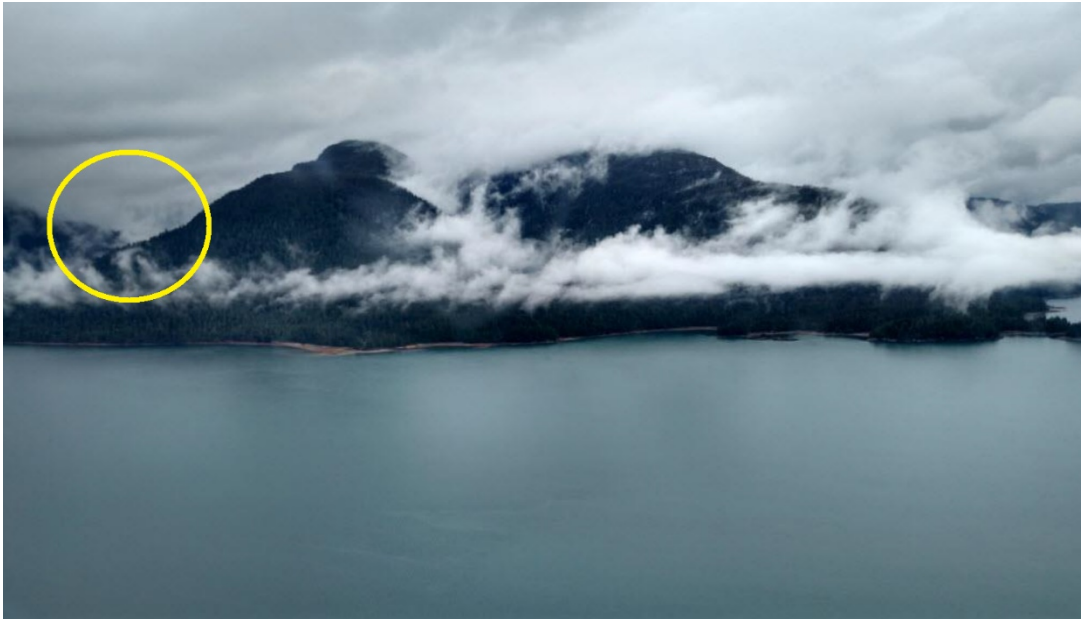
**Figure 13.** Photograph of entrance to Ella Narrows (circled) taken by a passenger on board the first Promech flight in the accident tour group to depart Rudyerd Bay.

The pilot of this first Promech flight stated that, when his flight reached Ella Lake, a cloud ceiling was above the lake about 1,600 to 1,700 ft msl, with a slightly lower ceiling (about 1,400 to 1,600 ft msl) over the south end of the lake. He reported that there were no “jagged edges” or “hanger” clouds below the ceiling. He recalled encountering misty rain and flying near the clouds but said his visibility was never obscured and recalled that he could see Thorne Arm (located about 5 nm from the south end of Ella Lake) while the flight was over the lake.

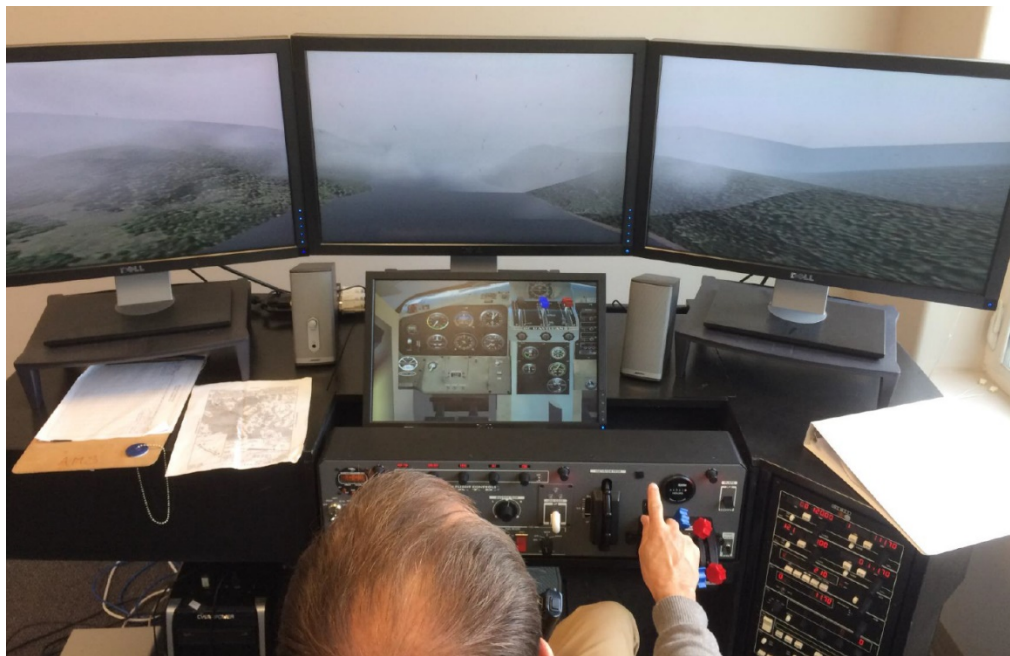
**Figure 15.** Medallion Foundation BATD and CFIT-avoidance training scenario.

Medallion's BATD, in which the accident pilot trained, consists of three 27-inch monitors for the out-the-window view, one smaller monitor for cockpit instrumentation, and physical flight and aircraft system controls (see figure 15). The BATD does not have (and is not required to have) a navigation information display (like the moving map capability of the Chelton EFIS installed in the accident airplane). The BATD uses X-Plane® software and has a separate monitor for the instructor's station.

The cue-based training module that the accident pilot completed in the BATD included a scenario that required him to escape an inadvertent encounter with IMC by reversing course. NTSB investigators observed a demonstration of the training module, which involved an overwater flight with progressively decreasing cloud ceiling and visibility. Investigators noted that both the ceiling height and forward visibility were uniform and transitioned abruptly when adjusted by the instructor. Also, the terrain features and ground texture were not photorealistic.
