Rapid Descent Into Terrain
Island Express Helicopters Inc.
Sikorsky S-76B, N72EX
Calabasas, California
January 26, 2020

NTSB/AAR-21/01
PB2021-100900

Aircraft Accident Report

Abstract: This report discusses the January 26, 2020, accident involving a Sikorsky S-76B helicopter, N72EX, being operated by Island Express Helicopters Inc. as a Title 14 *Code of Federal Regulations (CFR)* Part 135 on-demand flight, that crashed into terrain in Calabasas, California. The pilot and the eight passengers died. Safety issues identified in this report include the pilot's preflight weather and flight risk planning, the flight's entry into instrument meteorological conditions and the pilot's inadequate adverse weather avoidance, the pilot's spatial disorientation, influences on the pilot's decision to continue the flight into adverse weather, Island Express' incomplete implementation of its safety management system (SMS), the benefits of a mandatory SMS, the benefits of flight simulation devices for pilot training in adverse weather avoidance, the benefits of a flight data monitoring program, and the value of crash-resistant flight recorder systems in preventing future accidents. As a result of

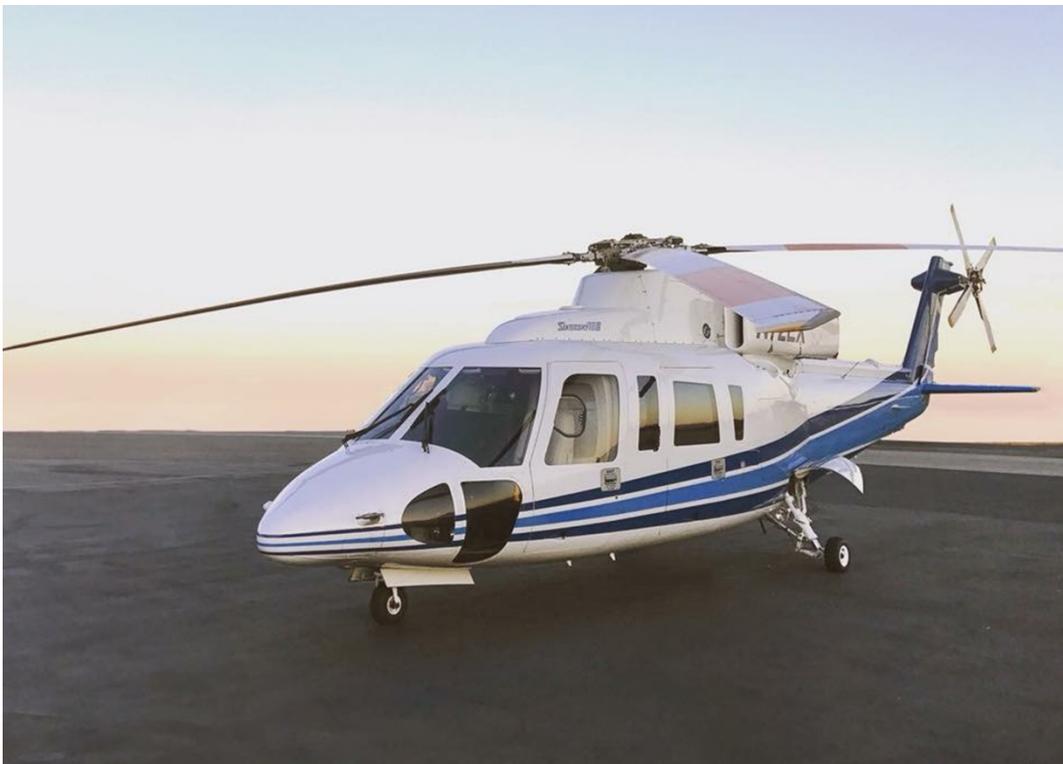
Figure 1. Preaccident photograph of the accident helicopter.

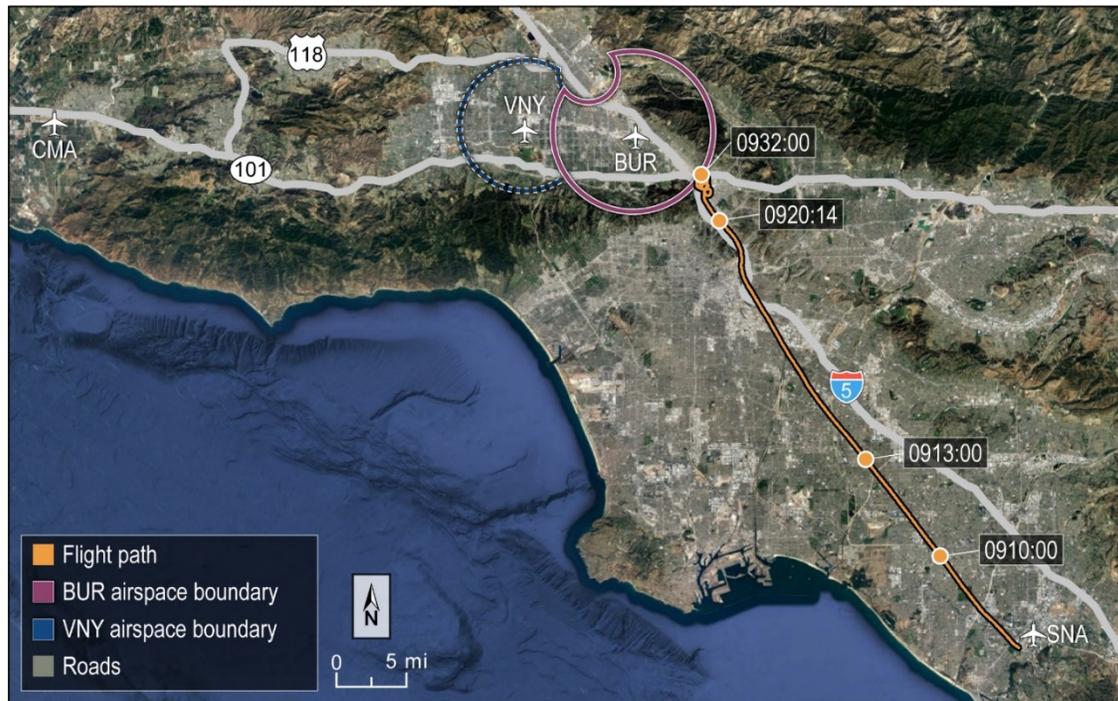
Between about 0921 and 0932, the helicopter circled outside of the BUR airspace on the southeast side near US 101 at altitudes that varied between about 900 to 1,100 ft msl (400 to 650 ft agl over varied terrain heights), and its groundspeed varied between about 40 and 70 kts. At 0927:52, the BUR ATC tower controller advised the pilot that, due to multiple airplanes departing the Van Nuys Airport (VNY), Van Nuys, California, to the south, the pilot could expect to head north to follow Interstate 5 (I-5) before crossing the VNY airspace to head west toward CMA, and the pilot replied, “no problem” (see figure 2).

Figure 2. Accident flight's departure from SNA and holding turns southeast of BUR until 0932.

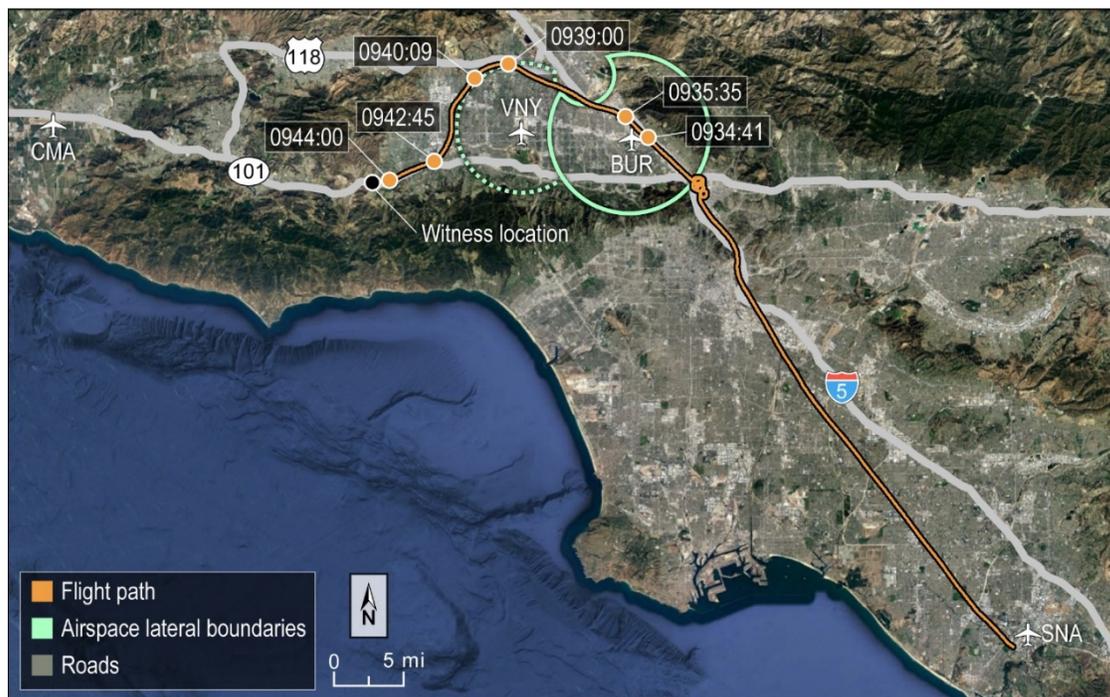
At 0942:45, the helicopter reached US 101 and began to follow it west toward CMA while flying about 1,420 ft msl (550 ft agl). According to the helicopter performance study, the helicopter’s groundspeed was about 140 kts. A witness who saw the helicopter flying over US 101 reported fog and overcast cloud conditions that varied with “heavy low clouds” in some places and areas where the clouds were “quite high.” She saw the helicopter flying “below or at the cloud line” before it “disappeared into heavy clouds” that she described as a “thick wall.” Based on ADS-B data, the helicopter was at the location the witness described about 0944:32 and was at an altitude of about 1,370 ft msl (450 ft agl) (see figure 3).

Figure 3. Accident flight’s path up to 0944:32 and location of ground witness.

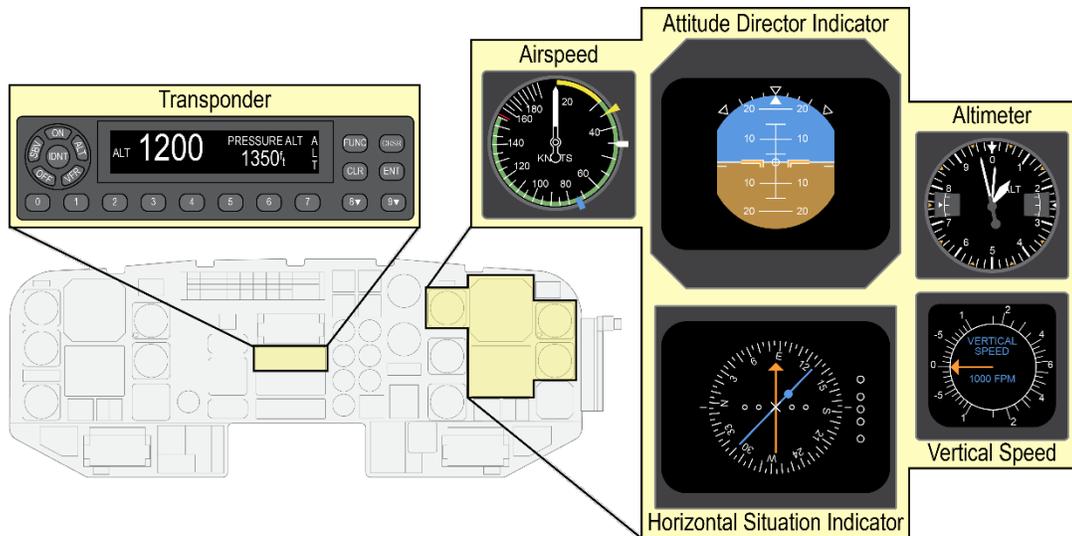
The DAFCS was integrated with the helicopter's Honeywell EDZ-705 electronic flight instrument system, which provided attitude director indicator and horizontal situation indicator information to both the pilot's and copilot's displays. The helicopter's instruments also included two airspeed indicators, two altimeters, a standby attitude indicator, and two Mode S transponders with GPS and ADS-B "out" capabilities. The relative locations of select instruments for the pilot (right side of the cockpit) and a transponder are shown in figure 6.

Figure 6. Exemplar instruments and transponder.

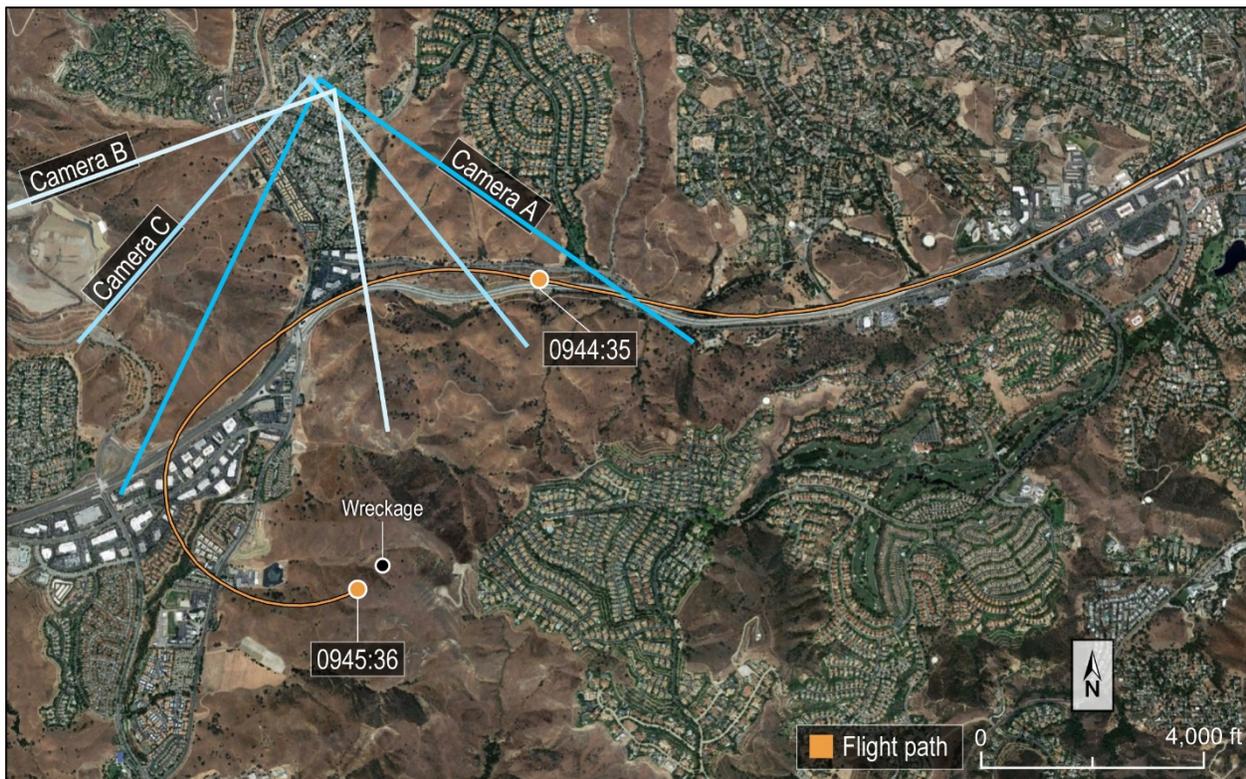
The NTSB performed a visibility study using videos captured by three generally south-facing cameras located at baseball fields about 1.8 miles north of the accident site. Based on the imagery, sound spectrum analysis of the audio, and ADS-B data for the accident flight, the study determined that, between 0944:35 and the time of the accident, segments of the accident flight passed within the field of view of one or more of the cameras (see figure 11).³⁷

Figure 11. Relative locations of camera fields of view to the accident flight and accident site.
