AIRCRAFT ACCIDENT REPORT

TEXAS INTERNATIONAL AIRLINES, INC.

DOUGLAS DC-9, N1308T

JANUARY 11, 1970

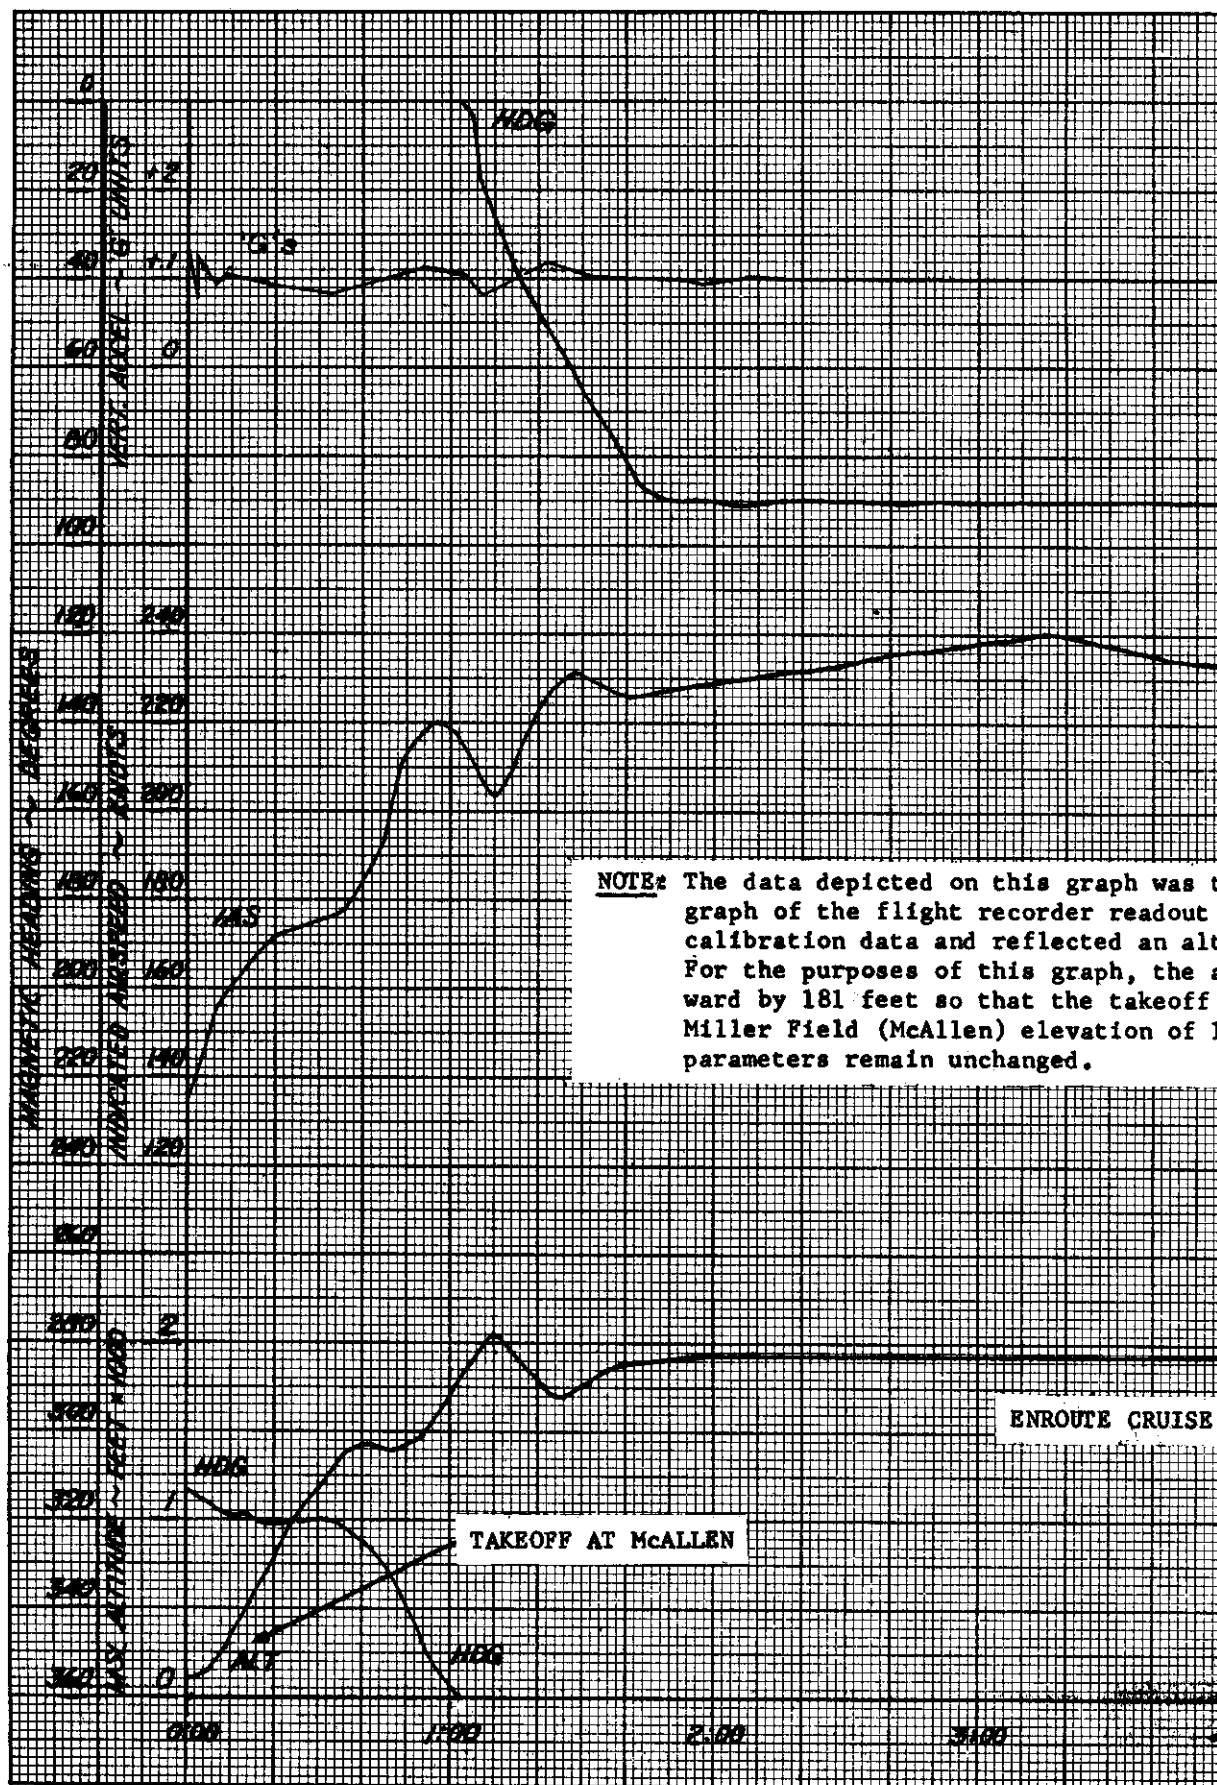
dicted on this graph was taken from the original data
 flight recorder readout which was based on Fairchild
 data and reflected an altitude of -75 feet for takeoff.
 poses of this graph, the altitude trace was shifted up-
 feet so that the takeoff portion coincides with the
 (McAllen) elevation of 106 feet MSL. The other three
 remain unchanged.
