AIRCRAFT ACCIDENT REPORT

Delta Air Lines, Inc.
Douglas DC-9-32, N3329L
Louisville, Kentucky
September 8, 1970

NATIONAL TRANSPORTATION SAFETY BOARD
Washington, D. C. 20591
REPORT NUMBER: NTSB-AAR-71-15

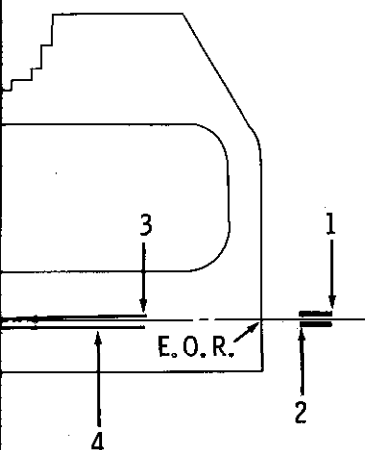
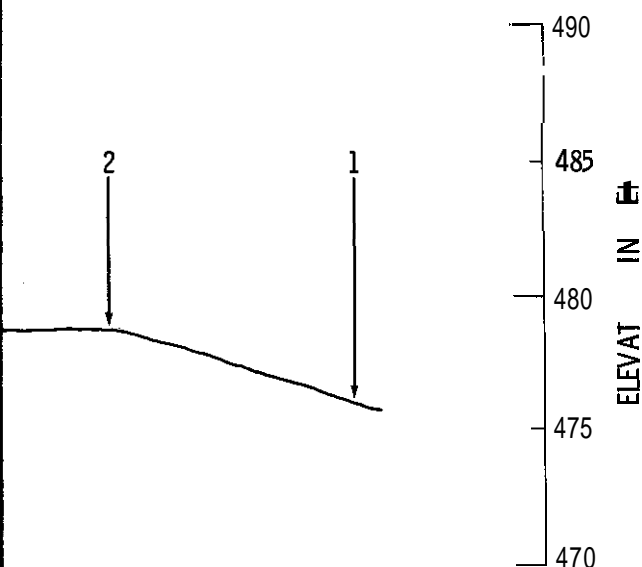
PLAN AND PROFILE VIEW OF RUNWAY 29

1. TOUCHDOWN POINTS OF THE LEFT AND RIGHT MAIN LANDING GEAR TIRES 156 FEET BEFORE THE RUNWAY THRESHOLD.
2. TRACKS OF THE LEFT AND RIGHT MAIN LANDING GEAR TIRES END 83 FEET BEFORE THE RUNWAY THRESHOLD.
3. INDICATIONS OF REAR FUSELAGE CONTACT ON THE RUNWAY 262 FEET FROM THE THRESHOLD.
4. INDICATIONS OF THE LEFT MAIN LANDING GEAR TIRES SKIDDING ON THE RUNWAY SURFACE 385 FEET FROM THE THRESHOLD AND 8 FEET TO THE LEFT OF THE RUNWAY CENTERLINE.
5. INDICATIONS THAT THE LEFT MAIN LANDING GEAR TIRES HAD BLOWN-OUT 1,488 FEET FROM THE RUNWAY THRESHOLD AND 16 FEET TO THE LEFT OF THE RUNWAY CENTERLINE.
6. STOPPING POINT OF THE AIRCRAFT ON THE RUNWAY 4,457 FEET FROM THE THRESHOLD.
