AIRCRAFT ACCIDENT REPORT

CAPITOL INTERNATIONAL AIRWAYS , INC .

DC-8-63F, N4909C

REPORT NUMBER: NTSB-AAR-72-12

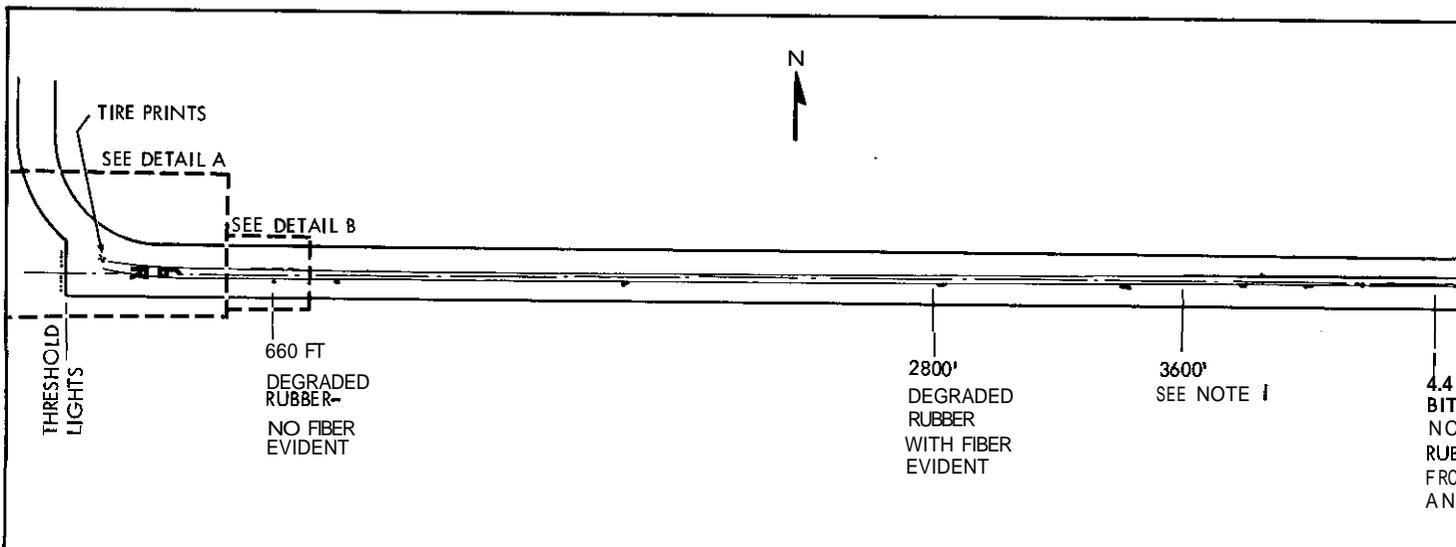
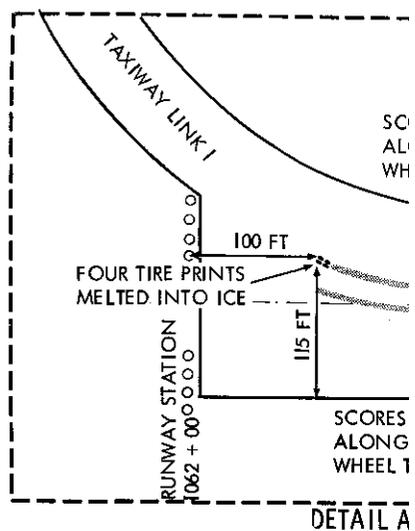
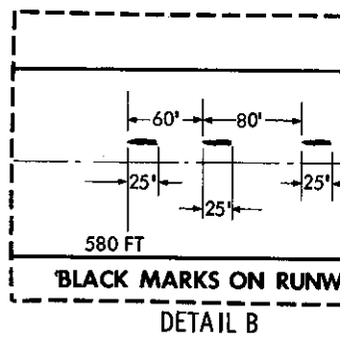
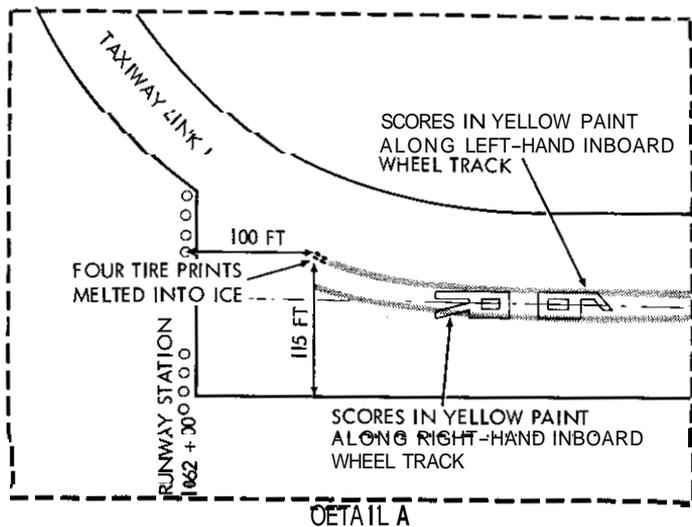
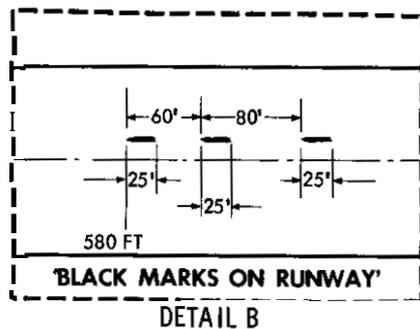
NOTE 1

LH INBD WHEEL TRACK LEAVING
DARK TRACK WITH DARK BAND
(1/2" TO 2") ON LH EDGE. TRACK
CEASED AT 4400', BUT NARROW
BAND AND SCORING OF RUNWAY
CONTINUED TO END OF RUNWAY
